State of Washington Department of Ecology
Cruise Ship Memorandum of Understanding, Cruise Operations in Washington State Inspection Report

Inspection Date August 2, 2014	Permit Number NA	County King	Receiving Waters Marine Waters	Ecology Inspector Amy Jankowiak
Entry Time 8:53 am	Photos Taken	Samples Taken	Inspection Announced	Discharges to: <input checked="" type="checkbox"/> Surface Water
Exit Time 10:44 am	<input checked="" type="checkbox"/> Yes <input type="checkbox"/> No	<input type="checkbox"/> Yes <input checked="" type="checkbox"/> No	<input checked="" type="checkbox"/> Yes <input type="checkbox"/> No	<input type="checkbox"/> Ground Water <input type="checkbox"/> Dewater <input type="checkbox"/> POTW
Name and Location of Site Inspected: NORWEGIAN JEWEL, Norwegian Cruise Line Pier 66 Seattle, Washington				Additional Participants/Inspectors:
On-Site Representative(s): <i>Name/Title/Phone/e-mail</i> Spiros Zervopoulos, Environmental Officer Env21@NCL.com				
Responsible Official(s): <i>Name/Title/Address/Phone/e-mail</i> Randall R. Fiebrandt, Director, Environmental Operations Norwegian Cruise Line 7665 Corporate Center Drive, Miami, FL 33126 rfiebrandt@ncl.com 305-436-4956

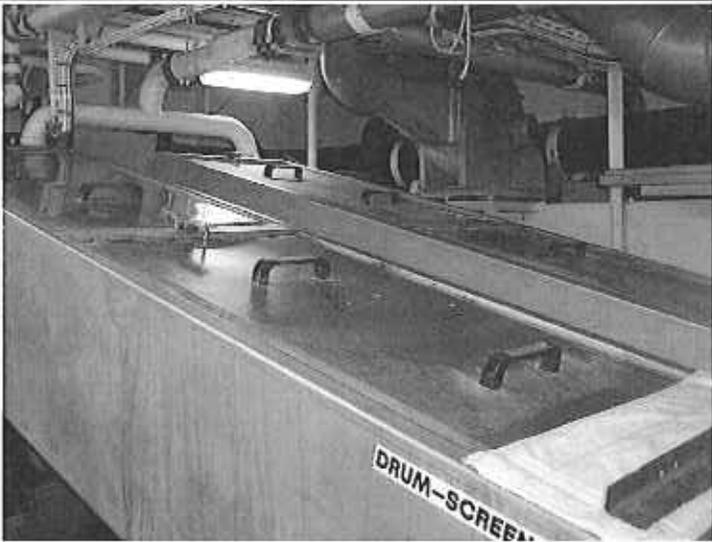
Blackwater, which includes toilet waste and infirmity drains by vacuum to one of the collection tanks and graywater which includes sink and shower water, galley water, spa water and laundry water, combines in tanks before combining and entering the drum screens. There are two drum screens (photo #03) which provide pre-screening. The drum screens are cleaned weekly with water. Solids from the drum screens go to the sludge tank (photo #17). Liquid flow from the drum screens then enters the biostep tanks (photos #04 and #05) for biological treatment (biofilm on rotating plastic pieces – 2 tanks in series, air added). After biostep, coagulants and polymers are added (photo #08). Clarification then occurs via flotation tanks (photos #06, #07 and #09). Solids from the flotation tanks are sent to the sludge tank along with the screenings to be held for later discharge. Liquid flow then moves to the polishing filters (photo #10) for ultrafiltration (2 rotating mesh drums). Flow then moves to ultraviolet light (UV) disinfection (photo #14). There are three UV units, of which two are typically used with 14 bulbs each. The bulbs are alarmed for bulb failure and intensity. The UV sleeves are cleaned by dosing Ameroid RSR cleaner automatically, daily. The UV light sleeves are also hand wiped about once a month. Effluent (photo #13) from the UV units is either discharged directly overboard via the discharge port (photo #15) or is held for discharge later outside of MOU waters. The engineer showed us how the valve system works when the turbidity is raised (photo #12). A total suspended solids (TSS) meter measures solids (equivalent to turbidity) continuously at the UV system. The TSS meter is alarmed at 30 mg/l to shut down the discharge. Effluent pH is also continuously monitored (photo #11). And flow is measured at the discharge port (photo #16). The Scanship operator said that the meter only spikes when cleaning occurs.

PHOTO #:03 DATE: AUGUST 2, 2014
TAKEN BY: AMY JANKOWIAK FILE No.: P8020124
DESCRIPTION: SCANSHIP SCREENS

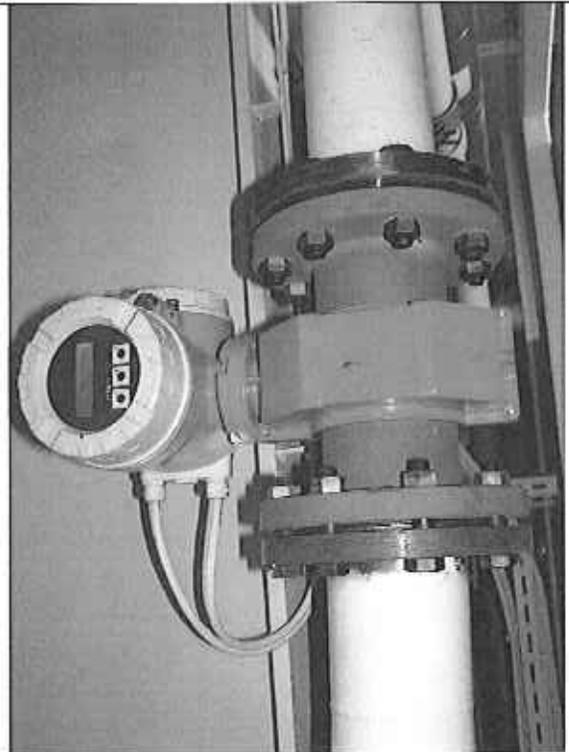
PHOTO #:16 AUGUST 2, 2014
TAKEN BY: AMY JANKOWIAK FILE No.: P8020145
DESCRIPTION: SCANSHIP DISCHARGE PORT FLOW METER

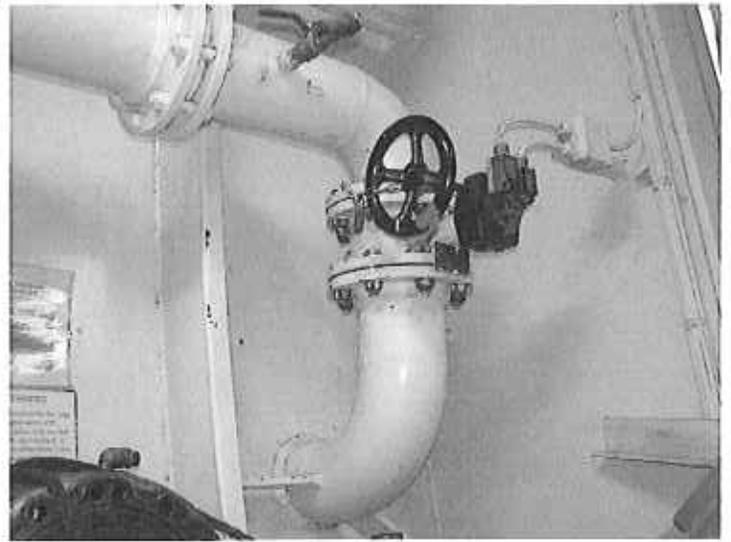
Screenings and grit from drum screen as well as biomass (sewage sludge) from the Scanship system is held and then discharged (photo #18) outside of MOU related waters.

PHOTO #:18 DATE: AUGUST 2, 2014
TAKEN BY: AMY JANKOWIAK FILE No.: P8020146
DESCRIPTION: SCANSHIP BIOSLUDGE DISCHARGE PORT

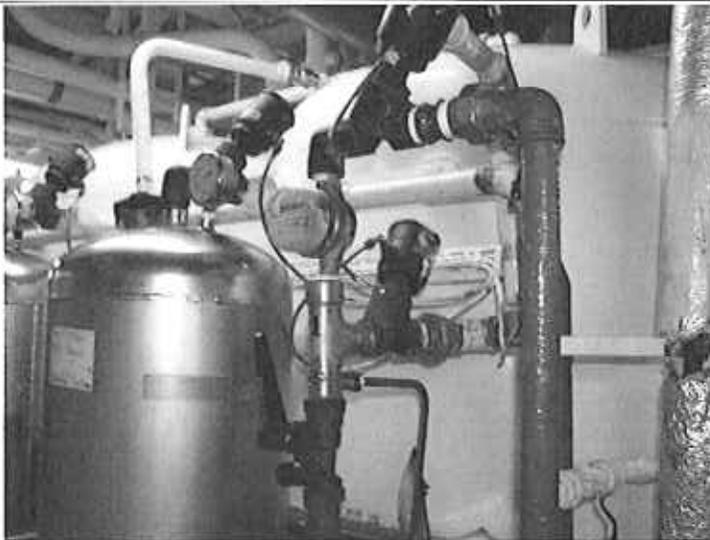
Oily bilge is treated first with a Marin Floc oily water separator system (photos #19 and #20) and then with an RWO oily water separator system (photo #21) to bring oil content down to <15 ppm. Values are usually less than 5 ppm. Discharges (photo #23) occur at less than 15 ppm and outside of MOU related waters. A white box (photo #22) is used to prevent discharges of more than 15 ppm. At the time of the inspection, a vendor was on board to calibrate the two white boxes. Oily sludge is drummed and offloaded for proper disposal. Oily rags are incinerated.

PHOTO #:19 DATE: AUGUST 2, 2014
TAKEN BY: AMY JANKOWIAK FILE No.: P8020137
DESCRIPTION: BILGE – OILY WATER SEPARATOR MARIN FLOC

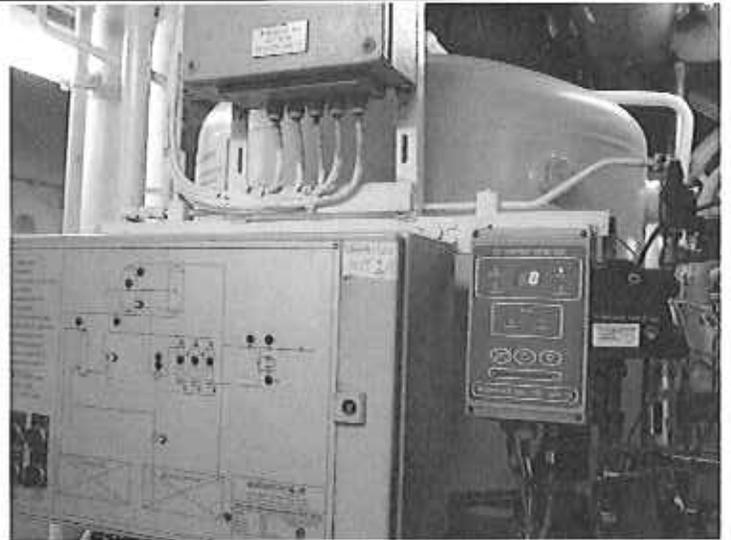
PHOTO #:20 AUGUST 2, 2014
TAKEN BY: AMY JANKOWIAK FILE No.: P8020138
DESCRIPTION: BILGE – OWS MARIN FLOC

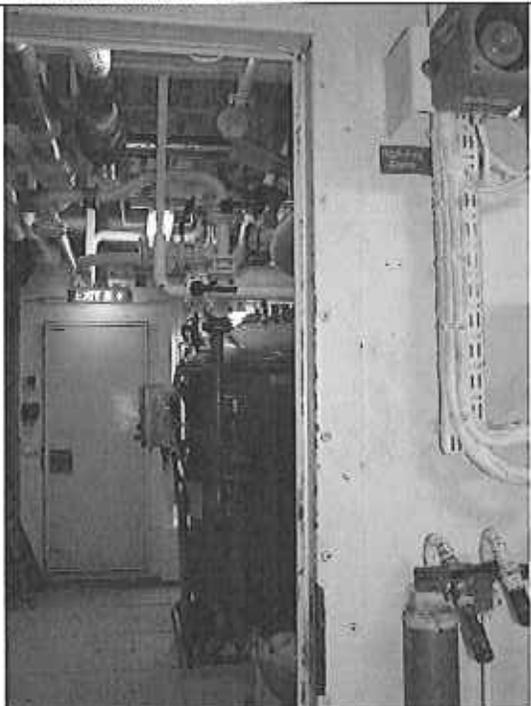
PHOTO #:21 DATE: AUGUST 2, 2014
TAKEN BY: AMY JANKOWIAK FILE No.: P8020140
DESCRIPTION: BILGE OWS RWO

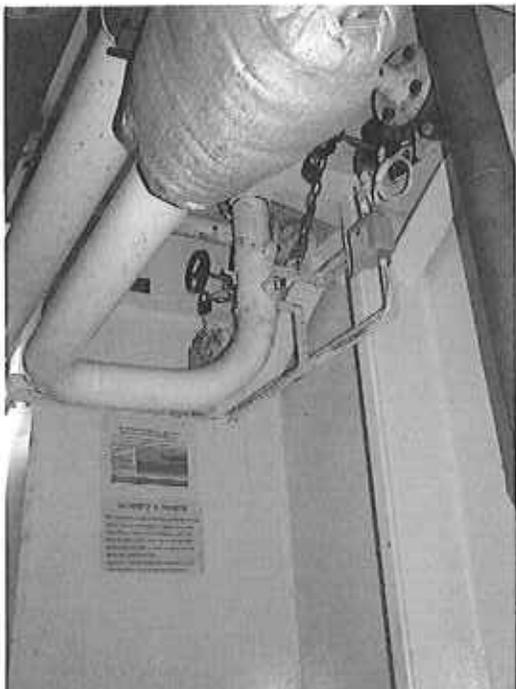
PHOTO #:23 DATE: AUGUST 2, 2014
TAKEN BY: AMY JANKOWIAK FILE No.: P8020143
DESCRIPTION: OWS DISCHARGE PORT

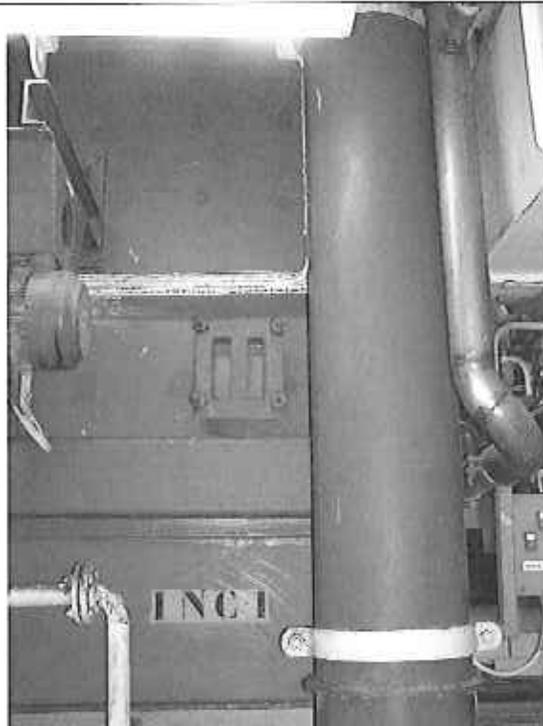
Incinerator ash is offloaded and tested annually for non-hazardous status. Results have passed. Food-contaminated cardboard, soft plastics and paper are incinerated (photo #30). The amount of materials being incinerated has reduced drastically and the vessel plans to remove one of the two incinerators (photo #24) for space. Fuel at <1% sulfur is used throughout the cruise.

PHOTO #:24 AUGUST 2, 2014
TAKEN BY: AMY JANKOWIAK FILE No.: P8020147
DESCRIPTION: INCINERATOR (FROM BELOW)

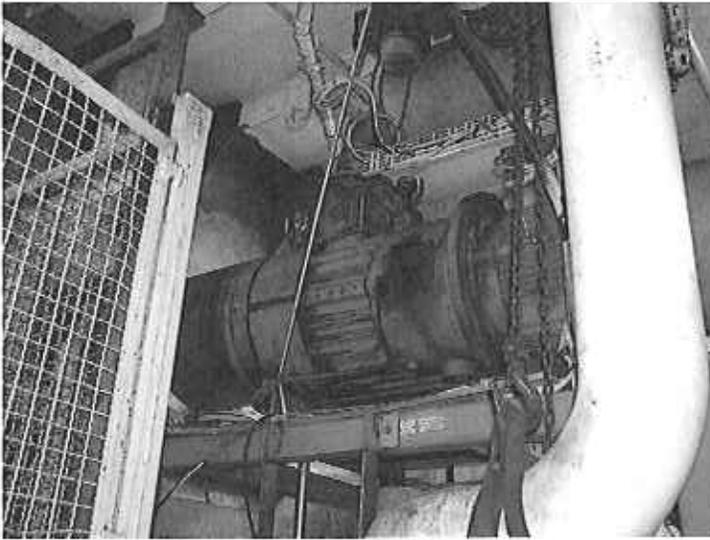
Food waste is sorted prior to going into the pulper (photo #25). Bones are crushed and some food is sent to the new compost bins (photo #32) which are offloaded in Victoria. To assure proper sorting, signs, training and checks are done. Solid food waste is discharged outside of MOU related waters after pulping and with pulping water after recirculation. Grease is collected from galley grease traps and offloaded.

PHOTO #25 DATE: AUGUST 2, 2014
TAKEN BY: AMY JANKOWIAK FILE No.: P8020148
DESCRIPTION: FOOD WASTE PULPER

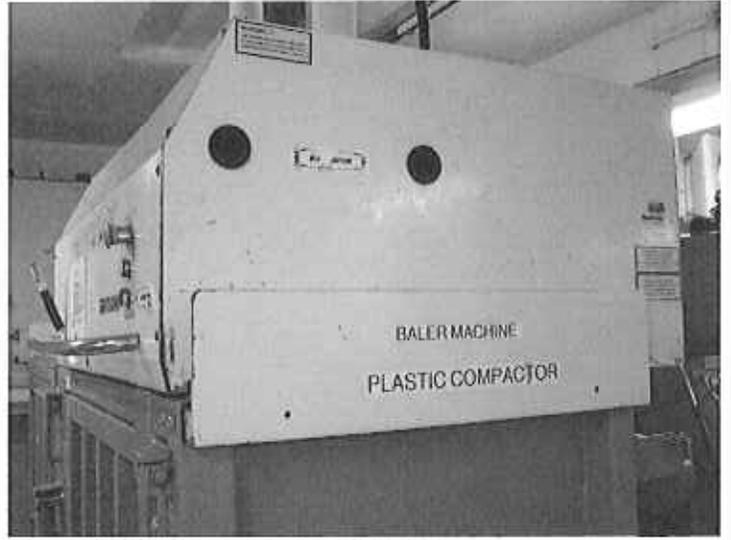
(photo #26), pallets, aluminum, tin, scrap metal, batteries (photo #31) some paper, non-contaminated cardboard, used cooking oil (photo #29), and other materials are recycled. Reduction and reuse opportunities are broadly used to prevent the amount of waste. Some materials are stored in cold storage (photo #32).

PHOTO #26 DATE: AUGUST 2, 2014
TAKEN BY: AMY JANKOWIAK FILE No.: P8020151
DESCRIPTION: PLASTICS COMPACTOR

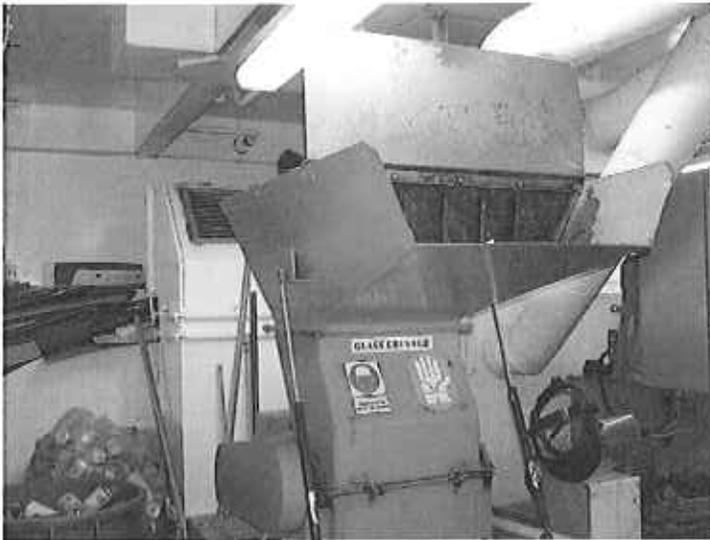
The various solid waste streams are collected, sorted, stored (photo #28), and sent ashore or incinerated as appropriate. The garbage record book was reviewed and showed consistency with requirements. Glass (photo #27), some plastics

PHOTO #27 DATE: AUGUST 2, 2014
TAKEN BY: AMY JANKOWIAK FILE No.: P8020152
DESCRIPTION: GLASS CRUSHER

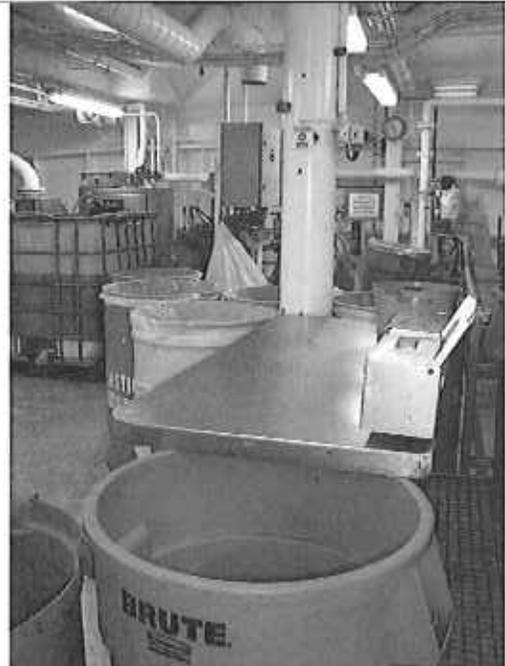
PHOTO #28 AUGUST 2, 2014
TAKEN BY: AMY JANKOWIAK FILE No.: P8020153
DESCRIPTION: GARBAGE/RECYCLING SORTING

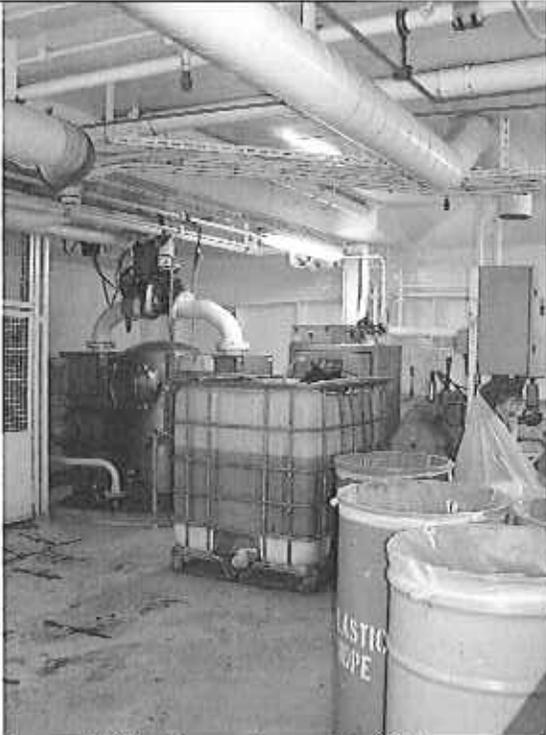
PHOTO #:29 DATE: AUGUST 2, 2014
TAKEN BY: AMY JANKOWIAK FILE No.: P8020154
DESCRIPTION: USED COOKING OIL CONTAINER

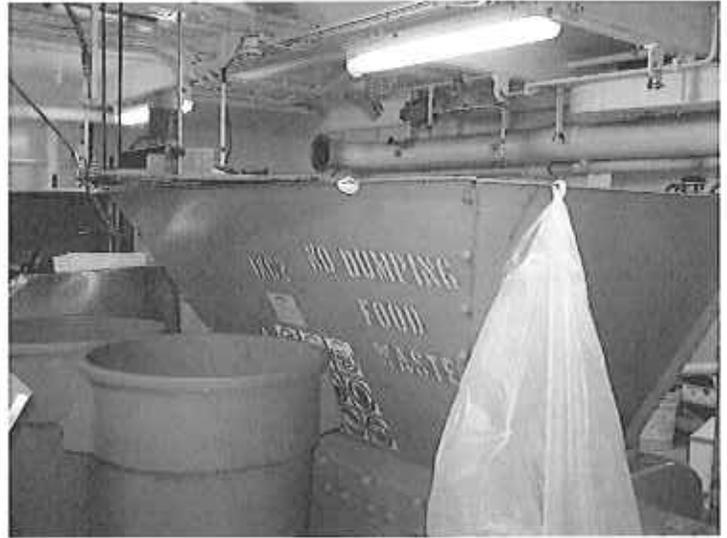
PHOTO #:30 DATE: AUGUST 2, 2014
TAKEN BY: AMY JANKOWIAK FILE No.: P8020155
DESCRIPTION: INCINERATOR LOADING

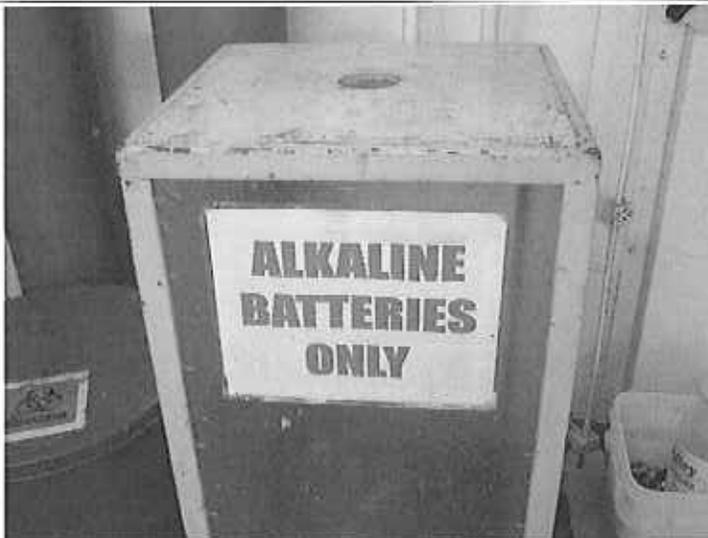
PHOTO #:31 DATE: AUGUST 2, 2014
TAKEN BY: AMY JANKOWIAK FILE No.: P8020156
DESCRIPTION: BATTERY COLLECTION

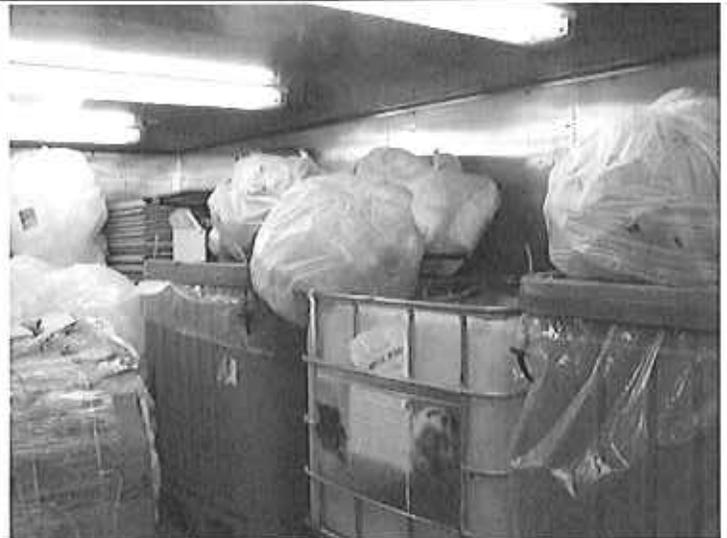
PHOTO #:32 AUGUST 2, 2014
TAKEN BY: AMY JANKOWIAK FILE No.: P8020157
DESCRIPTION: COLD STORAGE ROOM AND COMPOST BINS (BLUE)

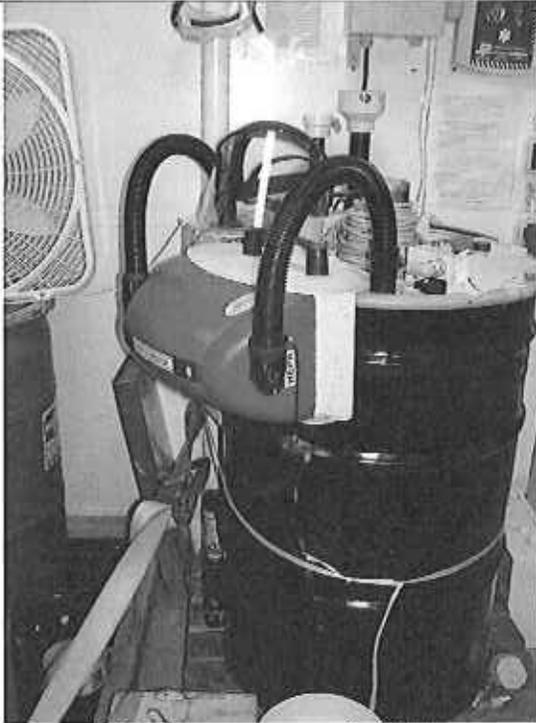
Fluorescent lamps go through a bulb crusher (photo #33) and are then offloaded. Mercury filters are offloaded as hazardous waste. Other types of bulbs are offloaded as hazardous waste (photo #34).

PHOTO #:33 DATE: AUGUST 2, 2014
TAKEN BY: AMY JANKOWIAK FILE No.: P8020159
DESCRIPTION: FLUORESCENT BULB EATER

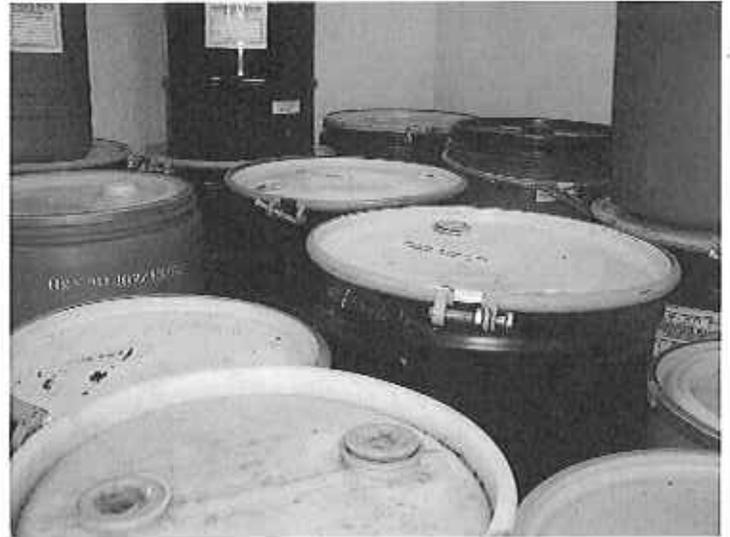
PHOTO #:34 DATE: AUGUST 2, 2014
TAKEN BY: AMY JANKOWIAK FILE No.: P8020160
DESCRIPTION: HAZARDOUS WASTE STORAGE
