CITY OF SUMAS, WA

Shoreline Jurisdiction Vicinity Map

Sehome Planning & Development

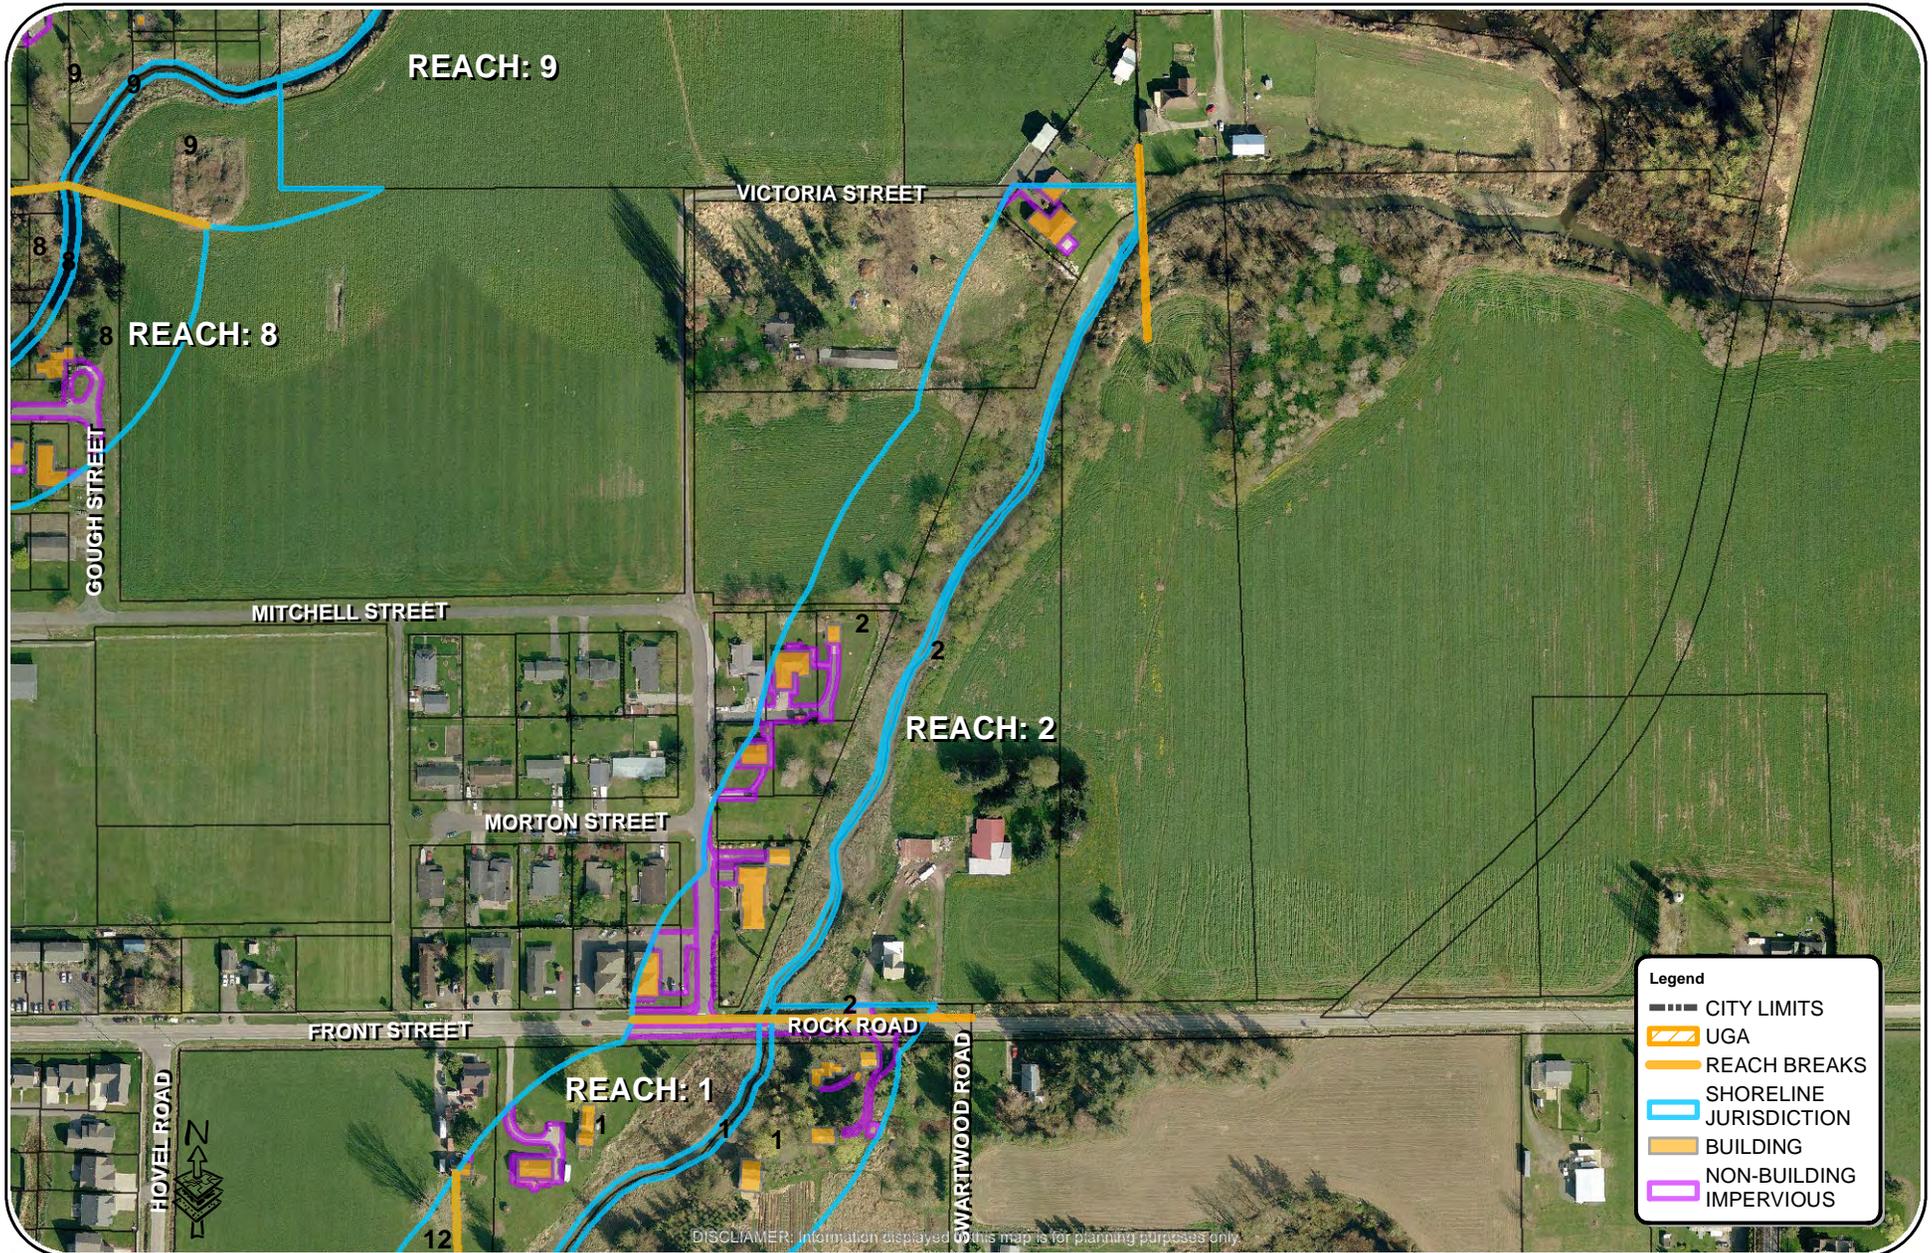
Reach 2

Land Use	Current Shoreline Designation	Conservancy. Area adjacent to creek designated natural system protection area in Comp Plan. (Ref # 2)
	Current Land Use	AG (crop), industrial. (Ref # 3, 7)
	Zoning	Industrial (14.6 ac), agriculture (0.7 ac). (Ref # 2, 16)
Potential Species Present	Wildlife species	None. (Ref # 12)
	Fish species	Sockeye presence documented; winter steelhead presence presumed; Coho rearing. Chum, cutthroat and coho mapped as present (Ref # 13, 18)
	PHS species/habitat	Wetlands associated with Sumas River (upper basin). Emergent and scrub-shrub wetland provide wildlife habitat and water quality/quantity protection. (Ref # 12)
	TSE species	ESU for coho, fall/winter chum; RU for bull trout (Ref # 13)
	Invasive wildlife/fish species	No data.
Physical Environment	Acres of land in reach	Total: 15.3 ac (Ref # 1)
	Aquatic vegetation	No data.
	Slope	No slope data listed by DOE (Ref # 6). Site class and moderate to high liquefaction hazard listed by Whatcom County (DNR 2004). (Ref # 17)

Buildings	One (1). (Ref # 1)
	Culverts/stormwater utilities	No data. Not likely. (Ref # 3, 7).
	Geology	Glacial outwash. (Ref # 9)
	Tributary Creeks	None. (Ref # 1, 3, 13)
	Impervious surface	Impervious 0.9 ac (6%) (Ref # 1)
	Roads/transportation	None. (Ref # 7)
	Soils	Briscot silt loam (Ref # 4)
	Topography	Approximate elevation is 35 feet. (Ref # 6)
	FEMA	All but a few fringe buffer areas are in the 100 year floodplain. (Ref # 1)
	Terrestrial Vegetation	Approximately half of the reach is characterized by native deciduous shrubs and some trees. The remainder of the reach is pasture/agricultural land – these areas are vegetated with native and non-native herbaceous species. Native vegetation present has the potential to provide good habitat, but provides shade and overhanging vegetation over the creek. Patches of Himalayan blackberry are present throughout the reach. (Ref # 3)
Riparian Function	Aquatic substrate type	No data.

Channel confinement	Confined within bank-full width, unconfined in basin due to topography. (Ref # 3, 6)
	Channel gradient	Low (0.07%). (Ref # 9)
	Channel migration zone	Unknown.
	Creosote structures	No data.
	In-water structures	No data.
	Fish passage blockages	None. (Ref # 13)
	LWD presence	No data. Low recruitment potential, mostly shrubs and small trees. (Ref # 3, 9)
	Riffle/pool analysis	No data.
	DOE 303(d)	Category 4A for fecal and DO (TMDL approved by EPA). (Ref # 10)
	Toxic sites/land fills	None listed. However, industrial area is located just north of reach where a confirmed toxic site is located. (Ref # 8)
	Point source pollution	Groundwater wells show increased levels of ethylene dibromide in drainage;

anthropogenic nitrate concentrations in surface water (Ref # 9). Agriculture and higher intensity industrial uses and possible sources are located adjacent to the reach. Higher intensity sources are located in the upper watershed where dairy and agriculture is more prevalent. (Ref # 3, 7)
Historic & Cultural	Historic aerials	None available on-line. Presume geomorphology has been stable for several decades.
	Archeological sites	None indicated. (Ref # 5)
	Historic sites	None indicated. (Ref # 5)
	Parks & public access	None. (Ref # 1)
Function Analysis	Reach Function <ul style="list-style-type: none"> • Hydrologic • Shoreline Vegetation • Habitat 	<p>Functioning with impairments. Rainfall dominated; flashy winter and early spring peaks, low summer, variable spring and fall flows. Impairment in basin due to loss of wetland area, draining, filling, ditching and removal of vegetation for agriculture.</p> <p>Functioning, with some impairments. Vegetation moderate in majority of reach, with some areas not as dense or with fewer trees. Reach flanked by agriculture and industry. Quality of vegetation has benefited from location near property boundaries. Agriculture reduces width of vegetation in some areas.</p> <p>Terrestrial: Impaired.</p> <p>Aquatic: Functioning with impairment (water quality and temperature). Most likely functioning better for fish support than Sumas River.</p>

Limiting Factors	<ul style="list-style-type: none"> ▪ Existing land uses ▪ Water quality ▪ Zoning
	Functions <ul style="list-style-type: none"> • Sustainable • Not Sustainable 	<p>Sustainable at current levels: hydrologic, shoreline vegetation, and aquatic habitat. However, sustainability affected by private property ownership.</p> <p>Terrestrial habitat (without major change in surround land use).</p>
	Priority Actions	<ul style="list-style-type: none"> ▪ Preservation of current riparian corridor. ▪ Water quality improvement.
	Current Enhancement Projects	None known. Designated as natural system protection area in Comp Plan.
	Preservation/Enhancement Opportunities	<ul style="list-style-type: none"> ▪ Enhance riparian buffer: increase width and species diversity of native shoreline vegetation; add evergreen species.

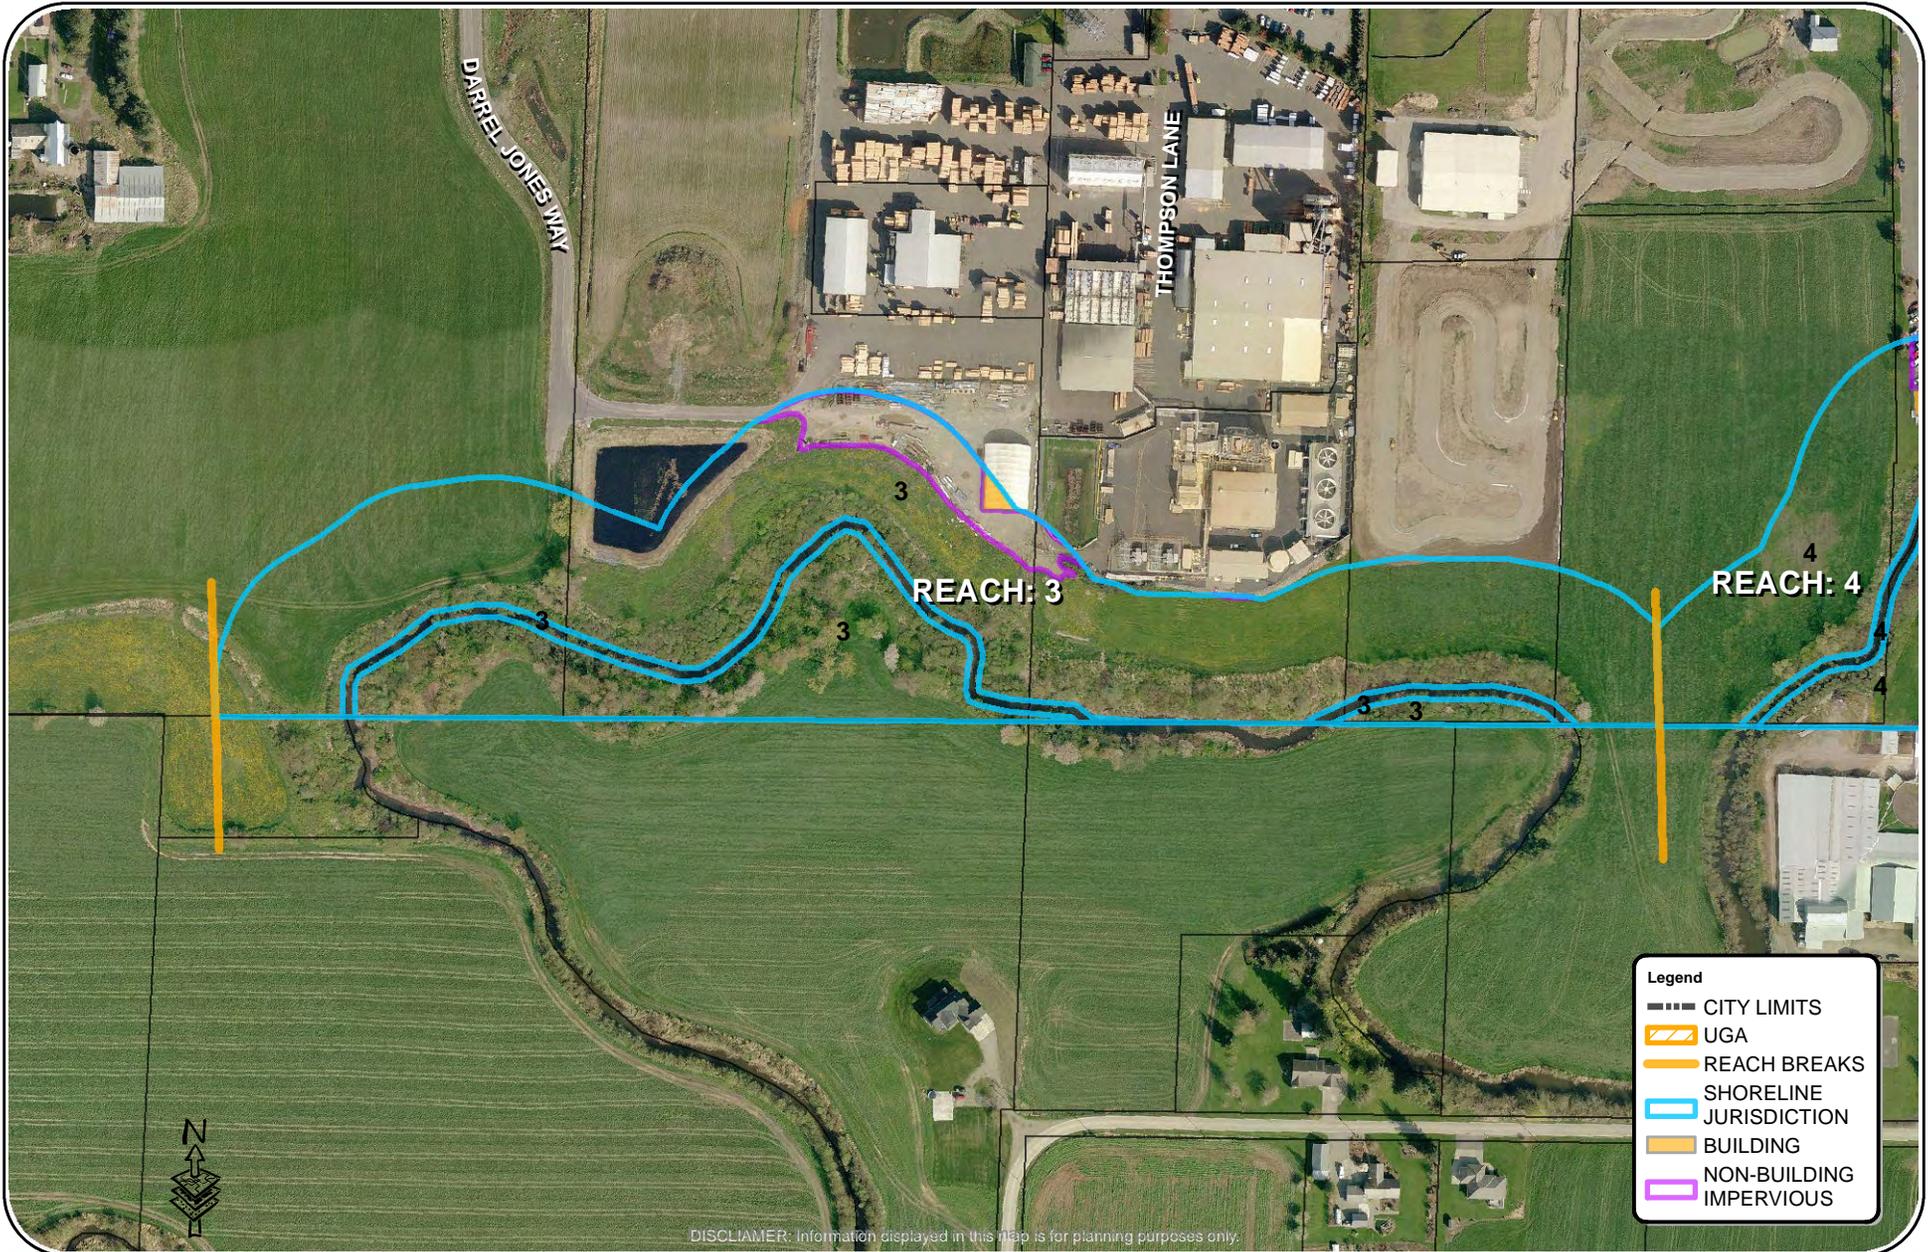
Reach 3

Land Use	Current Shoreline Designation	Conservancy, except Urban adjunct to industrial use on north side of creek. Some natural system protection area in southwest portion of reach. (Ref # 2)
	Current Land Use	AG (crop, livestock), industrial. (Ref # 3, 7)
	Zoning	Industrial (3.0 ac), agriculture (6.4 ac). (Ref # 2, 16)
Potential Species Present	Wildlife species	None. (Ref # 12)
	Fish species	Sockeye presence documented; winter steelhead presence presumed; Coho rearing. Chum, cutthroat and coho mapped as present (Ref # 13, 18)
	PHS species/habitat	Wetlands associated with Sumas River (upper basin). Emergent and scrub-shrub wetland provide wildlife habitat and water quality/quantity protection. The majority of wetland indicated north of the stream appears to be farmed (corn). (Ref # 12)
	TSE species	ESU for coho, fall/winter chum; RU for bull trout (Ref # 13)
	Invasive wildlife/fish species	No data.

Physical Environment	Acres of land in reach	Total: 9.4 ac (Ref # 1)
	Aquatic vegetation	No data.
	Slope	No slope data listed by DOE (Ref # 6). Site class and moderate to high liquefaction hazard listed by Whatcom County (DNR 2004). (Ref # 17)
	Buildings	Two (2) – industrial. (Ref # 1, 7)
	Culverts/stormwater utilities	No data. Likely none (Ref # 3, 7)
	Geology	Glacial outwash. (Ref # 9)
	Tributary Creeks	None (Ref # 1, 13)
	Impervious surface	Impervious 1.2 ac (13%) (Ref # 1)
	Roads/transportation	Railroad at northern terminus of reach, railspur near industrial use. (Ref # 1, 3, 7)
	Soils	Briscot silt loam (Ref # 4)
	Topography	Approximate elevation is 35 feet. (Ref # 6)
	FEMA	All but a few small buffer areas are in the 100 year floodplain. (Ref # 1)
	Terrestrial Vegetation	There is no road access to this reach; vegetation data is from aerial photographs. Approximately two-thirds of the reach is characterized by pasture/agricultural land – these areas are vegetated with native and non-native herbaceous or planted in corn. The remaining buffer areas are vegetated with deciduous shrubs, an occasional deciduous tree, and likely patches of Himalayan blackberry. Overall vegetation provides little shading. (Ref # 3)

Riparian Function	Aquatic substrate type	No data.
	Channel confinement	Confined within bank-full width, unconfined in basin due to topography. (Ref # 3, 6)
	Channel gradient	No data. (Ref # 13)
	Channel migration zone	Unknown.
	Creosote structures	No data; RR trestle?
	In-water structures	None observed. (Ref # 7)
	Fish passage blockages	None. (Ref # 13)
	LWD presence	No data. Low recruitment potential, mostly shrubs and small trees. (Ref # 3, 9)
	Riffle/pool analysis	No data.
	DOE 303(d)	Category 4A for fecal and DO (TMDL approved by EPA). (Ref # 10)

Toxic sites/land fills	None listed. However, industrial area is located just north of reach where a confirmed toxic site is located. (Ref # 8)
	Point source pollution	Groundwater wells show increased levels of ethylene dibromide in drainage; anthropogenic nitrate concentrations in surface water (Ref # 9). Agriculture and higher intensity industrial uses and possible sources are located adjacent to the reach. Higher intensity sources are located in the upper watershed where dairy and agriculture is more prevalent. (Ref # 3, 7)
Historic & Cultural	Historic aerials	None available on-line. Presume geomorphology has been stable for several decades.
	Archeological sites	None indicated. (Ref # 5)
	Historic sites	None indicated. (Ref # 5)
	Parks & public access	None. (Ref # 1)
Function Analysis	Reach Function <ul style="list-style-type: none"> • Hydrologic • Shoreline Vegetation • Habitat 	<p>Functioning with impairments. Rainfall dominated; flashy winter and early spring peaks, low summer, variable spring and fall flows. Impairment in basin due to loss of wetland area, draining, filling, ditching and removal of vegetation for agriculture.</p> <p>Impaired. Vegetation mostly shrubs, likely non-native. Agriculture (crop) has impacted buffer width and vegetation. Most of reach undeveloped with impervious surfaces.</p> <p>Terrestrial: Impaired.</p> <p>Aquatic: Functioning with impairment (water quality and temperature). Very little thermal cover. Most likely functioning better for fish support than Sumas River.</p>

Limiting Factors	<ul style="list-style-type: none"> ▪ Existing land uses ▪ Water quality ▪ Zoning
	Functions <ul style="list-style-type: none"> • Sustainable • Not Sustainable 	<p>Sustainable at current levels: hydrologic, shoreline vegetation, and aquatic habitat. However, sustainability affected by private property ownership.</p> <p>Terrestrial habitat (without major change in surround land use).</p>
	Priority Actions	<ul style="list-style-type: none"> ▪ Preservation of riparian corridor. ▪ Water quality improvement.
	Current Enhancement Projects	None known. South portion of reach designated as natural system protection area in Comp Plan.
	Preservation/Enhancement Opportunities	<ul style="list-style-type: none"> ▪ Enhance riparian buffer: increase width and species diversity of native shoreline vegetation; add evergreen species. ▪ Removal of any invasive species.

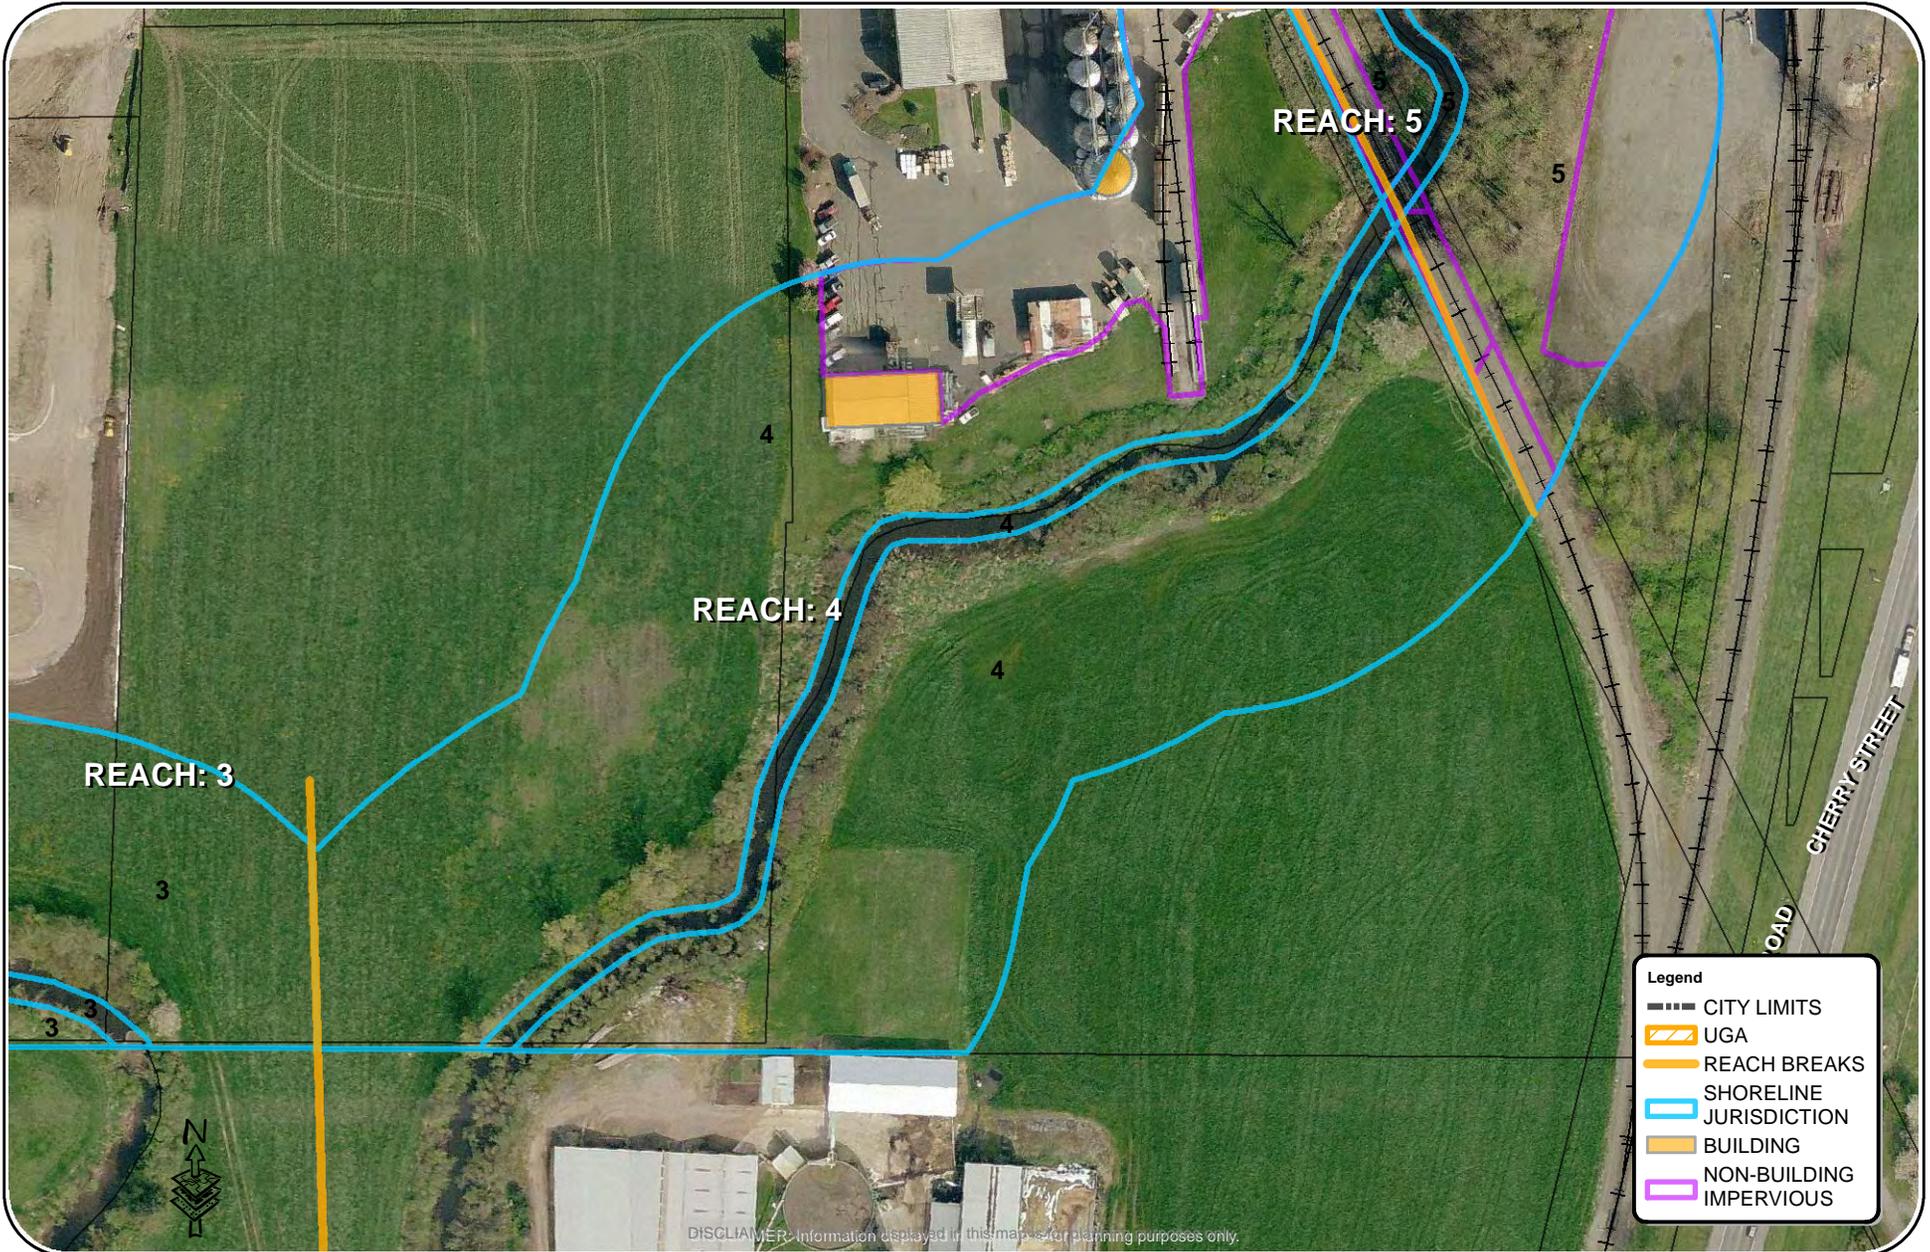
Reach 4

Land Use	Current Shoreline Designation	Conservancy. Area adjacent to creek designated natural system protection area in Comp Plan. (Ref # 2)
	Current Land Use	AG, industrial, residential, railroad corridors. (Ref # 3, 7)
	Zoning	Business traffic-oriented (3.9 ac), industrial (14.7 ac). (Ref # 1, 2, 16)
Potential Species Present	Wildlife species	None. (Ref # 12)
	Fish species	Sockeye presence documented; winter steelhead presence presumed; Coho rearing. Chum, cutthroat and coho mapped as present. (Ref # 13, 18)
	PHS species/habitat	Wetlands associated with Sumas River (upper basin). Emergent and scrub-shrub wetland provide wildlife habitat and water quality/quantity protection. (Ref # 12)
	TSE species	ESU for coho, fall/winter chum; RU for bull trout (Ref # 13)
	Invasive wildlife/fish species	No data.
Physical Environment	Acres in reach	Total: 18.6 ac. (Ref # 1)
	Aquatic vegetation	No data.
	Slope	No slope data listed by DOE (Ref # 6). Site class and moderate to high liquefaction hazard listed by Whatcom County (DNR 2004). (Ref # 17)

Buildings	Four (4) – business. (Ref # 1)
	Culverts/stormwater utilities	No data. Likely none (Ref # 3, 7)
	Geology	Glacial outwash. (Ref # 9)
	Tributary Creeks	None. (Ref # 1, 3, 13)
	Impervious surface	Impervious 4.4 ac (24%) (Ref # 1)
	Roads/transportation	Railroad at south and north end of reach, arterial bisects reach (Front Street), one access road (Johnson Street). (Ref # 3, 7)
	Soils	Briscot silt loam (Ref # 4)
	Topography	Approximate elevation is 35 feet. (Ref # 6)
	FEMA	All but three small areas of buffer are in the 100 year floodplain. (Ref # 1)
	Terrestrial Vegetation	The majority of the reach is characterized by native mixed deciduous trees and shrubs. Native vegetation has the potential to provide shading to the stream and good habitat. Smaller patches within the reach contain pasture – these areas are vegetated with native and non-native herbaceous species, or reed canarygrass, an invasive species. A patch of Himalayan blackberry is present near the northern end. A wetland mitigation site and native plantings are also located near the northern end. A trucking business and truck parking is located mid-reach on Johnson Street. (Ref # 3, 7)

Riparian Function	Aquatic substrate type	No data.
	Channel confinement	Confined within bank-full width, unconfined in basin due to topography. (Ref # 3, 6)
	Channel gradient	No data. (Ref # 13)
	Channel migration zone	Unknown.
	Creosote structures	No data; railroad trestles?
	In-water structures	None observed. (Ref # 7)
	Fish passage blockages	None. (Ref # 13)
	LWD presence	No data. Low recruitment potential, mostly shrubs and small trees. (Ref # 3, 9)
	Riffle/pool analysis	Substantial pool and backwater habitat, potentially spawnable riffles. (Ref # 9)
	DOE 303(d)	Category 4A for fecal and DO (TMDL approved by EPA) – up stream of Front Street. (Ref # 10)

Toxic sites/land fills	None listed. (Ref # 8)
	Point source pollution	Groundwater wells show increased levels of ethylene dibromide in drainage; anthropogenic nitrate concentrations in surface water (Ref # 9). Scattered low intensity residential uses, light agriculture, some light industrial. Higher intensity sources are located in the upper watershed where dairy and agriculture is more prevalent. (Ref # 3, 7)
Historic & Cultural	Historic aerials	None available on-line. Presume geomorphology has been stable for several decades.
	Archeological sites	None indicated. (Ref # 5)
	Historic sites	None indicated. (Ref # 5)
	Parks & public access	None. (Ref # 1)
Function Analysis	Reach Function <ul style="list-style-type: none"> • Hydrologic • Shoreline Vegetation • Habitat 	<p>Functioning with impairments. Rainfall dominated; flashy winter and early spring peaks, low summer, variable spring and fall flows. Impairment in basin due to loss of wetland area, draining, filling, ditching and removal of vegetation for agriculture in the upper watershed.</p> <p>Functioning, with some areas impaired. Many areas in this reach are undeveloped. Undeveloped areas are generally vegetation with native trees and shrubs. Developed areas are generally open space agriculture; some industrial and residential use.</p> <p>Terrestrial: Functioning in some areas (~50%).</p> <p>Aquatic: Functioning with impairment (water quality). Thermal cover better in this reach. Most likely functioning better for fish support than Sumas River.</p>

Limiting Factors	<ul style="list-style-type: none"> ▪ Water quality ▪ Zoning
	Functions <ul style="list-style-type: none"> • Sustainable • Not Sustainable 	Sustainable at current levels: hydrologic, shoreline vegetation, and terrestrial & aquatic habitat. However, sustainability affected by private property ownership.
	Priority Actions	<ul style="list-style-type: none"> ▪ Preservation of riparian corridor and terrestrial habitat. ▪ Water quality improvement.
	Current Enhancement Projects	A wetland mitigation project is located at the western end of the reach. Designated as natural system protection area in Comp Plan.
	Preservation/Enhancement Opportunities	<ul style="list-style-type: none"> ▪ Preservation of terrestrial vegetation, habitat and associated corridors. Particularly riparian corridors. ▪ Enhance riparian buffer: increase width of native shoreline vegetation in pasture areas. ▪ Removal of invasive species (Himalayan blackberry and reed canarygrass). ▪ Relocate truck parking outside of shoreline jurisdictional area.

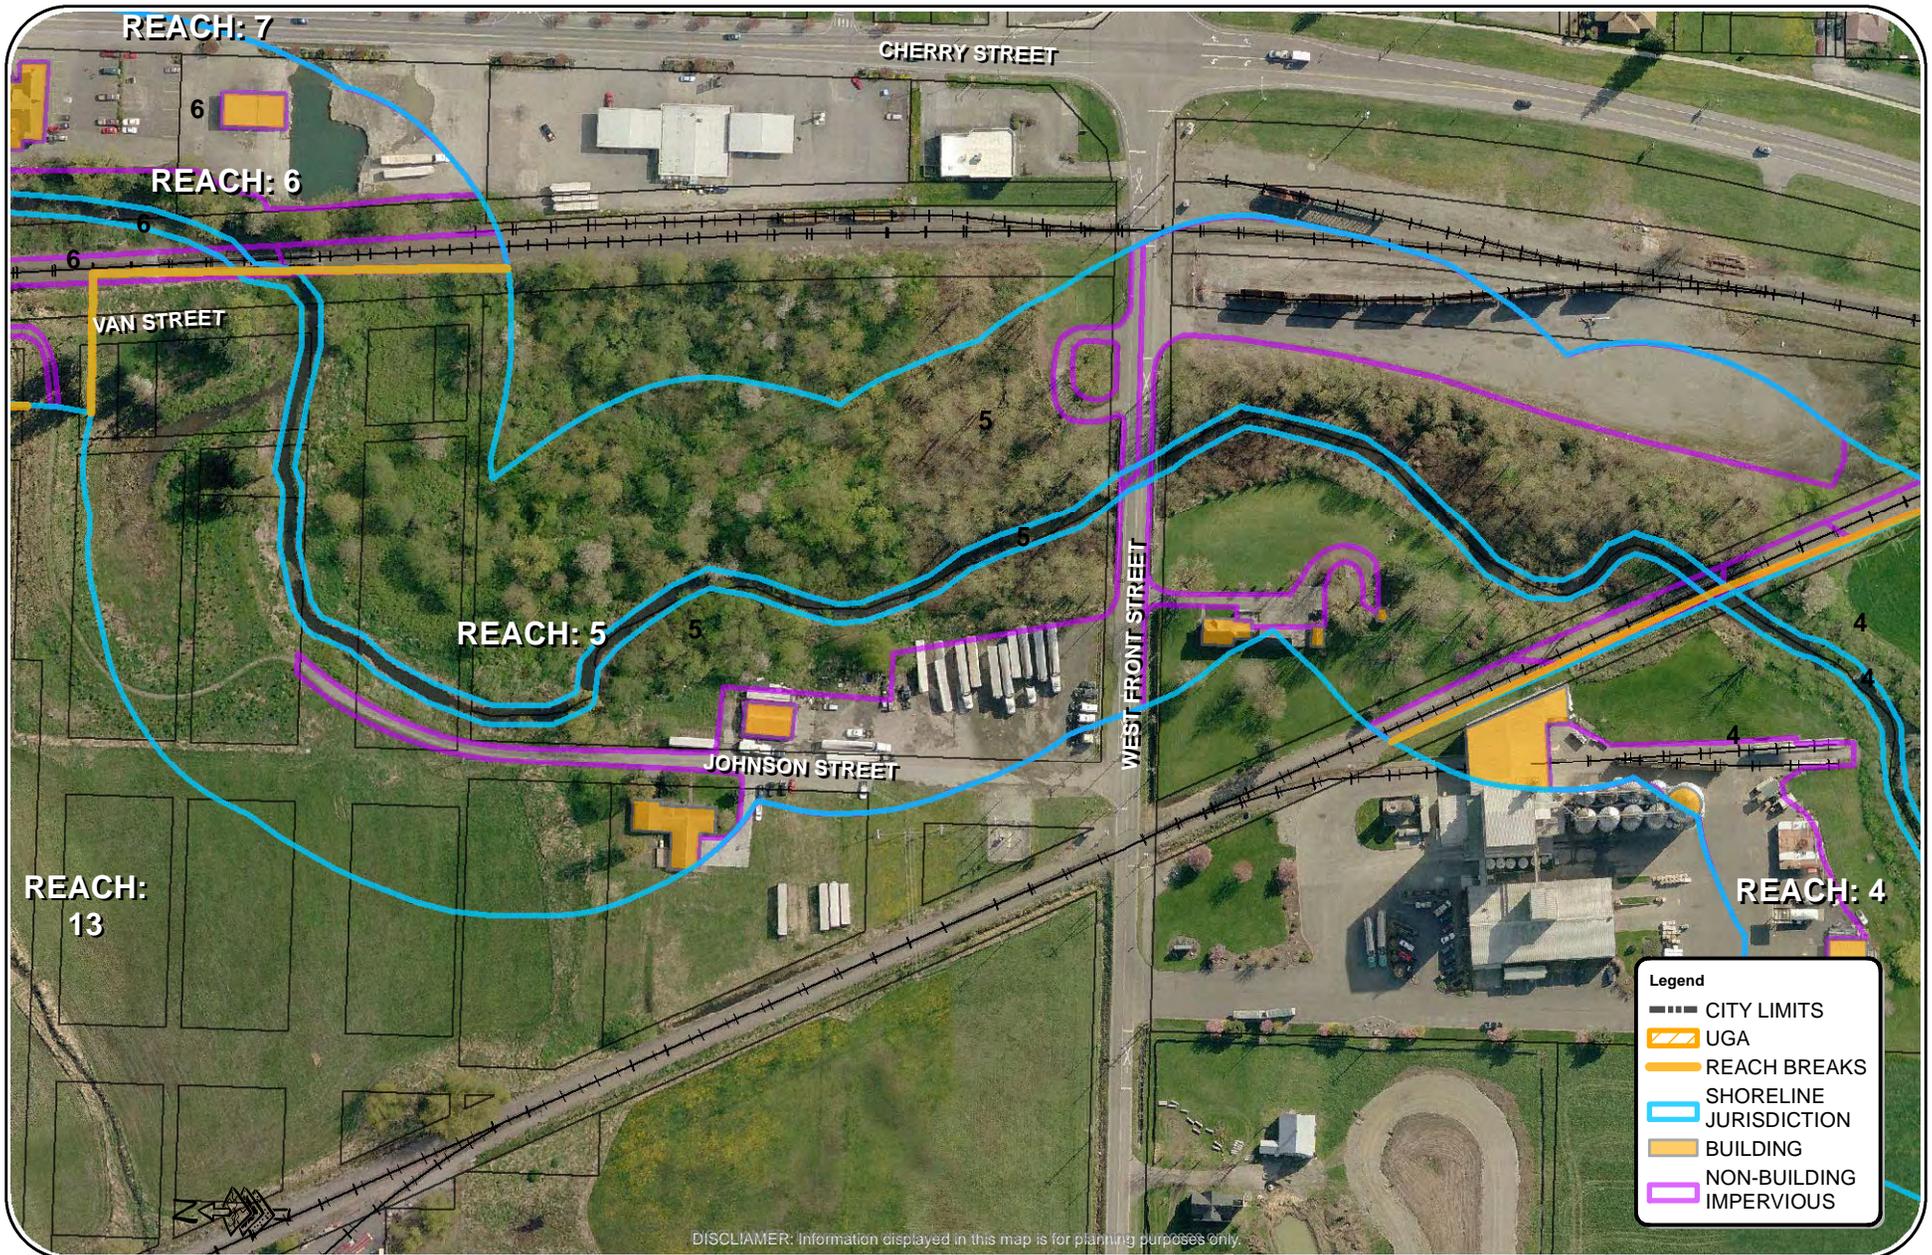
Reach 5

Land Use	Current Shoreline Designation	Urban (Ref # 2)
	Current Land Use	Business, railroad corridor. (Ref # 3, 7)
	Zoning	Business traffic-oriented (4.2 ac), business district general (1.1 ac), industrial (3.2 ac). (Ref # 2, 16)
Potential Species Present	Wildlife species	None. (Ref # 12)
	Fish species	Sockeye presence documented; Fall chum (to Sumas Creek only) and winter steelhead presence presumed; Coho rearing. Chum, cutthroat and coho mapped as present (DEA report). (Ref # 13, 18)
	PHS species/habitat	Wetlands associated with Sumas River (upper basin). Emergent and scrub-shrub wetland provide wildlife habitat and water quality/quantity protection. (Ref # 12)
	TSE species	ESU for coho, fall/winter chum; RU for bull trout (Ref # 13)
	Invasive wildlife/fish species	No data.
Physical Environment	Acres of land in reach	Total: 8.5 ac (Ref # 1)
	Aquatic vegetation	Reed canarygrass dominates the majority of the creek channel. (Ref # 3)

Slope	No slope data listed by DOE (Ref # 6). Site class and moderate to high liquefaction hazard listed by Whatcom County (DNR 2004). (Ref # 17)
	Buildings	Eight (8) – business. (Ref # 1)
	Culverts/stormwater utilities	No data. No culvert for the railroad, bridge crossing (Ref # 3).
	Geology	Glacial outwash. (Ref # 9)
	Tributary Creeks	One - Sumas Creek. (Ref # 1, 3, 13)
	Impervious surface	Impervious 4.7 ac (55%) (Ref # 1)
	Roads/transportation	Railroad runs entire length of reach, retail business parking, arterial (Third Street), major arterial (Cherry Street) at northern terminus of reach. (Ref # 3, 7)
	Soils	Briscot silt loam (Ref # 4)
	Topography	Approximate elevation is 35 feet. (Ref # 6)
	FEMA	Entire reach in the 100 year floodplain (some railroad areas excluded). (Ref # 1)
	Terrestrial Vegetation	A little less than half of the reach is characterized by native mixed trees and shrubs. Multiple invasive species observed in the understory. Much of the channel is vegetated with reed canarygrass. The majority of vegetation does not provide adequate shading over the channel. The remainder of the reach is developed (commercial, railway, roads). (Ref # 3)

Riparian Function	Aquatic substrate type	No data
	Channel confinement	Confined within bank-full width, unconfined in basin due to topography. (Ref # 3, 6)
	Channel gradient	No data. (Ref # 13)
	Channel migration zone	Unknown.
	Creosote structures	No data/ none observed (Ref # 3, 7)
	In-water structures	No data/ none observed (Ref # 3, 7) railroad bridge??
	Fish passage blockages	None. (Ref # 13)
	LWD presence	No wood observed. Low recruitment potential, mostly shrubs and small trees. (Ref # 3, 9)
	Riffle/pool analysis	Substantial pool and backwater habitat, potentially spawnable riffles. (Ref # 9)
	DOE 303(d)	None listed. (Ref # 10)
	Toxic sites/land fills	One leaking underground storage tank listed. (Ref # 8)

Point source pollution	Groundwater wells show increased levels of ethylene dibromide in drainage; anthropogenic nitrate concentrations in surface water (Ref # 9). Retail business, including fuel stations, and railroad dominate uses in reach. Higher intensity sources are located in the upper watershed where dairy and agriculture is more prevalent. (Ref # 3, 7)
Historic & Cultural	Historic aerials	None available on-line. Presume geomorphology has been stable for several decades.
	Archeological sites	None indicated. (Ref # 5)
	Historic sites	None indicated. (Ref # 5)
	Parks & public access	None. (Ref # 1)
Function Analysis	Reach Function <ul style="list-style-type: none"> • Hydrologic • Shoreline Vegetation • Habitat 	<p>Functioning with impairments. Rainfall dominated; flashy winter and early spring peaks, low summer, variable spring and fall flows. Impairment in basin due to loss of wetland area, draining, filling, ditching and removal of vegetation for agriculture in the upper watershed.</p> <p>Functioning, with impairments. Native trees and shrubs located throughout the reach which provides some shading and habitat, however many areas of the understory are dominated by non-native, invasive species. Only about 50% of the buffer is vegetated.</p> <p>Terrestrial: Impaired.</p> <p>Aquatic: Functioning, with impairments (water quality, thick vegetation in channel).</p>

Limiting Factors	<ul style="list-style-type: none"> ▪ Existing land uses ▪ Water quality ▪ Zoning
	Functions <ul style="list-style-type: none"> • Sustainable • Not Sustainable 	<p>Sustainable at current levels: hydrologic, shoreline vegetation, and aquatic habitat. However, sustainability affected by private property ownership.</p> <p>Terrestrial habitat (without major change in adjacent land use).</p>
	Priority Actions	<ul style="list-style-type: none"> ▪ Preservation of riparian corridor. ▪ Water quality improvement.
	Current Enhancement Projects	None known.
	Preservation/Enhancement Opportunities	<ul style="list-style-type: none"> ▪ Preservation of terrestrial vegetation, habitat and associated corridors. Particularly riparian corridors. ▪ Enhance riparian buffer: increase width of native shoreline vegetation, add vegetation to provide shading. ▪ Remove invasive species (Himalayan blackberry, field bind weed).

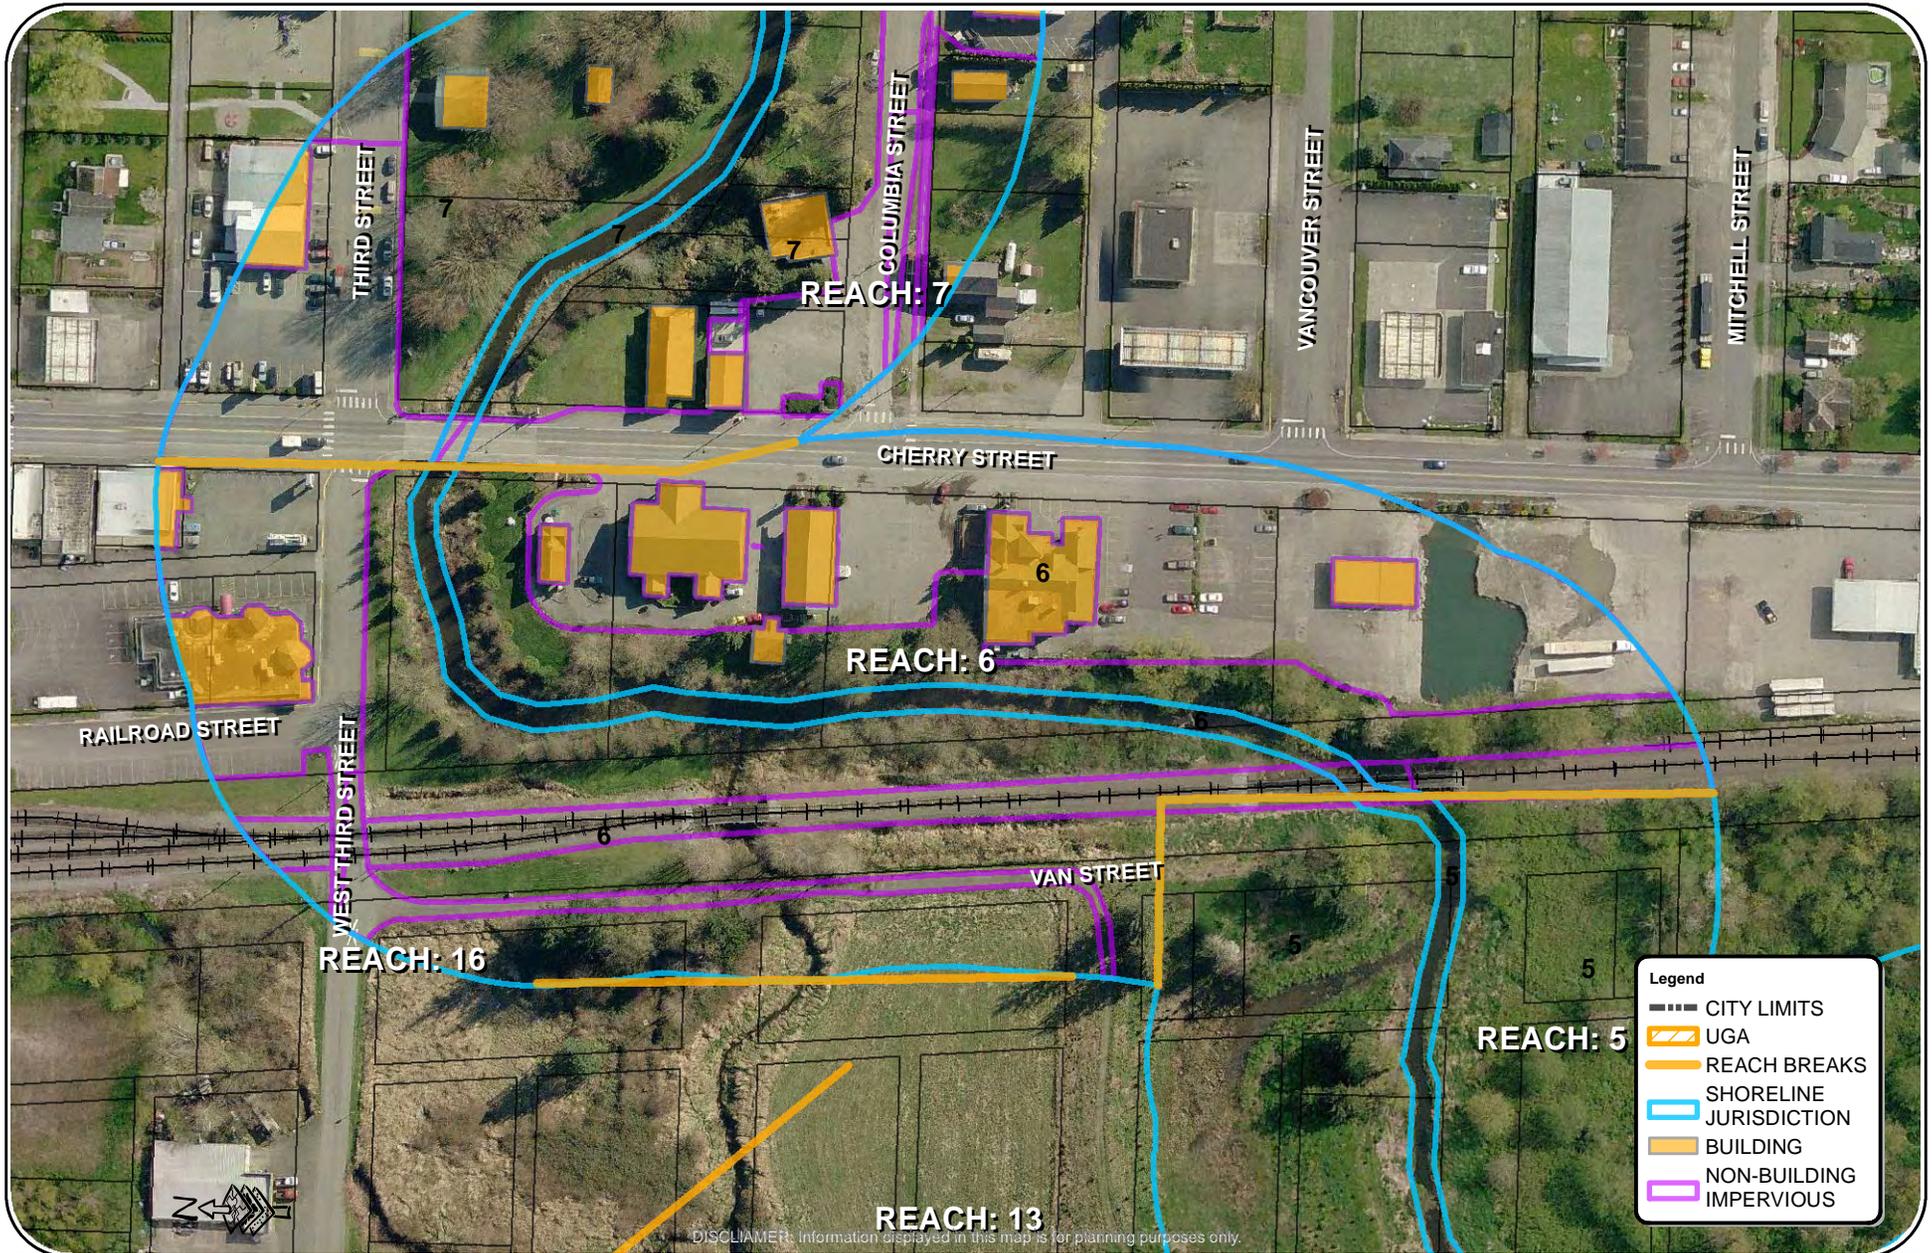
Reach 6

Land Use	Current Shoreline Designation	Urban (Ref # 2)
	Current Land Use	Residential, public park, undeveloped parcels, business. (Ref # 3, 7)
	Zoning	Residential high density (6.2 ac), business district general (0.8 ac), business low impact (1.7 ac), public (2.0 ac), business traffic-oriented (0.9 ac), industrial (0.04 ac), (Ref # 2, 16)
Potential Species Present	Wildlife species	None. (Ref # 12)
	Fish species	Sockeye presence documented; Fall chum and winter steelhead presence presumed; Coho rearing. Chum, cutthroat and coho mapped as present (Ref # 13, 18)
	PHS species/habitat	Wetlands associated with Sumas River (upper basin). Emergent and scrub-shrub wetland provide wildlife habitat and water quality/quantity protection. (Ref # 12)
	TSE species	ESU for coho, fall/winter chum; RU for bull trout (Ref # 13)
	Invasive wildlife/fish species	No data.
Physical Environment	Acres of land in reach	Total: 11.7 ac (Ref # 1)

Aquatic vegetation	No data.
	Slope	No slope data listed by DOE (Ref # 6). Site class and moderate to high liquefaction hazard listed by Whatcom County (DNR 2004). (Ref # 17)
	Buildings	Twenty-seven (27) – mixed uses. (Ref # 1)
	Culverts/stormwater utilities	No data. Culverts under Cherry Street and Sumas Avenue (Ref # 3, 7)
	Geology	Glacial outwash. (Ref # 9)
	Tributary Creeks	None. (Ref # 1, 3, 13)
	Impervious surface	Impervious 4.4 ac (38%) (Ref # 1)
	Roads/transportation	One major arterial (Cherry Street) at western terminus of reach, three arterials (Sumas Ave, Vancouver St, Columbia St). (Ref # 1)
	Soils	Briscot silt loam (Ref # 4)
	Topography	Approximate elevation is 35 feet. (Ref # 6)
	FEMA	Entire reach in the 100 year floodplain. (Ref # 1)
	Terrestrial Vegetation	The majority of the reach is vegetated with grasses and herbaceous species to the top of creek bank. Grasses are mowed, but not directly adjacent to the bank. Deciduous trees, native and non-native, are present in the park. A limited number of deciduous trees and shrubs are located south of the channel. Himalayan blackberry patches are present along the stream. Vegetation provides little to no shading. (Ref # 3)

Riparian Function	Aquatic substrate type	Silt (Ref # 3)
	Channel confinement	Confined within bank-full width, unconfined in basin due to topography. (Ref # 3, 6)
	Channel gradient	No data. (Ref # 13)
	Channel migration zone	Unknown.
	Creosote structures	No data/ non observed (Ref # 3, 7)
	In-water structures	No data/ none observed (Ref # 3, 7)
	Fish passage blockages	None. (Ref # 13)
	LWD presence	None observed. Tree cover along the shoreline is low to moderate. Recruitment potential is very low. (Ref # 3, 7, 9)
	Riffle/pool analysis	Low, habitat is homogenous. (Ref # 9)
	DOE 303(d)	Category 4A for fecal and DO (TMDL approved by EPA) – downstream of Sumas Avenue. (Ref # 10)

Toxic sites/land fills	None listed. (Ref # 8)
	Point source pollution	Groundwater wells show increased levels of ethylene dibromide in drainage; anthropogenic nitrate concentrations in surface water (Ref # 9). Scattered urban residential uses, roadways. Higher intensity sources are located in the upper watershed where dairy and agriculture is more prevalent. (Ref # 16)
Historic & Cultural	Historic aerials	None available on-line. Presume geomorphology has been stable for several decades.
	Archeological sites	None indicated. (Ref # 5)
	Historic sites	Sumas Methodist Church, Thomas House. (Ref # 5)
	Parks & public access	Public park at the northwestern end of reach; trail system planned. (Ref # 2, 3)
Function Analysis	Reach Function <ul style="list-style-type: none"> • Hydrologic • Shoreline Vegetation • Habitat 	<p>Functioning with impairments. Rainfall dominated; flashy winter and early spring peaks, low summer, variable spring and fall flows. Impairment in basin due to loss of wetland area, draining, filling, ditching and removal of vegetation for agriculture in the upper watershed.</p> <p>Impaired; native vegetation lacking, very little diversity of species or structure, no thermal cover. Some larger trees in public park but distance from creek offers little cover.</p> <p>Terrestrial: Impaired, but potential for improvement in areas. Aquatic: Functioning, but impaired.</p>

Limiting Factors	<ul style="list-style-type: none"> ▪ Existing land uses ▪ Water quality ▪ Zoning
	Functions <ul style="list-style-type: none"> • Sustainable • Not Sustainable 	Sustainable at current levels: hydrologic, shoreline vegetation, and terrestrial & aquatic habitat. However, sustainability affected by private property ownership.
	Priority Actions	<ul style="list-style-type: none"> ▪ Enhance riparian buffer. ▪ Water quality improvement.
	Current Enhancement Projects	None known
	Preservation/Enhancement Opportunities	<ul style="list-style-type: none"> ▪ Enhance riparian buffer: increase width and species diversity of native shoreline vegetation, install plants along bank for shading. ▪ Preserve undeveloped property north side of creek (possibility of city ownership?). ▪ Remove invasive species.
