CITY OF SUMAS, WA

Shoreline Jurisdiction Vicinity Map

Sehome Planning & Development

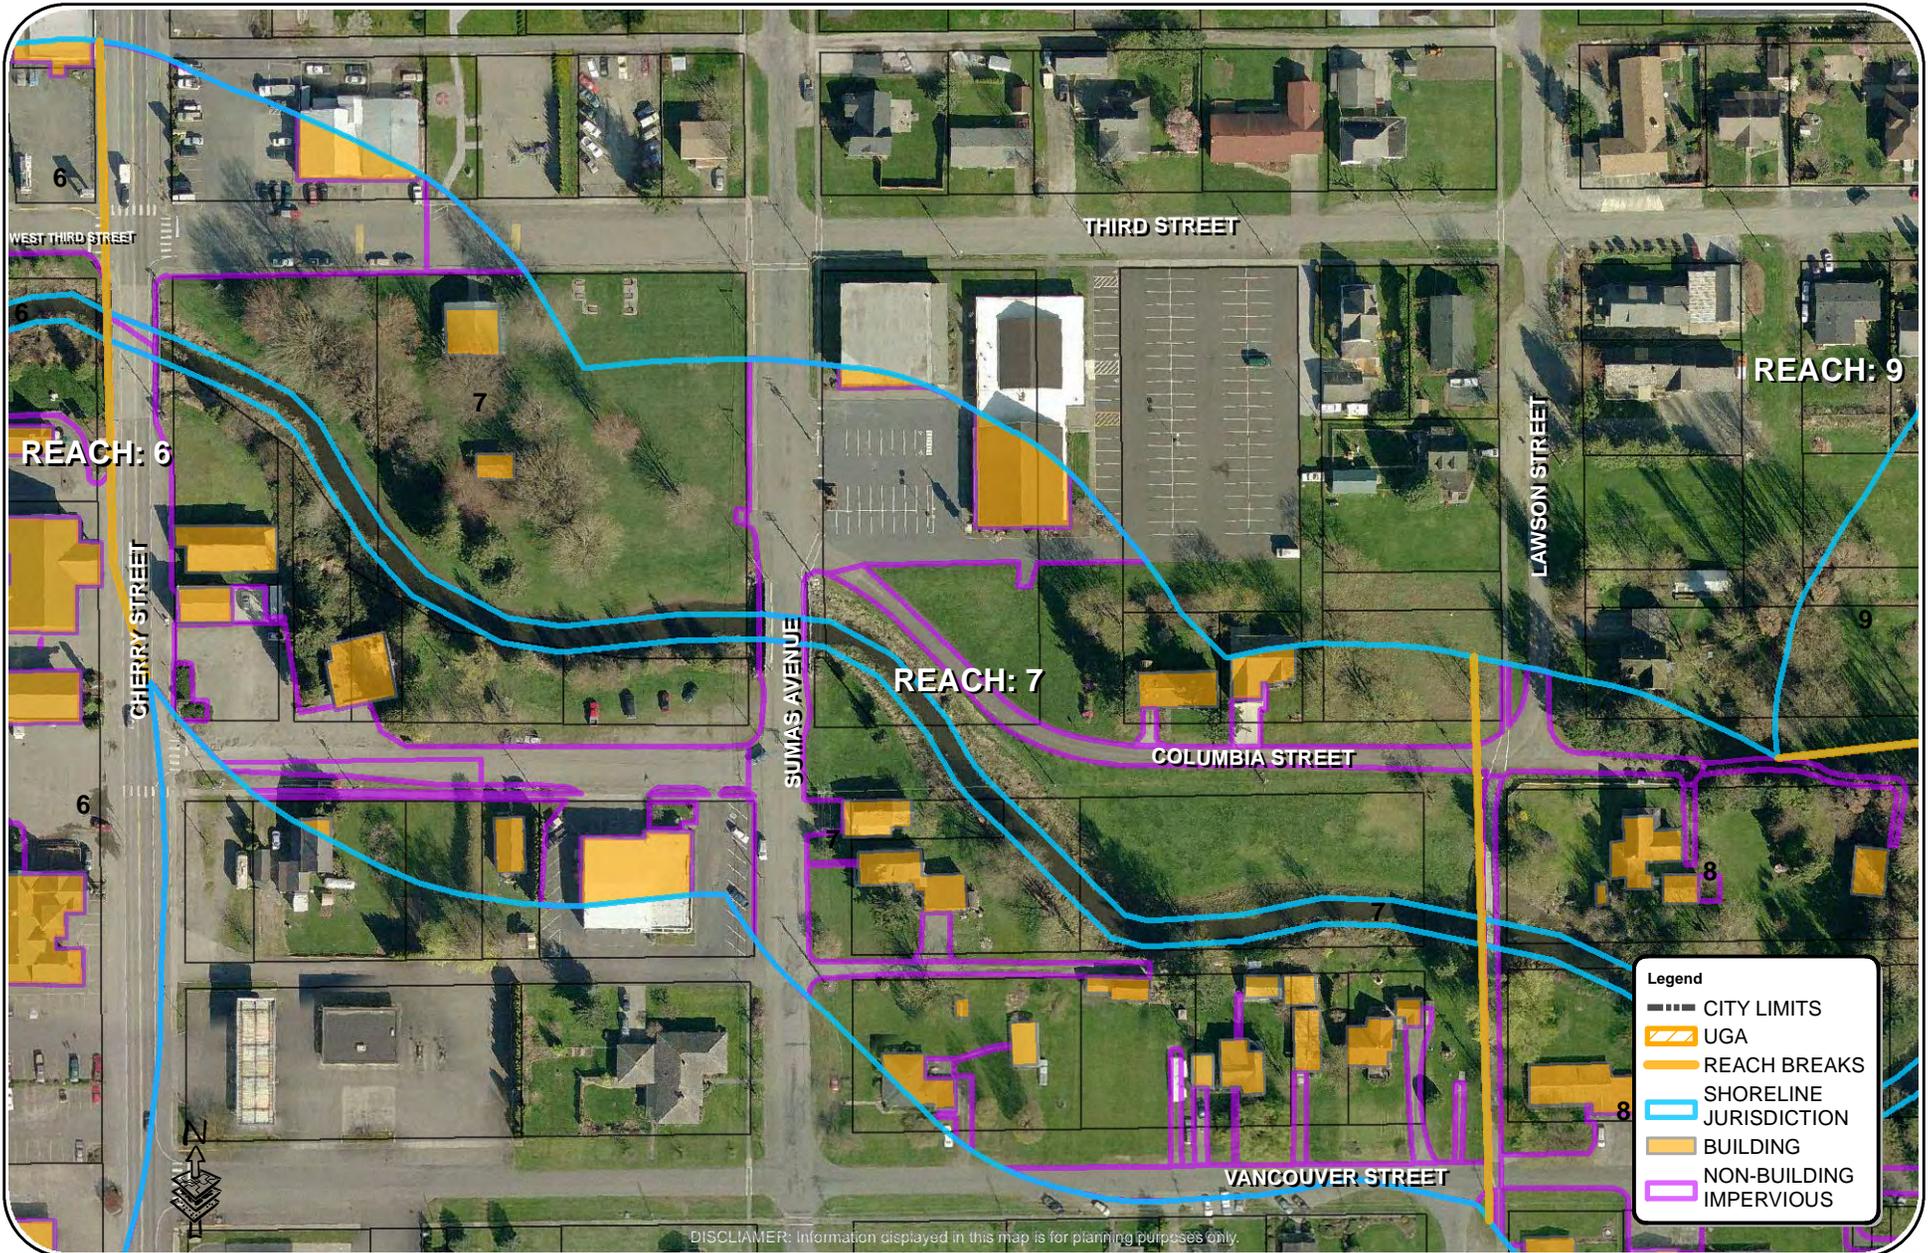
Reach 7

Land Use	Current Shoreline Designation	Urban (Ref # 2)
	Current Land Use	Residential. (Ref # 3, 7)
	Zoning	Residential high density (5.4 ac), agriculture (0.8 ac). (Ref # 2, 16)
Potential Species Present	Wildlife species	None. (Ref # 12)
	Fish species	Sockeye presence documented; Fall chum and winter steelhead presence presumed; Coho rearing. Chum, cutthroat and coho mapped as present (Ref # 13, 18)
	PHS species/habitat	Wetlands associated with Sumas River (upper basin). Emergent and scrub-shrub wetland provide wildlife habitat and water quality/quantity protection. (Ref # 12)
	TSE species	ESU for coho, fall/winter chum; RU for bull trout (Ref # 13)
	Invasive wildlife/fish species	No data.
Physical Environment	Acres of land in reach	Total: 6.2 ac (Ref # 1)
	Aquatic vegetation	No data.
	Slope	No slope data listed by DOE (Ref # 6). Site class and moderate to high liquefaction hazard listed by Whatcom County (DNR 2004). (Ref # 17)

Buildings	Twelve (12) – residential. (Ref # 1)
	Culverts/stormwater utilities	No data; unlikely (Ref #3, 7).
	Geology	Glacial outwash. (Ref # 9)
	Tributary Creeks	None. (Ref # 1, 3, 13)
	Impervious surface	Impervious 1.2 ac (19%) (Ref # 1)
	Roads/transportation	Two residential driveways; arterial access (Vancouver St). (Ref # 1, 7, 9)
	Soils	Briscot silt loam (Ref # 4)
	Topography	Approximate elevation is 35 feet. (Ref # 6)
	FEMA	Entire reach is in the 100 year floodplain, except for a very small portion of buffer. (Ref # 1)
	Terrestrial Vegetation	The majority of the reach is characterized by native mixed trees and shrubs. Small areas of lawn from adjacent residences encroach in a number of places. A small area in the northeast corner is agricultural land (corn). Native vegetation present has the potential to provide good habitat. (Ref # 3)
Riparian Function	Aquatic substrate type	No data.
	Channel confinement	Confined within bank-full width, unconfined in basin due to topography. (Ref # 3, 6)

Channel gradient	No data. (Ref # 13)
	Channel migration zone	Unknown.
	Creosote structures	No data/ none observed (Ref # 3, 7)
	In-water structures	No data/ none observed (Ref # 3, 7)
	Fish passage blockages	None. (Ref # 13)
	LWD presence	No data, unknown. Low to moderate recruitment due to tree density is reach. (Ref # 3, 6, 9)
	Riffle/pool analysis	Low, habitat is homogenous. (Ref # 9)
	DOE 303(d)	Category 4A for fecal and DO (TMDL approved by EPA). (Ref # 10)
	Toxic sites/land fills	None listed. (Ref # 8)
	Point source pollution	Groundwater wells show increased levels of ethylene dibromide in drainage; anthropogenic nitrate concentrations in surface water (Ref # 9). Urban residential

uses. Higher intensity sources are located in the upper watershed where dairy and agriculture is more prevalent. (Ref # 16)
Historic & Cultural	Historic aerials	None available on-line. Presume geomorphology has been stable for several decades.
	Archeological sites	None indicated. (Ref # 5)
	Historic sites	None indicated. (Ref # 5)
	Parks & public access	Planned trail. (Ref # 2)
Function Analysis	Reach Function <ul style="list-style-type: none"> Hydrologic Shoreline Vegetation Habitat 	<p>Functioning with impairments. Rainfall dominated; flashy winter and early spring peaks, low summer, variable spring and fall flows. Impairment in basin due to loss of wetland area, draining, filling, ditching and removal of vegetation for agriculture in the upper watershed.</p> <p>Functioning, with some areas impaired. Vegetation is mostly native with good diversity and structure; lawn encroaches into some areas. Overall this reach offers better habitat potential even though located in a residential area. Eastern end of reach adjacent to agricultural area (crop) – vegetation in this area is impaired.</p> <p>Terrestrial: Functioning, with impairments (residential uses). Aquatic: Functioning, with impairments.</p>

Limiting Factors	<ul style="list-style-type: none"> Existing land uses Water quality Zoning
	Functions <ul style="list-style-type: none"> Sustainable Not Sustainable 	Sustainable at current levels: hydrologic, shoreline vegetation, and terrestrial & aquatic habitat. However, sustainability affected by private property ownership and potential land development.
	Priority Actions	<ul style="list-style-type: none"> Preservation of riparian corridor – vegetation well established and native. Good habitat potential. Water quality improvement.
	Current Enhancement Projects	None known.
	Preservation/Enhancement Opportunities	<ul style="list-style-type: none"> Preservation of terrestrial vegetation, habitat and associated corridors. Particularly riparian corridors. Enhance riparian buffer: increase width of native shoreline vegetation in lawn areas.

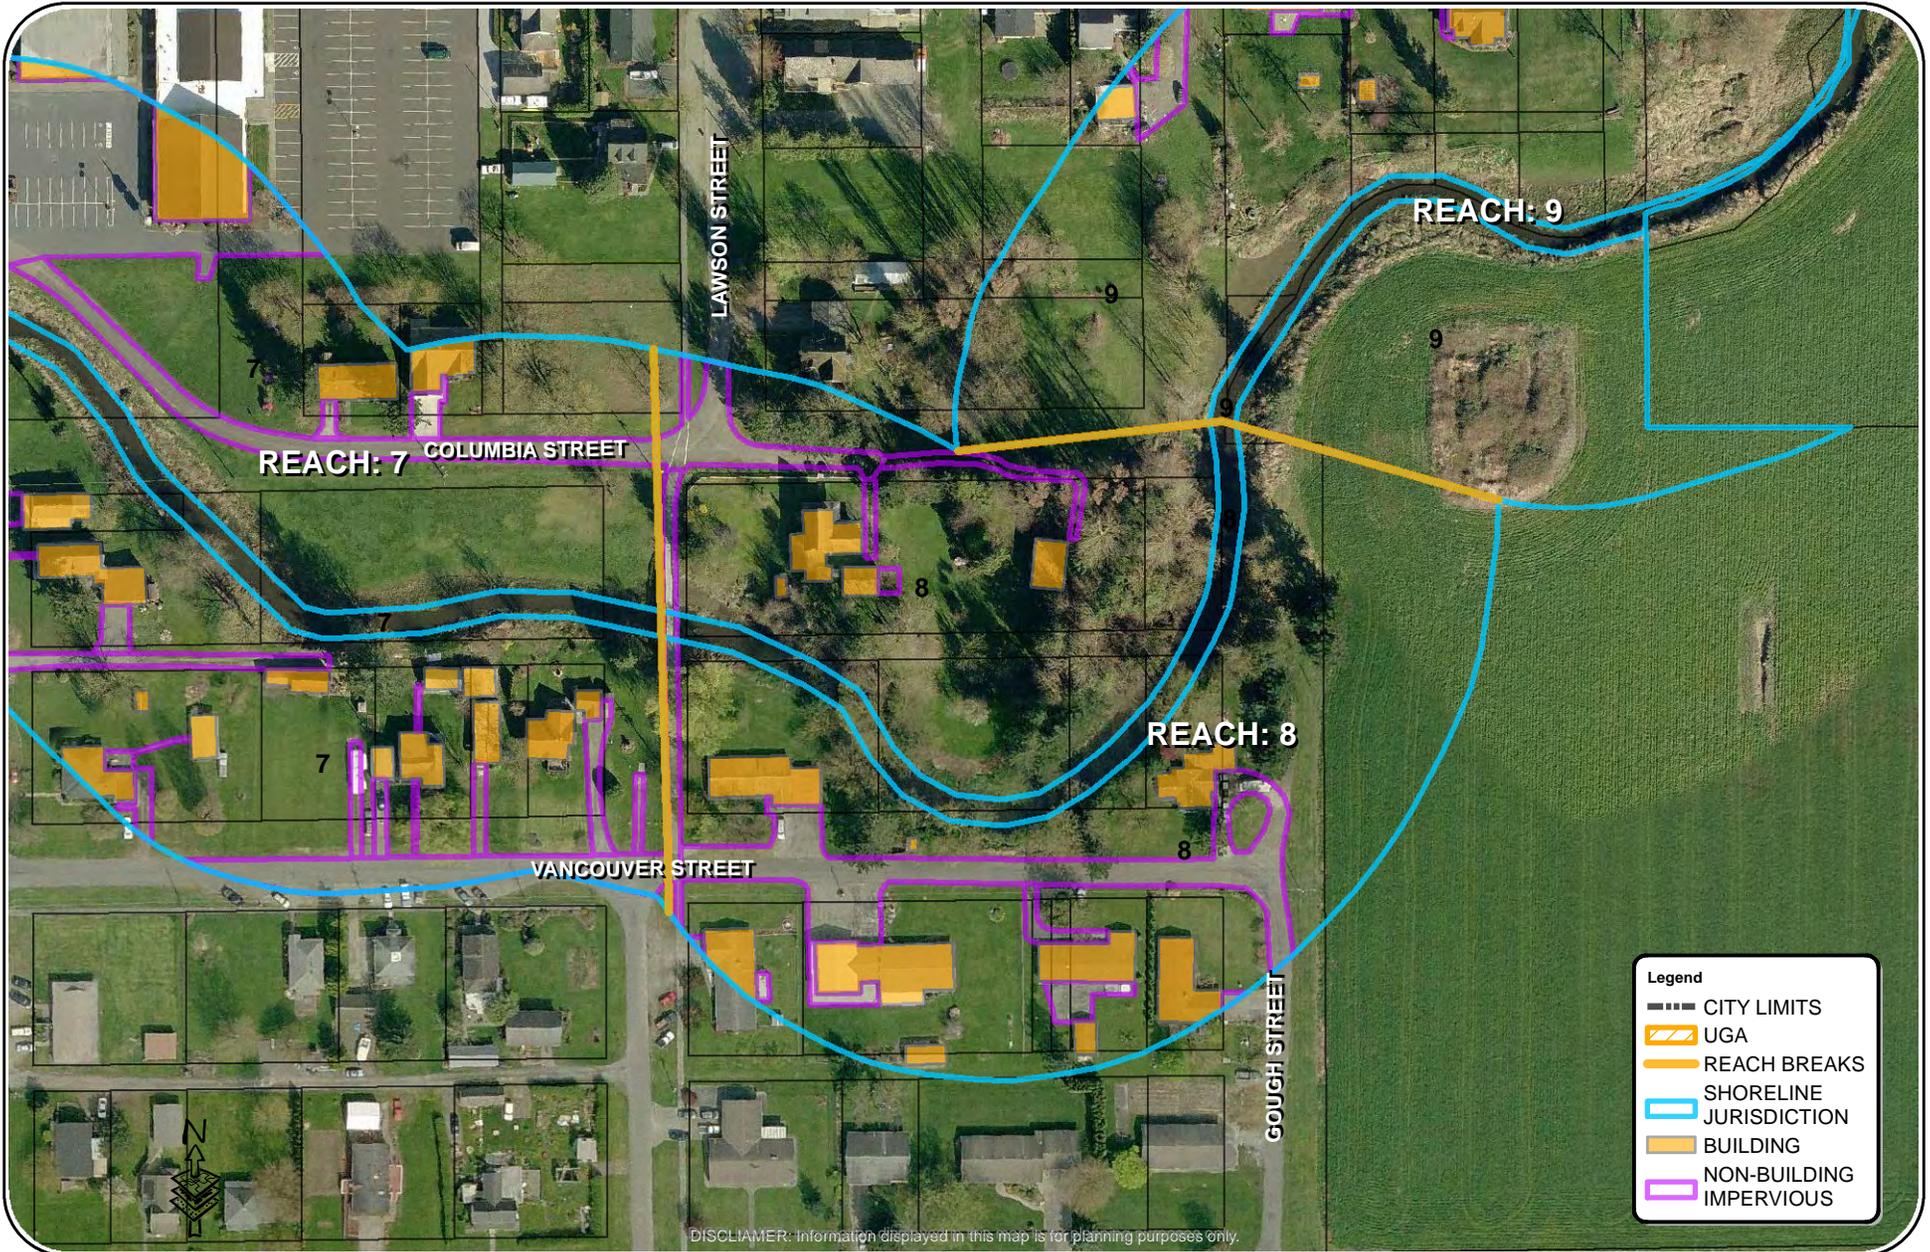
Reach 8

Land Use	Current Shoreline Designation	Urban north side, conservancy south side. (Ref # 2)
	Current Land Use	Residential, light AG, undeveloped parcels. (Ref # 3, 7)
	Zoning	Residential high density (9.7 ac), agriculture (1.4 ac). (Ref # 2, 16)
Potential Species Present	Wildlife species	None. (Ref # 12)
	Fish species	Sockeye presence documented; Fall chum and winter steelhead presence presumed; Coho rearing. Chum, cutthroat and coho mapped as present (Ref # 13, 18)
	PHS species/habitat	Wetlands associated with Sumas River (upper basin). Emergent and scrub-shrub wetland provide wildlife habitat and water quality/quantity protection. (Ref # 12)
	TSE species	ESU for coho, fall/winter chum; RU for bull trout (Ref # 13)
	Invasive wildlife/fish species	No data.
Physical Environment	Acres of land in reach	Total: 11.1 ac (Ref # 1)
	Aquatic vegetation	No data.
	Slope	No slope data listed by DOE (Ref # 6). Site class and moderate to high liquefaction hazard listed by Whatcom County (DNR 2004). (Ref # 17)

Buildings	Fifteen (15) – residential, some partial. (Ref # 1)
	Culverts/stormwater utilities	No data. Not likely (Ref # 3,7)
	Geology	Glacial outwash. (Ref # 9)
	Tributary Creeks	None. (Ref # 1, 13)
	Impervious surface	Impervious 1.1 ac (10%) (Ref # 1)
	Roads/transportation	Two residential driveways. (Ref # 3, 7)
	Soils	Sumas silt loam (Ref # 4)
	Topography	Approximate elevation is 35 feet. (Ref # 6)
	FEMA	Entire reach is in the 100 year floodplain. (Ref # 1)
	Terrestrial Vegetation	The majority of the reach is characterized by pasture areas vegetated with native and non-native grasses and herbaceous species, and large patches of Himalayan blackberry. A number of trees, deciduous and evergreen, are located throughout the reach. A small area near the southwest reach is agriculture (crop). Vegetation present provides little shade. (Ref # 3)
	Riparian Function	Aquatic substrate type
Channel confinement		Confined within bank-full width, unconfined in basin due to topography. (Ref # topo, presumed from observation)

Channel gradient		No data. (Ref # 13)
Channel migration zone		Unknown.
Creosote structures		No data/ none observed (Ref # 3, 7)
In-water structures		No data/ none observed (Ref # 3, 7)
Fish passage blockages		None. (Ref # 13)
LWD presence		None observed. Tree cover along the shoreline is low. Recruitment potential is low. (Ref # 3, 7, 9)
Riffle/pool analysis		Low, habitat is homogenous. (Ref # 9)
DOE 303(d)		Category 4A for fecal and DO (TMDL approved by EPA). (Ref # 10)
Toxic sites/land fills		None listed. (Ref # 6, 8)

Point source pollution	Groundwater wells show increased levels of ethylene dibromide in drainage; anthropogenic nitrate concentrations in surface water (Ref # 9). Scattered residential uses, crop agriculture. Higher intensity sources are located in the upper watershed where dairy and agriculture is more prevalent. (Ref # 16)
Historic & Cultural	Historic aerials	None available on-line. Presume geomorphology has been stable for several decades.
	Archeological sites	None indicated. (Ref # 5)
	Historic sites	None indicated. (Ref # 5)
	Parks & public access	None. (Ref # 1)
Function Analysis	Reach Function <ul style="list-style-type: none"> Hydrologic Shoreline Vegetation Habitat 	<p>Functioning with impairments. Rainfall dominated; flashy winter and early spring peaks, low summer, variable spring and fall flows. Impairment in basin due to loss of wetland area, draining, filling, ditching and removal of vegetation for agriculture in reach and upper watershed.</p> <p>Impaired. Majority of vegetation is non-native. Very little diversity of species or structure. Habitat value low; very little cover provided to creek.</p> <p>Terrestrial: Impaired, but could be improved.</p> <p>Aquatic: Functioning, with impairments.</p>

Limiting Factors	<ul style="list-style-type: none"> Existing land uses Water quality Zoning
	Functions <ul style="list-style-type: none"> Sustainable Not Sustainable 	Sustainable at current levels: hydrologic, shoreline vegetation, and terrestrial & aquatic habitat. However, sustainability affected by private property ownership.
	Priority Actions	<ul style="list-style-type: none"> Preservation of riparian corridor; enhance with trees and native vegetation for habitat and thermal cover. Water quality improvement.
	Current Enhancement Projects	None known.
	Preservation/Enhancement Opportunities	<ul style="list-style-type: none"> Enhance riparian buffer: increase width of native shoreline vegetation in pasture areas, added species diversity, added plants along the banks for shading. Removal of invasive species (Himalayan blackberry).

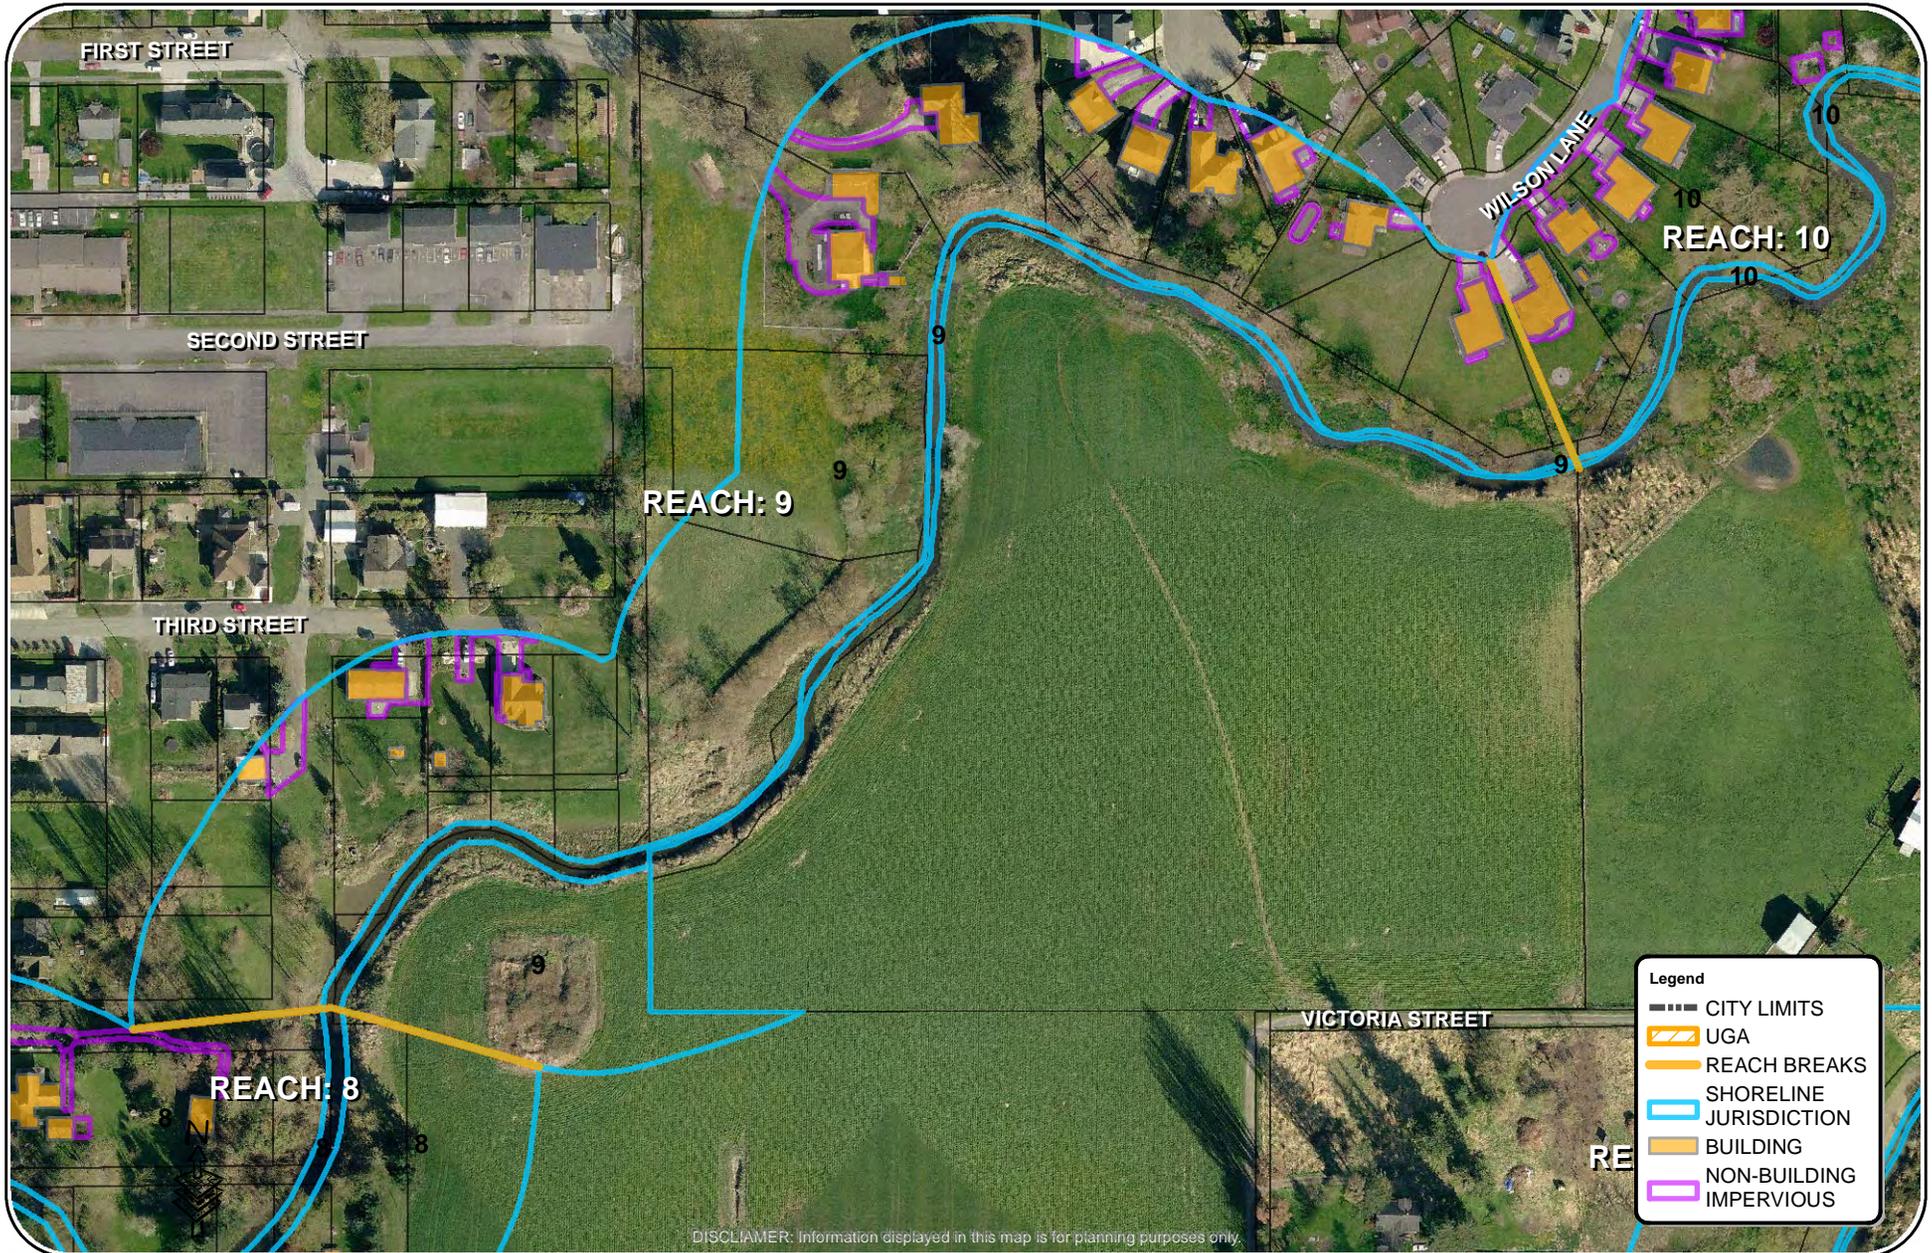
Reach 9

Land Use	Current Shoreline Designation	Urban on north side, conservancy on south side. (Ref # 2)
	Current Land Use	Residential. (Ref # 3, 7)
	Zoning	Residential high density (3.9 ac). (Ref # 2, 16)
Potential Species Present	Wildlife species	None. (Ref # 12)
	Fish species	Sockeye presence documented; Fall chum and winter steelhead presence presumed; Coho rearing. Chum, cutthroat and coho mapped as present (Ref # 13, 18)
	PHS species/habitat	Wetlands associated with Sumas River (upper basin). Emergent and scrub-shrub wetland provide wildlife habitat and water quality/quantity protection. (Ref # 12)
	TSE species	ESU for coho, fall/winter chum; RU for bull trout (Ref # 13)
	Invasive wildlife/fish species	No data.
Physical Environment	Acres of land in reach	Total: 3.9 ac (Ref # 1)
	Aquatic vegetation	No data.
	Slope	No slope data listed by DOE (Ref # 6). Site class and moderate to high liquefaction hazard listed by Whatcom County (DNR 2004). (Ref # 17)

Buildings	Seventeen (17) – all residential. (Ref # 1)
	Culverts/stormwater utilities	No data. No likely (Ref # 3, 7)
	Geology	Glacial outwash. (Ref # 9)
	Tributary Creeks	None. (Ref # 1, 13)
	Impervious surface	Impervious 1.0 ac (26%) (Ref # 1)
	Roads/transportation	Access road (Heron Lane) at eastern terminus of reach. (Ref # 3, 7)
	Soils	Briscot silt loam, Oridia silt loam, Sumas silt loam (Ref # 4)
	Topography	Approximate elevation is 35 feet. (Ref # 6)
	FEMA	Entire reach is in the 100 year floodplain. (Ref # 1)
	Terrestrial Vegetation	The majority of the reach is characterized by native deciduous trees and shrubs. A few small areas of lawn are also present. Native vegetation present has the potential to provide good habitat. Overhanging vegetation and shading are not present along the majority of the reach. Reed canarygrass is present in patches along the channel. (Ref # 3)
Riparian Function	Aquatic substrate type	Silt.

Channel confinement	Confined within bank-full width, unconfined in basin due to topography. (Ref # 3, 6)
	Channel gradient	None. (Ref # 13)
	Channel migration zone	Unknown.
	Creosote structures	No data/ none observed (Ref # 3, 7)
	In-water structures	No data/ none observed (Ref # 3, 7)
	Fish passage blockages	None. (Ref # 13)
	LWD presence	None observed. Tree cover along the shoreline is moderate. Recruitment potential is moderate. (Ref # 3, 7, 9)
	Riffle/pool analysis	Low, habitat is homogenous. (Ref # 9)
	DOE 303(d)	Category 4A for fecal and DO (TMDL approved by EPA). (Ref # 10)
Toxic sites/land fills	None listed. (Ref # 6, 8)

Point source pollution	Groundwater wells show increased levels of ethylene dibromide in drainage; anthropogenic nitrate concentrations in surface water (Ref # 9). Residential uses. Higher intensity sources are located in the upper watershed where dairy and agriculture is more prevalent. (Ref # 16)
Historic & Cultural	Historic aerials	None available on-line. Presume geomorphology has been stable for several decades.
	Archeological sites	None indicated. (Ref # 5)
	Historic sites	None indicated. (Ref # 5)
	Parks & public access	None. (Ref # 1)
Function Analysis	Reach Function <ul style="list-style-type: none"> • Hydrologic • Shoreline Vegetation • Habitat 	<p>Functioning with impairments. Rainfall dominated; flashy winter and early spring peaks, low summer, variable spring and fall flows. Impairment in basin due to loss of wetland area, draining, filling, ditching and removal of vegetation for agriculture in the upper watershed.</p> <p>Functioning in areas, impaired in other. Some native tree and shrub habitat along shoreline; open areas with blackberry and reed canarygrass. Residential lawn encroaches in areas. Follow agricultural practice has allowed tree and shrubs to re-vegetate shoreline and buffer – although not all species are native. Potential for restoration.</p> <p>Terrestrial: Functioning, with impairments. Aquatic: Functioning with impairments.</p>

Limiting Factors	<ul style="list-style-type: none"> ▪ Existing land uses ▪ Water quality ▪ Zoning
	Functions <ul style="list-style-type: none"> • Sustainable • Not Sustainable 	Sustainable at current levels: hydrologic, shoreline vegetation, and terrestrial & aquatic habitat. However, sustainability affected by private property ownership.
	Priority Actions	<ul style="list-style-type: none"> ▪ Preservation of riparian corridor; buffer enhancement plantings to improve habitat and structure. ▪ Water quality improvement.
	Current Enhancement Projects	None known
	Preservation/Enhancement Opportunities	<ul style="list-style-type: none"> ▪ Preservation of terrestrial vegetation, habitat and associated corridors. Particularly riparian corridors. ▪ Enhance riparian buffer: increase width and species diversity of native shoreline vegetation, add plants along the banks to provide shading.
