**SKAGIT ENVIRONMENTAL  
BANK**

Skagit County, Washington

*Public Notice Version of the  
Wetland Mitigation Bank Prospectus*

Clear Valley Environmental Farm, LLC  
Mount Vernon, San Francisco, Denver  
Kevin F. Noon Ph.D.  
Telephone: (303) 679-8262

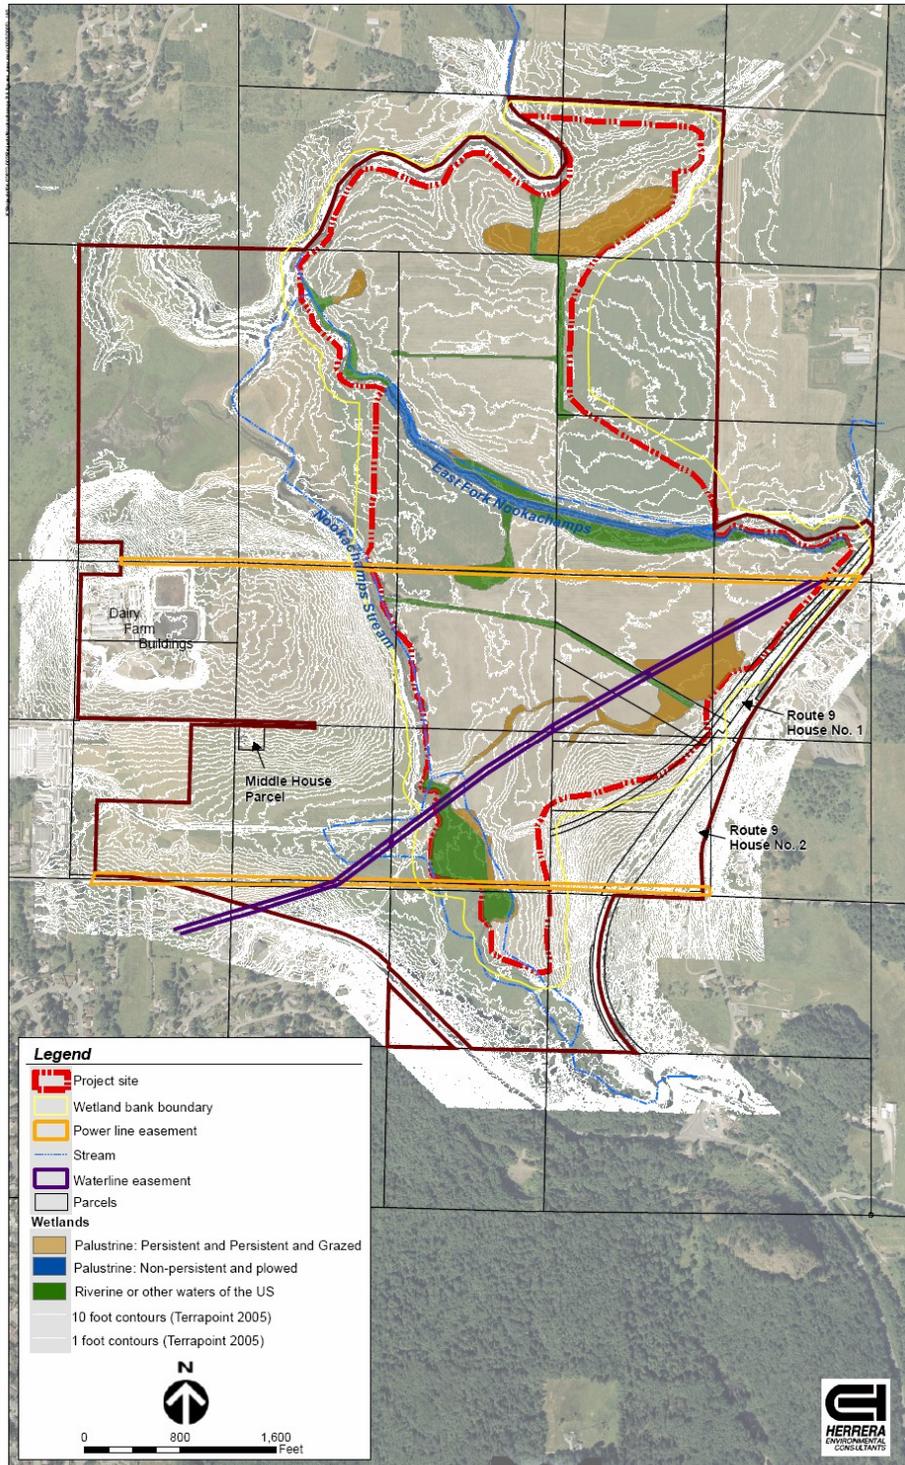
**Figure 2: Property Map**

**THIS GRAPHIC SHOWS ENTIRE 805 ACRE PROPERTY, AND THE 355 ACRE BANK SITE, ALL PERTINENT EASEMENTS AND THE EXISTING WETLAND DELINEATION. PLEASE REFER TO PAGES 6 AND 9 FOR MORE DETAIL REGARDING THIS GRAPHIC.**

Figure 1. Property bank boundary, easements, and wetlands.

We have performed a wetland delineation of the Bank site. This report has been confirmed by the United States Army Corps of Engineers and the Washington State Department of Ecology. We have included approximately 59 acres of palustrine or riverine wetlands in the 355 acre Bank; these wetlands exhibit all of the definitional wetland characteristics, and therefore have been delineated as existing wetlands. The remaining approximately 296 acres of the Bank are plowed areas that have modified hydrologic conditions; they were likely wetlands prior to being ditched or graded to drain for row cropping (sometime after 1941), but are no longer meet the definition of wetlands.

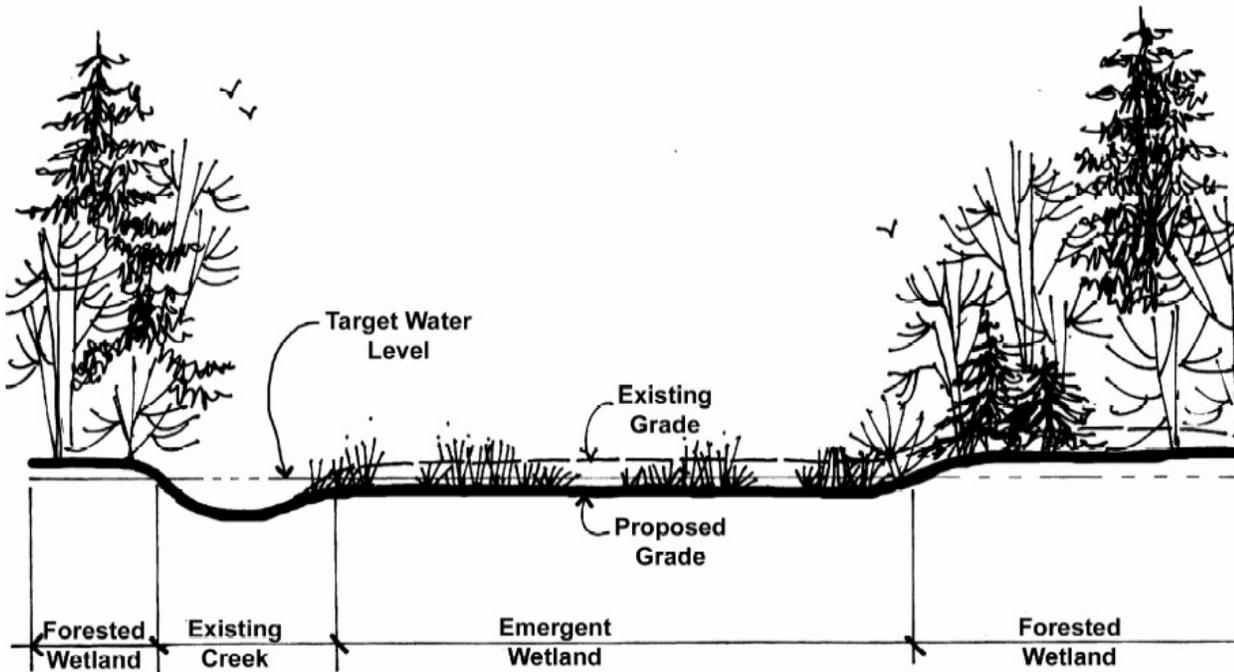
**Figure 4: Typical Cross Section A1**

**THIS GRAPHIC IS A TYPICAL CROSS SECTION OF WHAT WILL BE RESTORED ON THE BANK SITE. PLEASE REFER TO PAGE 14 FOR MORE DETAIL REGARDING THIS GRAPHIC.**

Skagit Environmental Bank  
Section A1  
Not to Scale

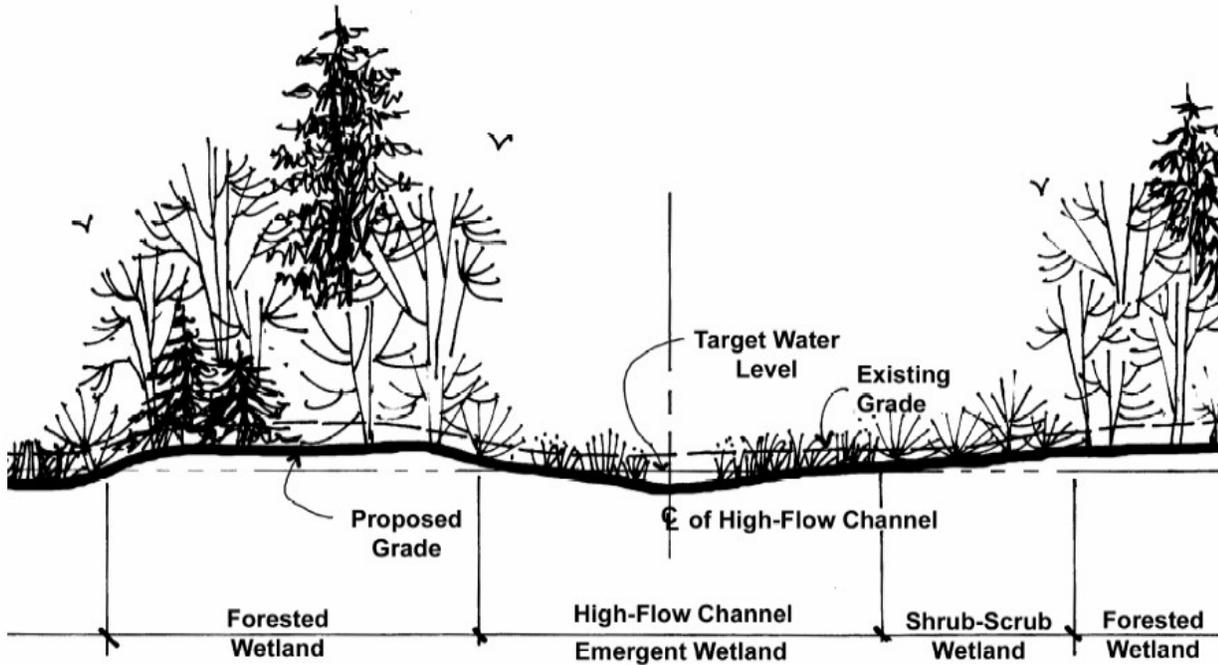
**Figure 5: Typical Cross Section A2**

THIS GRAPHIC IS A TYPICAL CROSS SECTION OF WHAT WILL BE RESTORED ON THE BANK SITE. PLEASE REFER TO PAGE 14 FOR MORE DETAIL REGARDING THIS GRAPHIC.

Skagit Environmental Bank  
Section A2  
Not to Scale

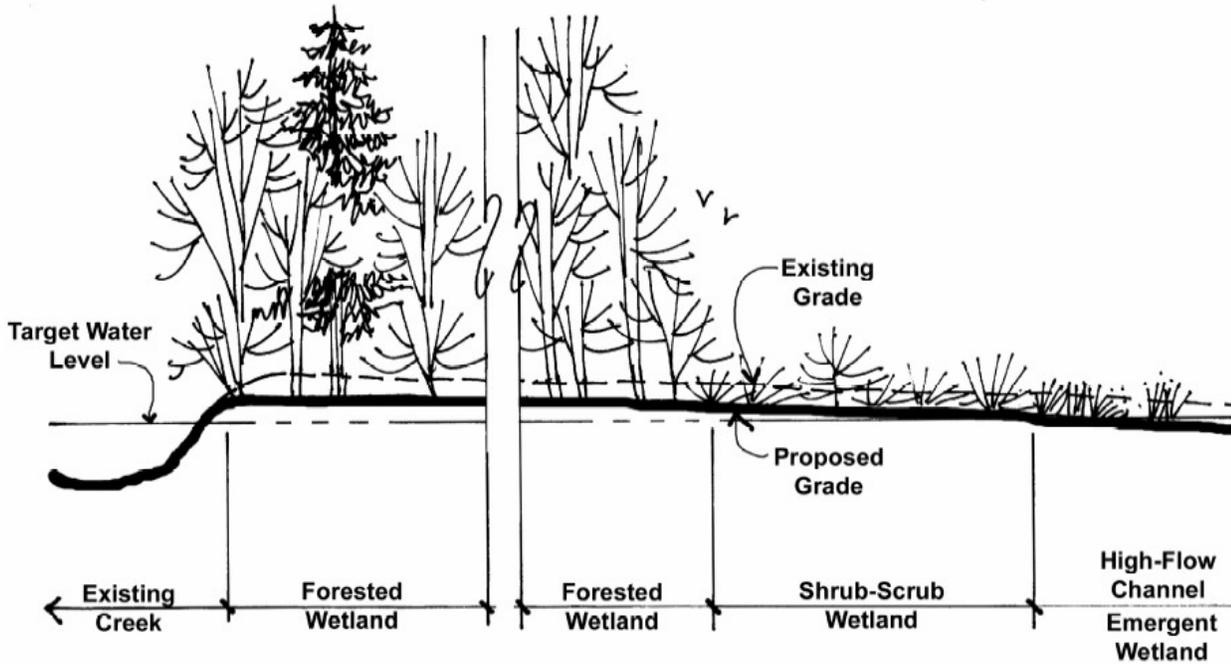
**Figure 6: Typical Cross Section B1**

**THIS GRAPHIC IS A TYPICAL CROSS SECTION OF WHAT WILL BE RESTORED ON THE BANK SITE. PLEASE REFER TO PAGE 14 FOR MORE DETAIL REGARDING THIS GRAPHIC.**

Skagit Environmental Bank  
Section B1  
Not to Scale

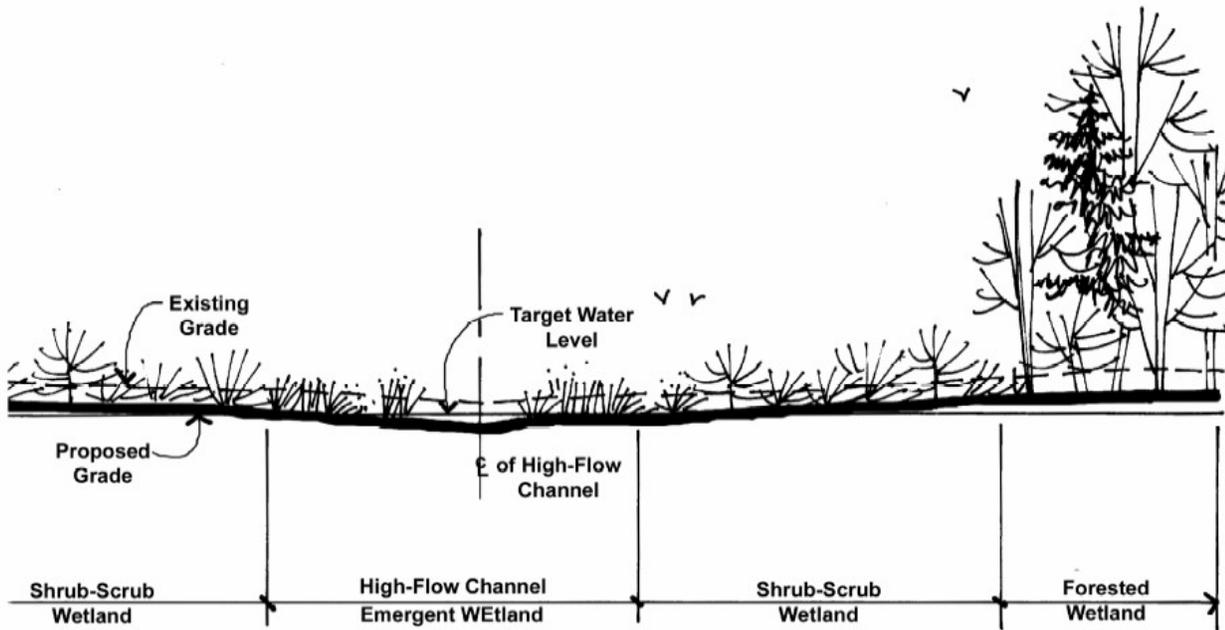
**Figure 7: Typical Cross Section B2**

This graphic is a typical cross section of what will be restored on the Bank Site. Please refer to page 14 for more detail regarding this graphic.

Skagit Environmental Bank  
Section B2  
Not to Scale

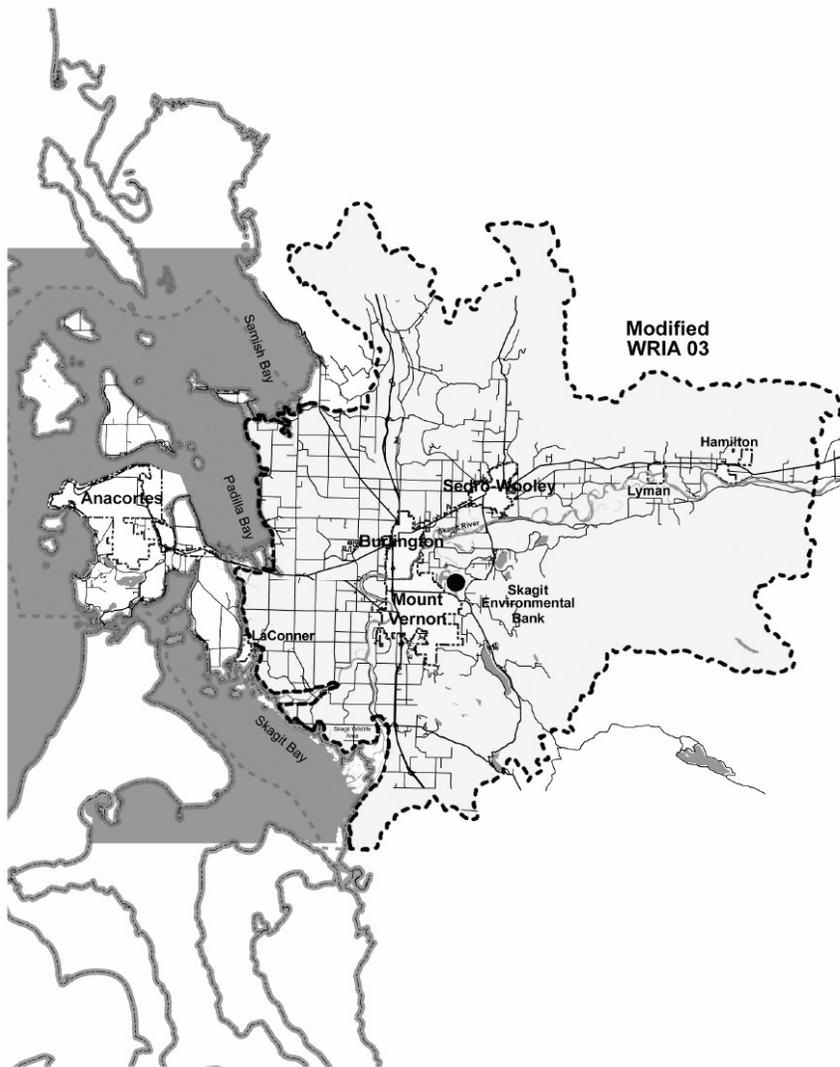
**Figure 8: Proposed Service Area WRIA 3**

This graphic denotes the Service Area that the Skagit Environmental Bank believes it should be granted. This area is the entire WRIA 3, excluding any estuarine wetlands, and adjacent Islands of the Puget Sound. The Service Area is the ecologically consistent area within which it is felt that the Bank Site can appropriately compensate for impacts to like wetland habitats. Please refer to page 20 for more detail regarding this graphic.

**Skagit Environmental Bank**  
Proposed Service Area - WRIA 03 - Modified  
Sources: Skagit County GIS/Mapping Services, Washington State Dept. of Ecology

The proposed geographic service area (that is, the area within which the Bank may be used to compensate for permitted impacts) includes fresh-water wetlands within the Washington State Water Resource Inventory Lower Skagit-Samish Watershed Area WRIA 03; this would exclude the Islands in Puget Sound adjacent to the WRIA 03 Watershed Area, and would exclude all estuarine (saltwater) wetlands. Please see Figure 8 "Service Area Map" in the Appendix. The Bank may be used to compensate for permitted impacts in adjacent portions of WRIs 01 and 05 if specifically approved on a case by case basis by the appropriate regulatory agencies and the Signatories, and such mitigation would be practicable and environmentally preferable to other compensation alternatives. The final decision as to who can use the Bank for compensation will be determined by the appropriate permitting agencies.

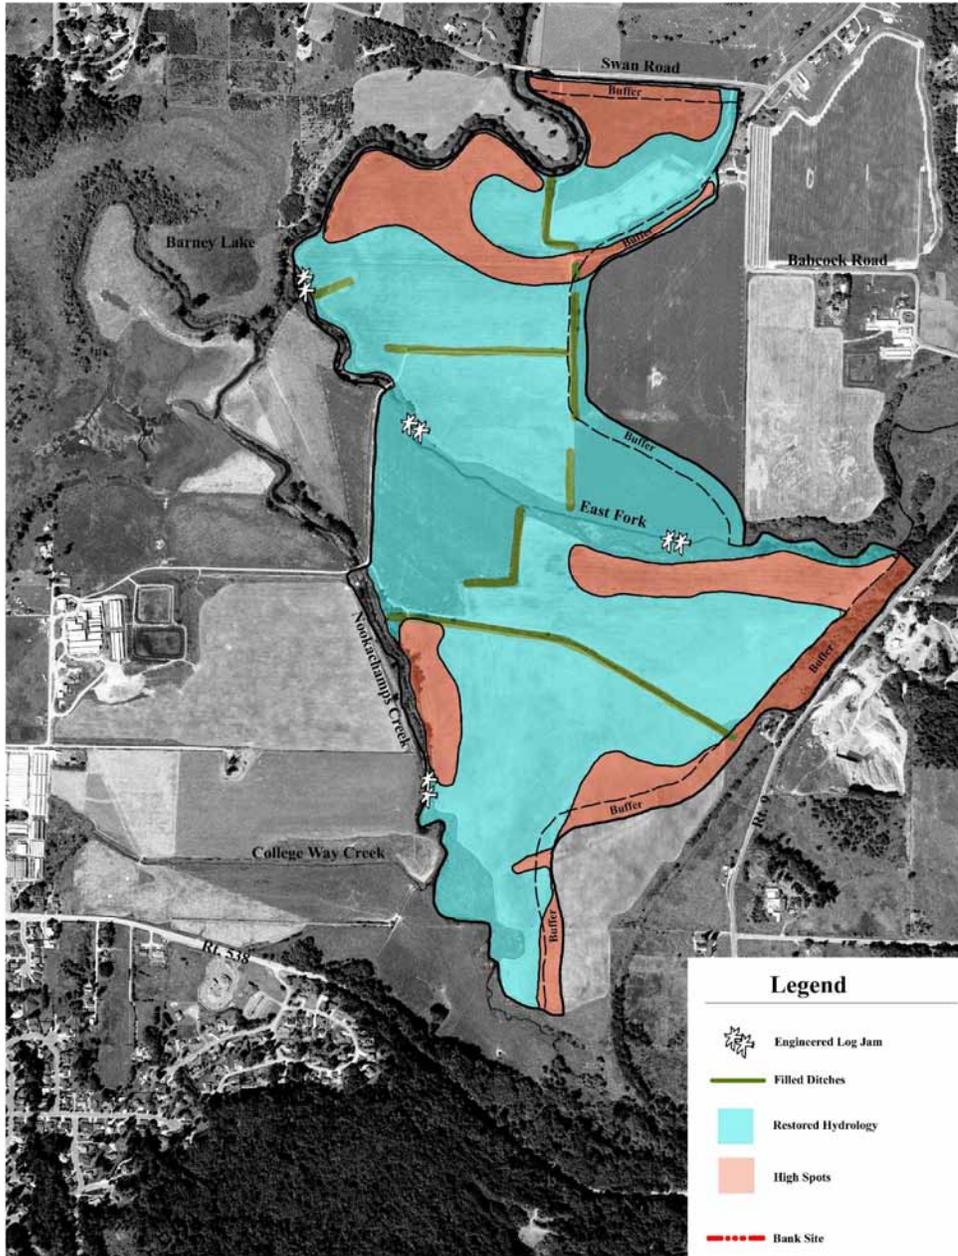
**Figure 9: Functional Phase 1 Map**

THIS GRAPHIC DENOTES THE PHASE 1 CONSTRUCTION PLANS FOR THE BANK SITE. PLEASE REFER TO PAGES 16, 17 AND 19 FOR MORE DETAIL REGARDING THIS GRAPHIC.

**Skagit Environmental Bank**  
Functional Phasing Plan - Phase 1 Hydrologic Conditions Restored

1. Make the modifications to restore the hydrology to the entire Bank site, and put down a wetland or upland seed cover crop as appropriate and wait a year. Please see Figure 9 Functional Phase 1 in Appendix for map.
2. Collect new data over that year, and then design the high-flow channels based on the new hydrologic conditions and data and excavate and plant the high-flow channels, then wait three years and plant the remaining restored hydrologic areas

Based on our experience we anticipate that, as a result of these modifications, we will have restored wetland hydrologic conditions (saturation within a foot of the surface for more than 12 days) to more than 80 % of the site. About 20% of the Bank will still not be restored to hydrologic conditions (please see the areas labeled “High Spots” on the Phase 1 Plan). These areas are higher because in the past farmers graded the fields for drainage purposes and pushed the extra fill to the edges of the fields, thereby creating these higher bermed areas. For that reason, we have to excavate in order to bring the remaining surface down to our target hydrologic conditions near the ground water table. That will be done in Functional Phases 2 and 3.

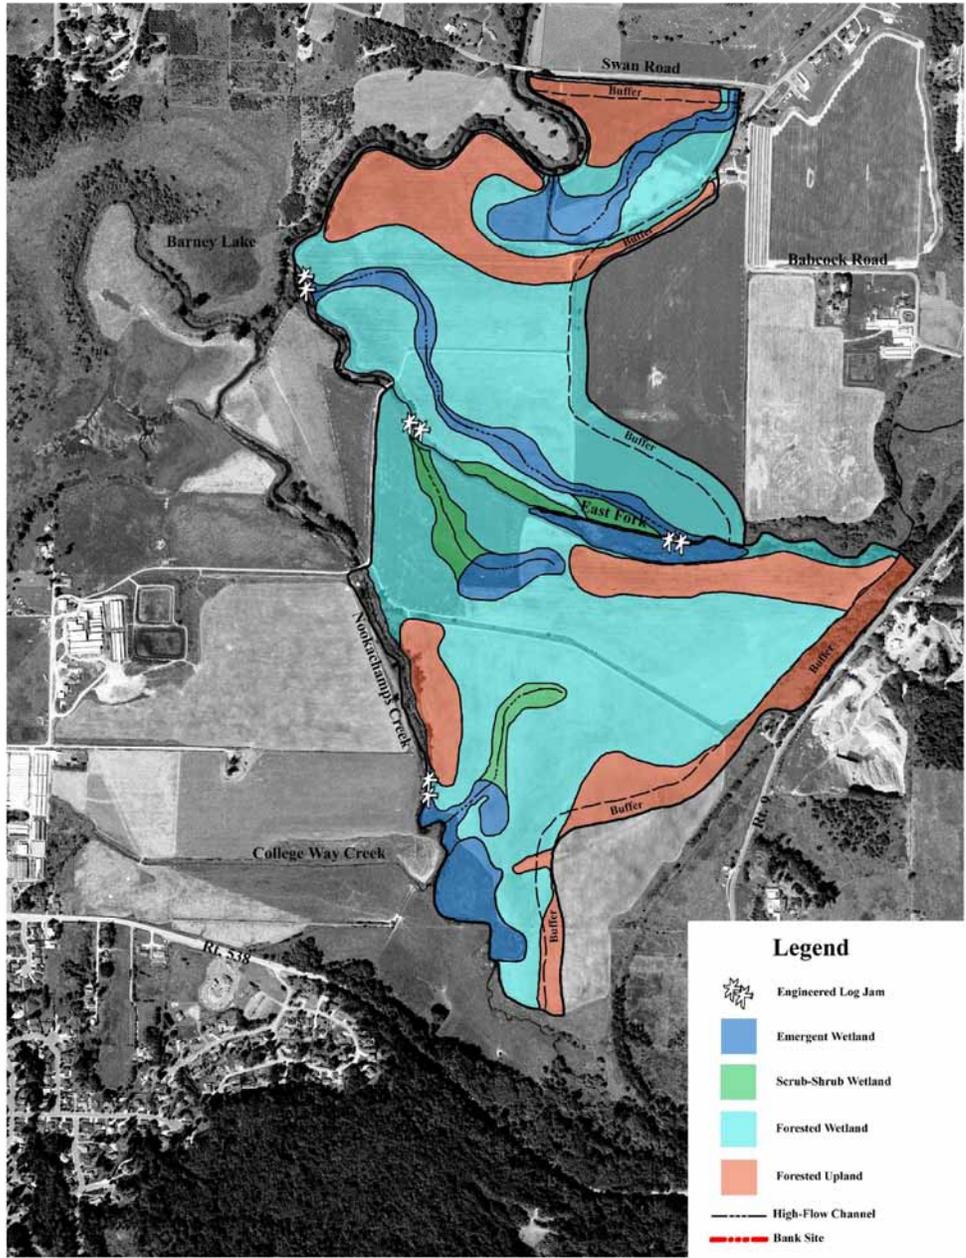
**Figure 10: Functional Phase 2 Map**

THIS GRAPHIC DENOTES THE PHASE 2 CONSTRUCTION PLANS FOR THE BANK SITE. PLEASE REFER TO PAGES 16, 17 AND 19 FOR MORE DETAIL REGARDING THIS GRAPHIC.

**Skagit Environmental Bank**  
Functional Phasing Plan - Phase 2 High-Flow Channels Constructed

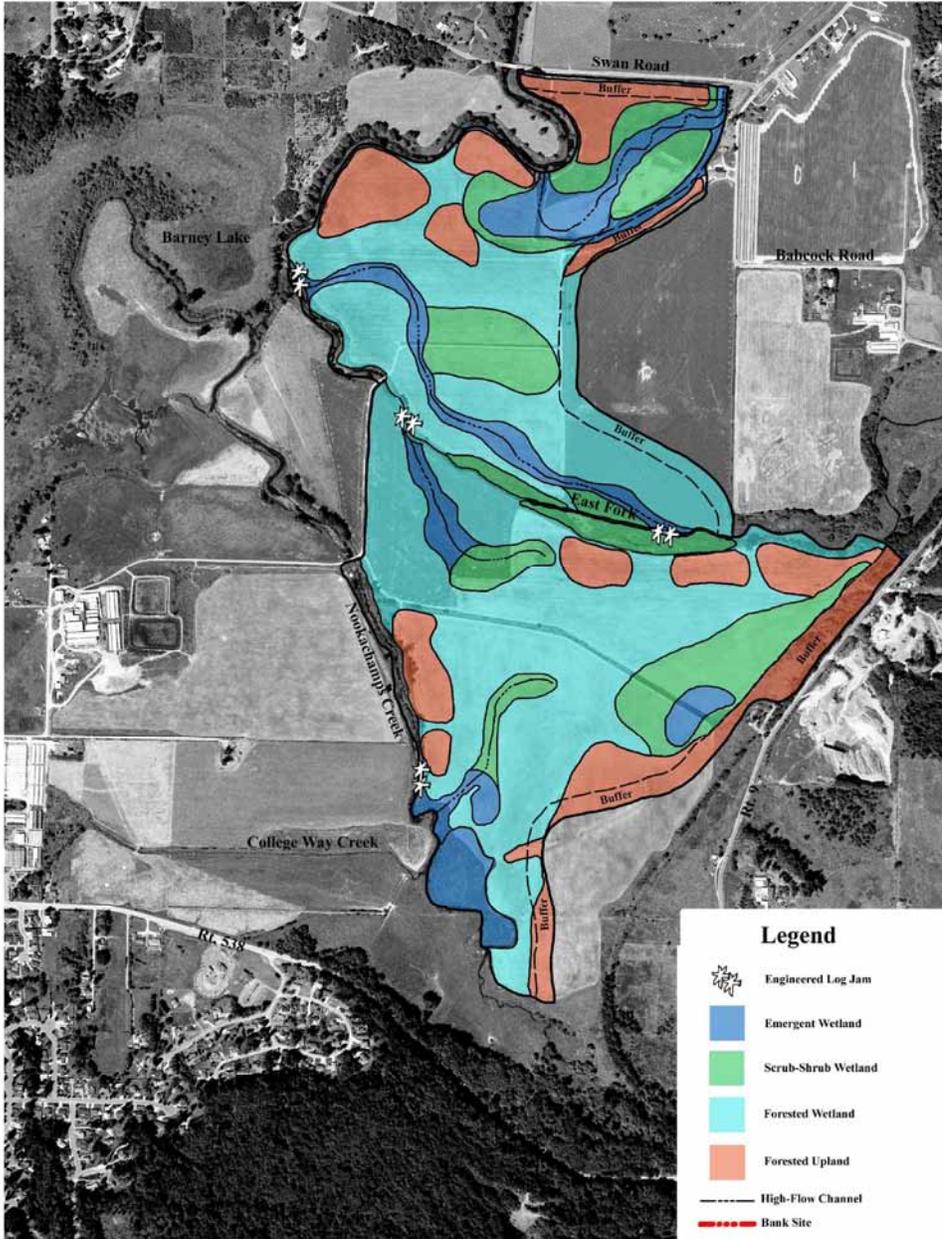
***Figure 11: Functional Phase 3 Map***

**THIS GRAPHIC DENOTES THE PHASE 3 CONSTRUCTION PLANS FOR THE BANK SITE. PLEASE REFER TO PAGES 16, 18 AND 19 FOR MORE DETAIL REGARDING THIS GRAPHIC.**

**Skagit Environmental Bank**  
 Functional Phasing Plan - Phase 3 Grading and Planting Finalized

3. Finally, excavate the remaining “high” areas (or those areas that do not meet the wetland hydrologic conditions), and plant these excavated areas. Please see Figure 11 Functional Phase 3 in Appendix for map.

The third functional phase will be to excavate (down to the appropriate hydrologic conditions) the remaining 20 percent, or approximately 70 acres, of the Bank. We believe that the areas that will remain non-hydric after Phase 1 and 2 modifications will be the graded soils or bermed areas close to the creeks. Those areas labeled "High Spots" on Figure 11 Functional Phase 3 Map in the Appendix, and show what we anticipate to be left after excavation.

The areas on the Phasing Plans are based on our knowledge of the "high spots" on the Bank, well data, and our analysis of aerial photographs of pre-farmed conditions. The high spots or bermed areas appear to be an attempt to move soils to create drainage across the once-flat fields. They may have also been created to confine the stream flows to the creek channels. Since these graded areas were sculpted to be at higher elevations than what naturally existed, they will likely not become hydric after the modifications from Phases 1 and 2 – hence the need to excavate them. We now plan that these areas will be sculpted into a mosaic of small (less than 10 acre)

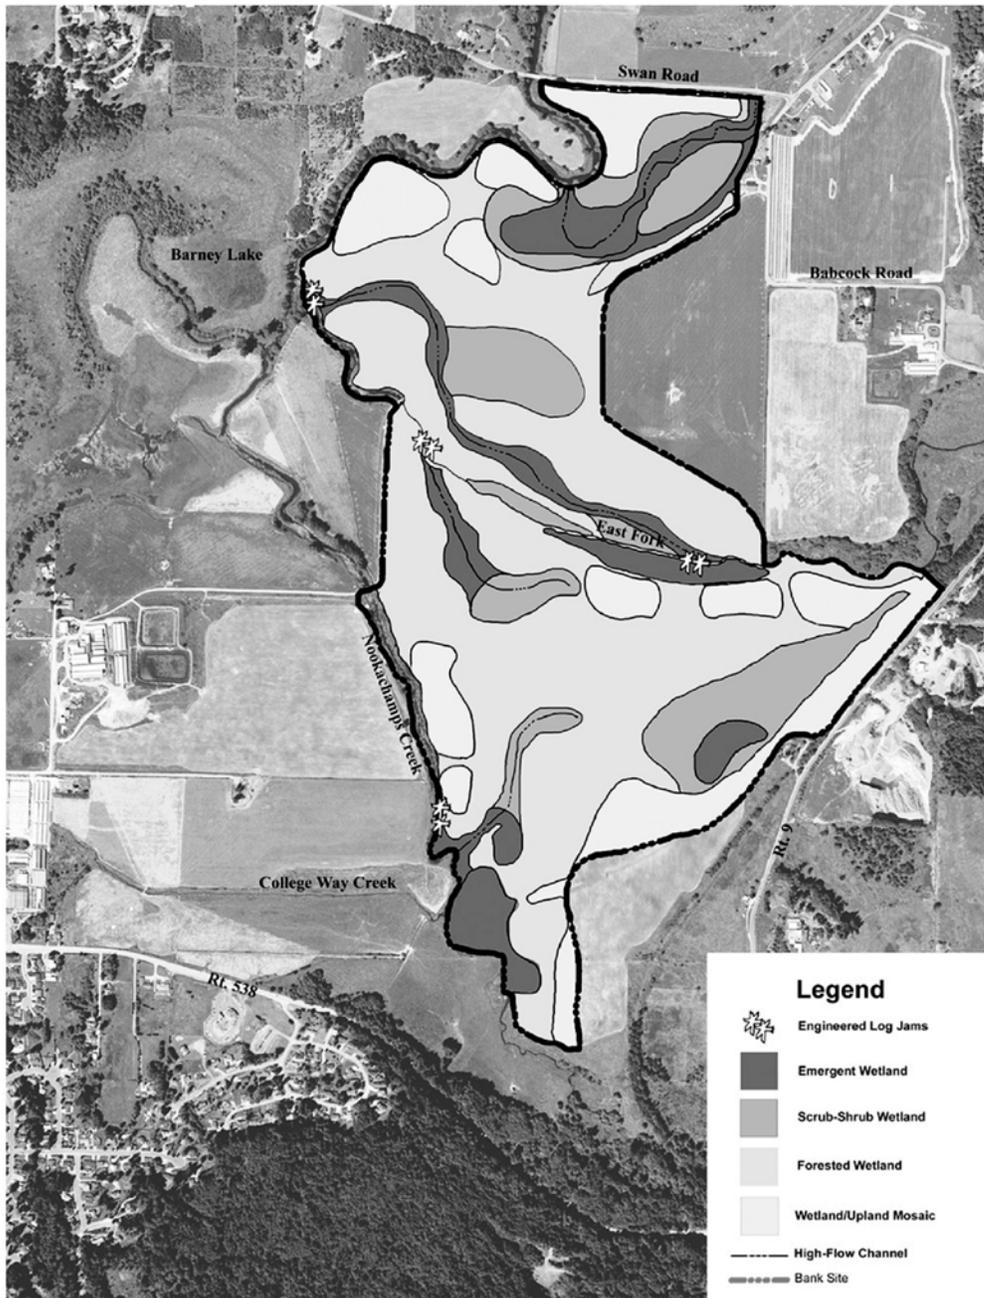
Figure 12 Post Final Construction Bank Site, Black and White

**Skagit Environmental Bank**  
Design Plan
