**TERRACE MITIGATION BANK**  
**Clark County, Washington**

**PROSPECTUS**

**Submitted July 2014**  
**Revised September 2014**

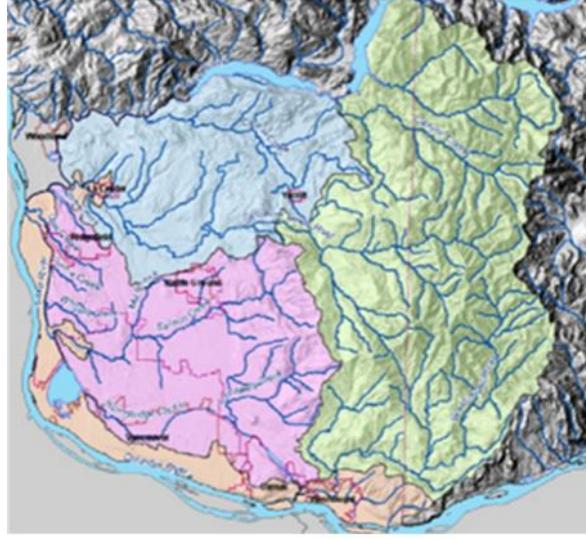
**Map 1. Landscape Groups.** Green is the Rain-on Snow and Snow-Dominated Mountainous unit; blue is the Rain-dominated Mountainous unit (East Fork and Mainstem of the Lewis); pink is the Terrace unit; and orange identifies the Columbia River unit.

The proposed service area for wetlands includes all plains and terraces, nearly level to gently sloping, within the Terrace Hydrogeologic Unit (Map 1) as described in the 2009 *Watershed Characterization of Clark County* and that also encompasses the somewhat excessively drained to very poorly drained soils of bottom lands and terraces (NRCS 2014, Ecology 2009). These soils can be grouped into associations that have essential characteristics in common (texture, drainage capability, slope). Using these criteria, a service area that includes all relatively flat terrain within the central and western portions of the Terrace unit is feasible. This would include the watersheds of the Burnt Bridge Creek, Lacamas Creek, Lakeshore, and Salmon Creek (Figure 5).

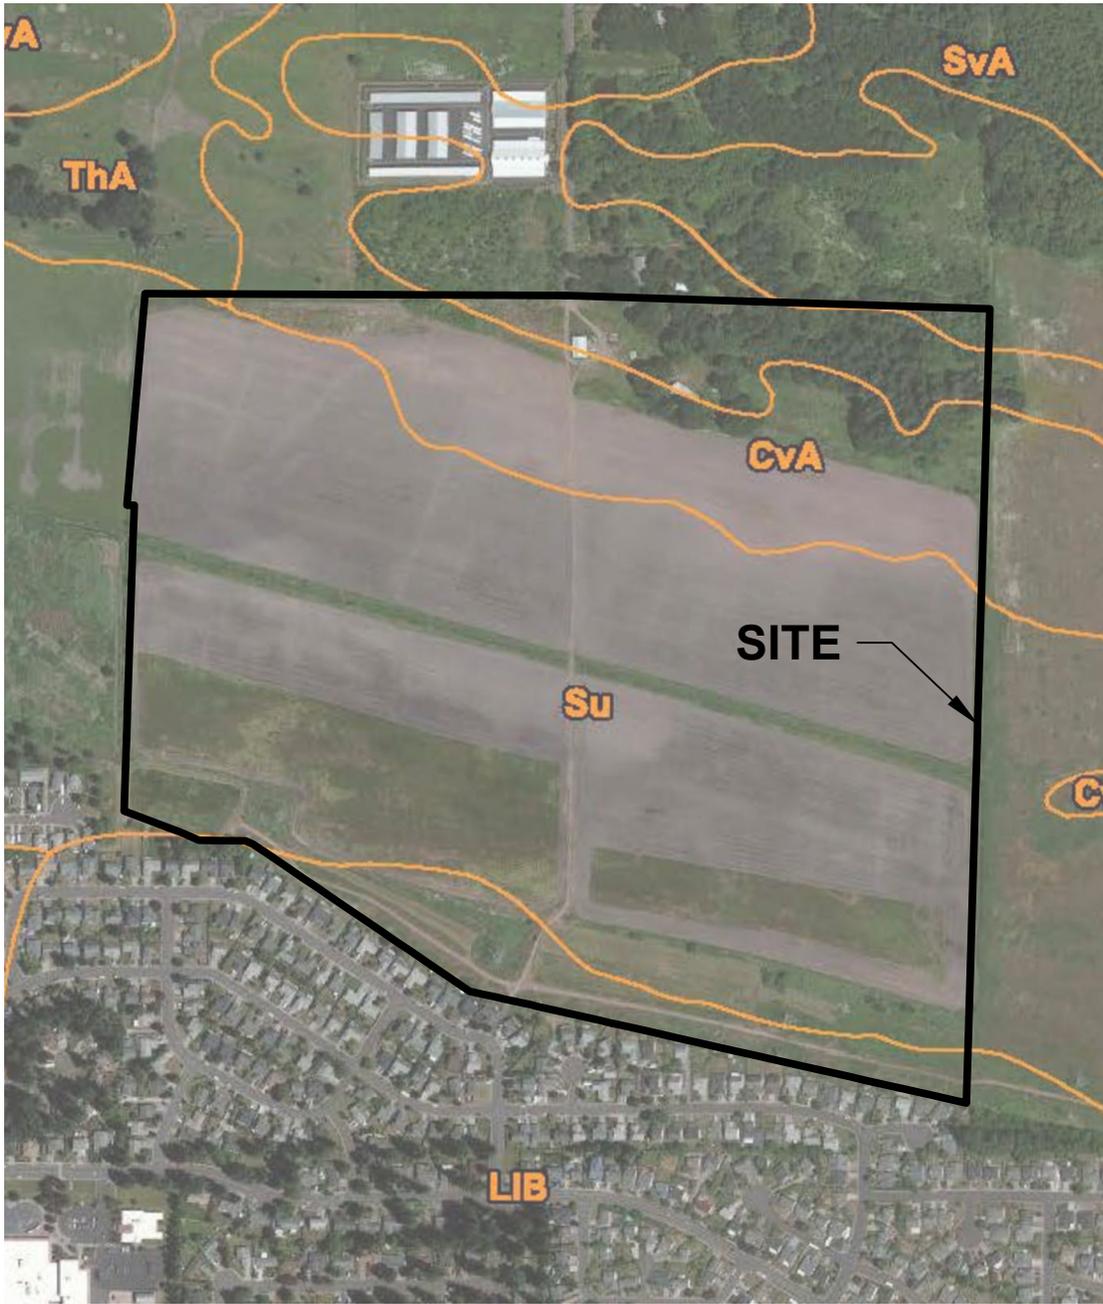
**Figure 3**  
**SOIL SURVEY MAP**  
 Terrace Wetland Mitigation Bank  
 Rotschy, Inc.  
 City of Vancouver, Clark County, Washington  
 Section 11, 12, 13, & 14, Township 2N, Range 2E, W.M.

- CvA** Cove silty clay loam, 0 to 3 percent slopes. Hydric.
- LIB** Lauren very gravelly loam, 0 to 8 percent slopes. Not hydric.
- Su** Semiahmoo muck, shallow variant. Hydric.
- SvA** Sifton gravelly loam, 0 to 3 percent slopes.

Soils mapped (NRCS 2014) within the site boundaries are Cove silty clay loam (hydric), Sifton gravelly loam, and Semiahmoo muck (hydric). The Cove and Semiahmoo are characterized as poorly drained and found in depressions or floodplains. The Sifton loams are characterized as somewhat excessively drained soils found on mostly flat, wide terraces. The developed portion of the site (northeast corner) including the stands of Oregon white oak is situated on the rapidly permeable Sifton gravelly loam. Two of the soils mapped onsite by the NRCS (Cove silty clay loam and Semiahmoo muck) are listed on the *Hydric Soils List for Washington* (NRCS 2013). These hydric soils make up the greater portion of the site and are the soils that have been historically drained for agriculture (Figure 3).

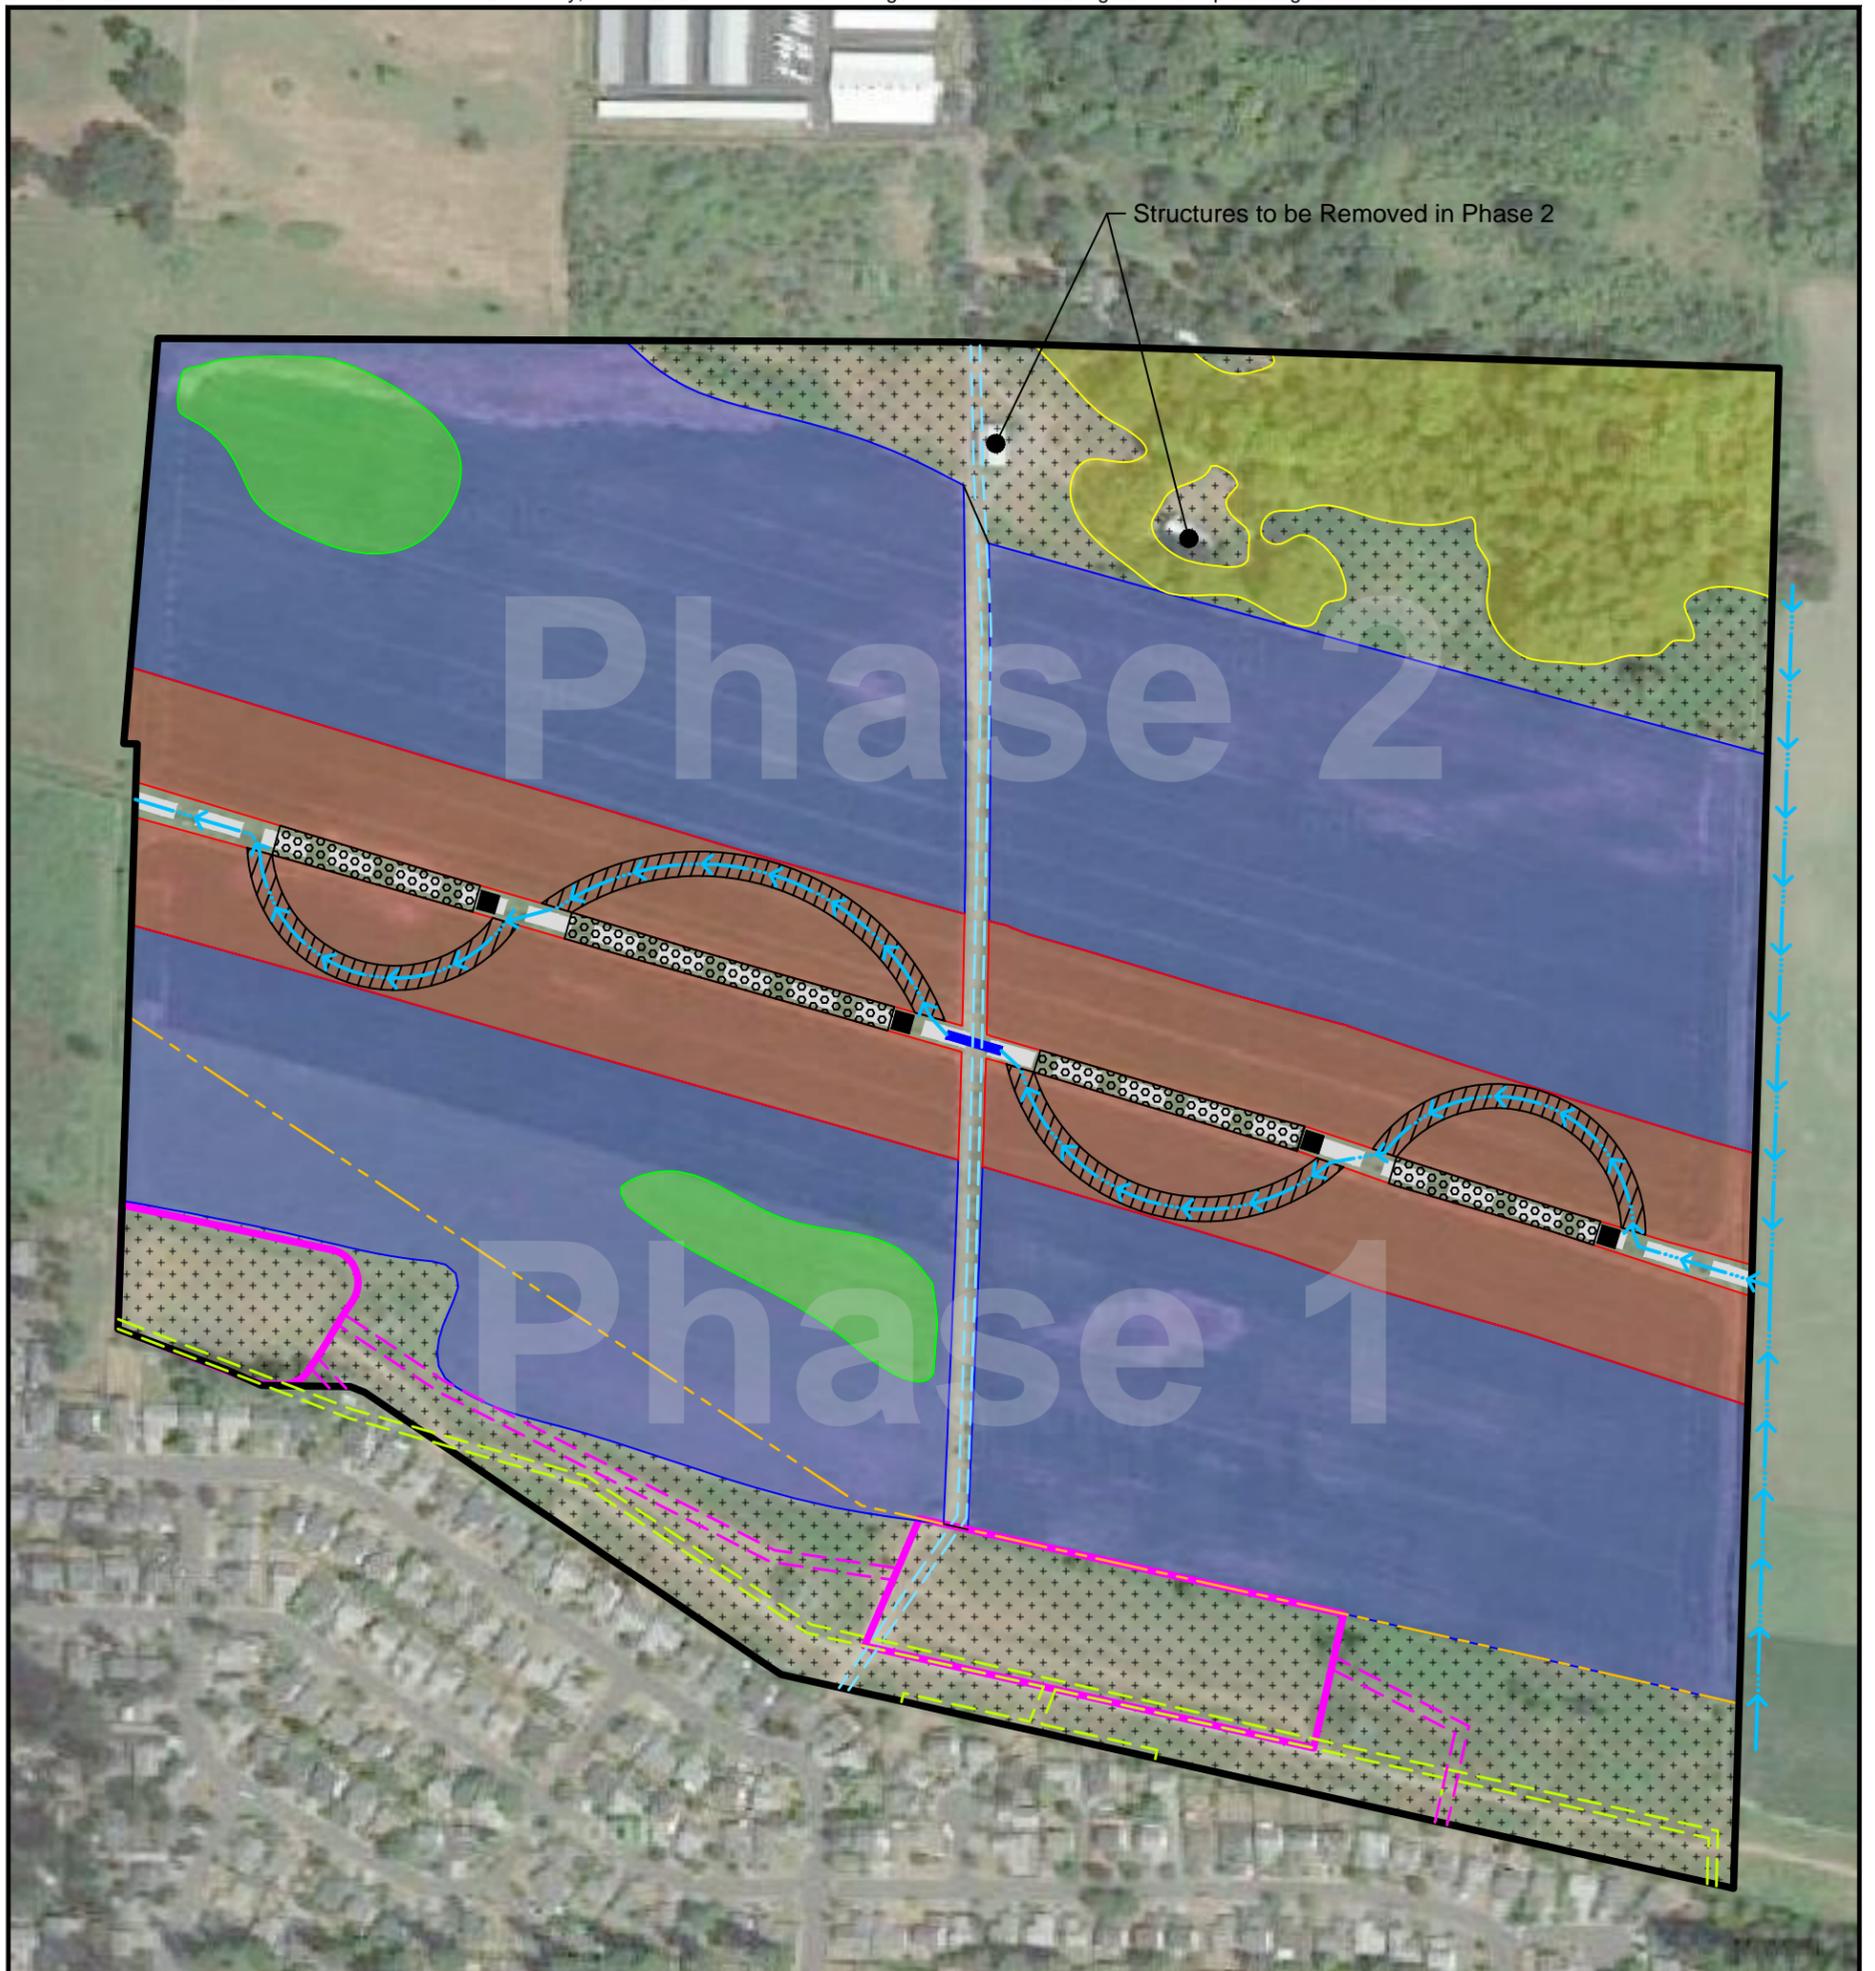
Figure 4  
**CONCEPTUAL DESIGN MAP**  
 Terrace Wetland Mitigation Bank  
 Rotschy, Inc.  
 City of Vancouver, Clark County, Washington  
 Section 11, 12, 13, & 14, Township 2N, Range 2E, W.M.

Structures to be Removed in Phase 2

Phase 2

Phase 1

The site is currently a farmed field with several existing jurisdictional wetlands (Figure 4). Roughly eight upland acres in the northeast corner of the property is developed with residential and farm buildings.

two phases, with the first phase taking place south of the stream channel (Figure 4) Specifically the Bank project will aim for:

The final project design will be developed with collaboration with the IRT after adequate analysis of the site has occurred. The initial data collected on the site, historical information on extent of wetland areas prior to conversion to agriculture in the late 1800s, restoration and re-establishment goals within the surrounding watershed, and past experience on similar projects have all contributed to a conceptual design for the Bank site (Figure 4). The key elements of the project design are:

- Re-establish approximately 88 acres of wetland in farmed and drained acreage north and south of the Burnt Bridge Creek channel by removing or blocking drainage tiles and pipes. Remove or control invasive species and plant native bog shrub and emergent species
- Rehabilitate existing wetland areas by enhancement and improving hydrology
- Increase stream channel complexity by meandering of the channelized stream, creating back channel habitat, allow the area to contain elements of both aquatic and terrestrial ecosystems which mutually influence each other, and reconnect floodplain to adjacent wetlands
- Plant riparian buffer areas with native trees and shrubs to increase shading and lower water temperatures, and provide improved habitat structure and diversity
- Preserve Oregon white oak woodlands and enhance with additional oak saplings and possible removal of competing Douglas-fir.

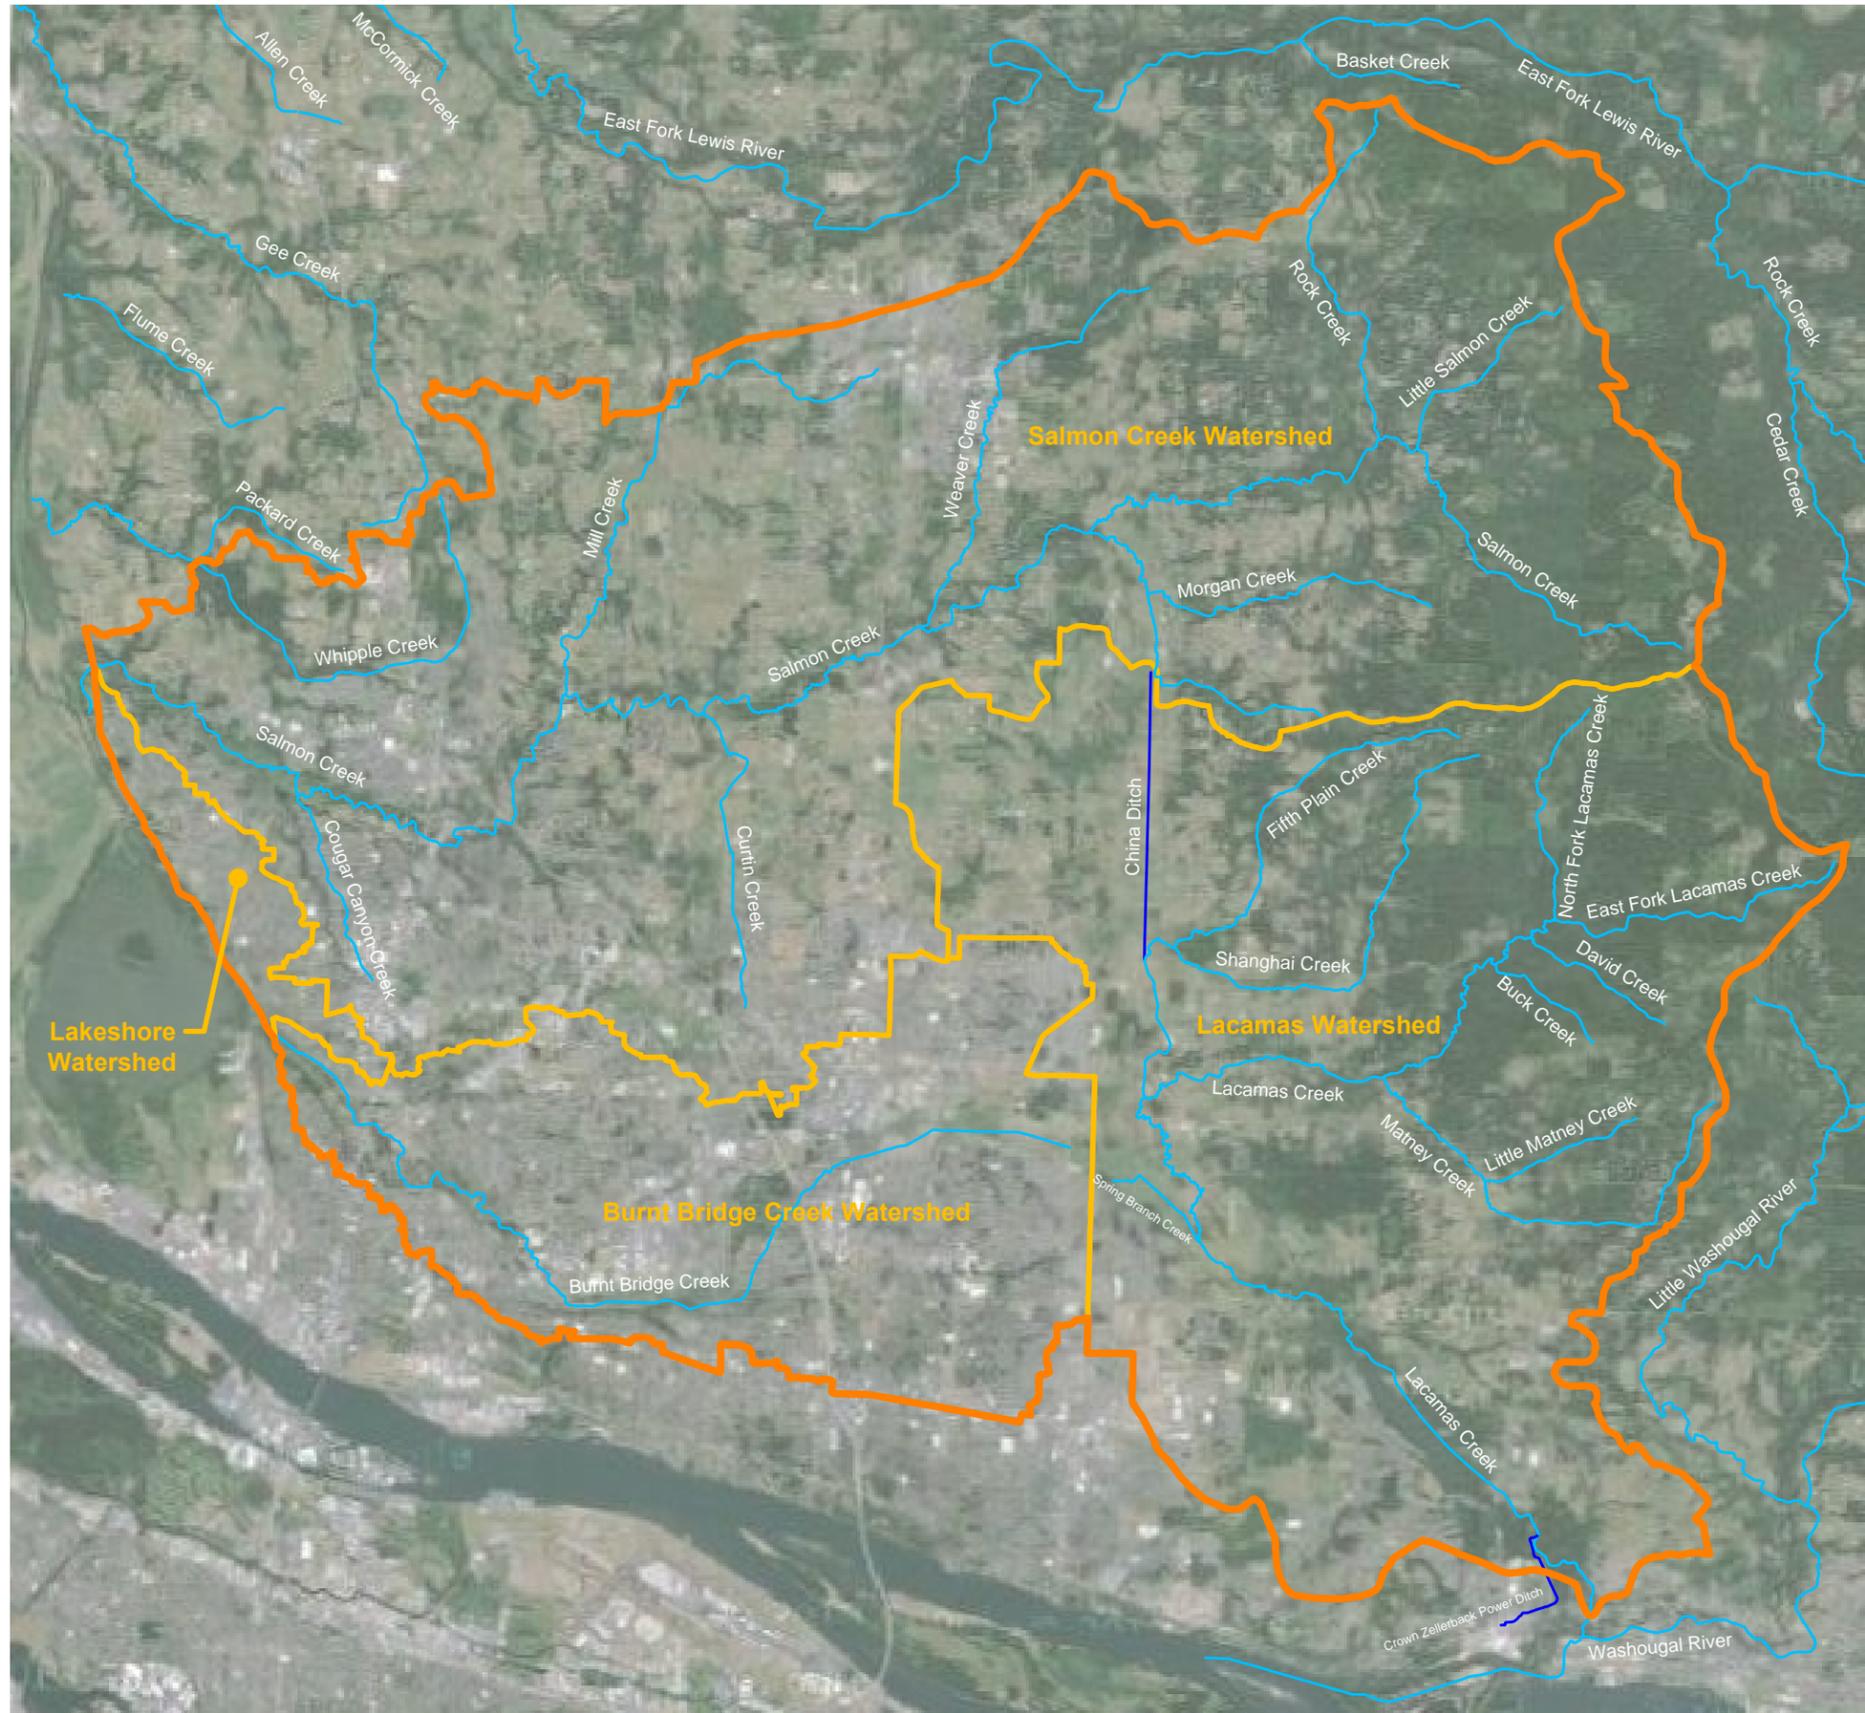
Figure 5  
 PROPOSED SERVICE AREA MAP  
 Terrace Wetland Mitigation Bank  
 Rotschy, Inc.  
 City of Vancouver, Clark County, Washington  
 Section 11, 12, 13, & 14, Township 2N, Range 2E, W.M.

**Service Area**

The Bank's Service Area extends to the limits of the Terrace hydrogeologic unit, as described in the Watershed Characterization of Clark County (Ecology 2009). This covers the majority of the Salmon Creek Water Resource Inventory Area (WRIA 28) as defined below in Table 1 and Table 2.
