State of Washington Department of Ecology
Cruise Ship Memorandum of Understanding, Cruise Operations in Washington State Inspection Report

Name and Location of Site Inspected: RHAPSODY OF THE SEAS, Royal Caribbean Cruise Line Pier 91 Seattle, Washington	Additional Participants/Inspectors: Lazaro Eleuterio, Ecology
On-Site Representative(s): <i>Name/Title/Phone/e-mail</i> Lizel De Bruin, Environmental Officer RH EnvironmentalOfficer@rccl.com James Nazar, Staff Captain	
Responsible Official(s): <i>Name/Title/Address/Phone/e-mail</i> Rich Pruitt, Director Environmental Programs Royal Caribbean International 1080 Caribbean Way, Miami, FL 33132 Office: 305-982-2179; Cell: 305-495-2845; RPruitt@rccl.com	Other Facility Data: Notification made to Rich Pruitt on August 4, 2014

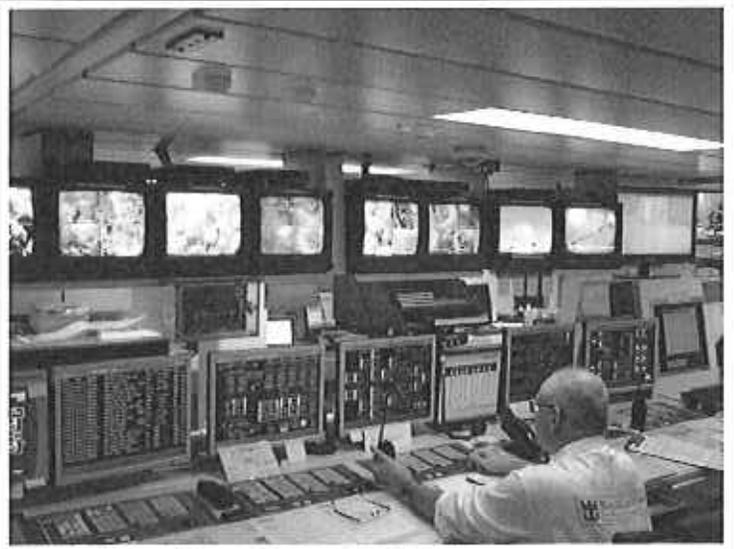
PHOTO #:02 DATE: AUGUST 8, 2014
TAKEN BY: LAZARO ELEUTERIO FILE No.: P7090124
DESCRIPTION: ENGINE CONTROL ROOM WITH PORT KEY BOX

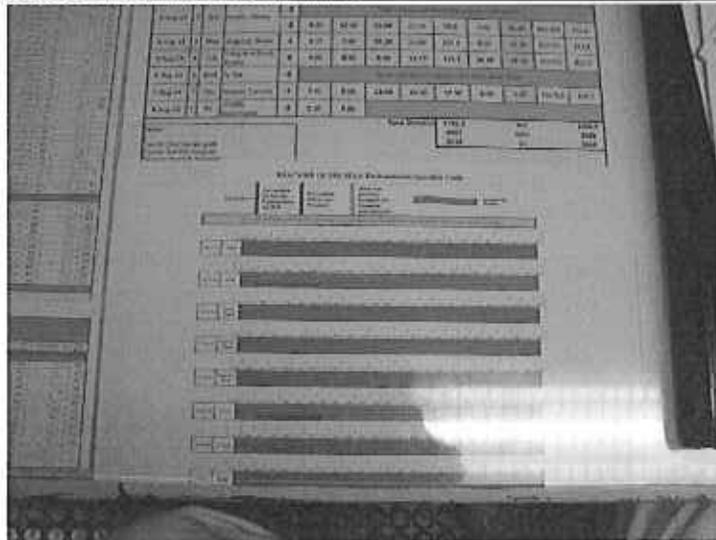
PHOTO #:03 DATE: AUGUST 8, 2014
TAKEN BY: LAZARO ELEUTERIO FILE No.: P7090126
DESCRIPTION: DISCHARGE PLAN (ECR)

All discharges occur outside of 13 nautical miles (they add a one mile buffer beyond their normal policy). A pre-season plan (photo #03) is put into place and if a discharge is to occur, staff on the Bridge communicate with the ECR staff to verify that they are in an area where discharges are allowed. Both electronic and paper charts are used for navigation. Discharge locations are recorded in the ECR and electronically (photo #02). The discharge ports have padlocks on them and the keys are kept in the control room under the Watchkeeper's eye, a spare with the Chief Engineer. The ports are also tagged when in restricted areas. For black water and gray water, the latitude and longitude coordinates are recorded in the *Sewage and Graywater Discharge Record Book*. The date, time and location of both the start and the stop of the discharges are recorded, along with port location, effluent type, and volumes. The vessel has about 80 hours of holding capacity for black and gray water. All wastewater discharge records that were reviewed appeared to be in compliance with the MOU and did not occur in MOU waters, Washington State waters or the Olympic Coast National Marine Sanctuary (OCNMS) (MOU related waters).

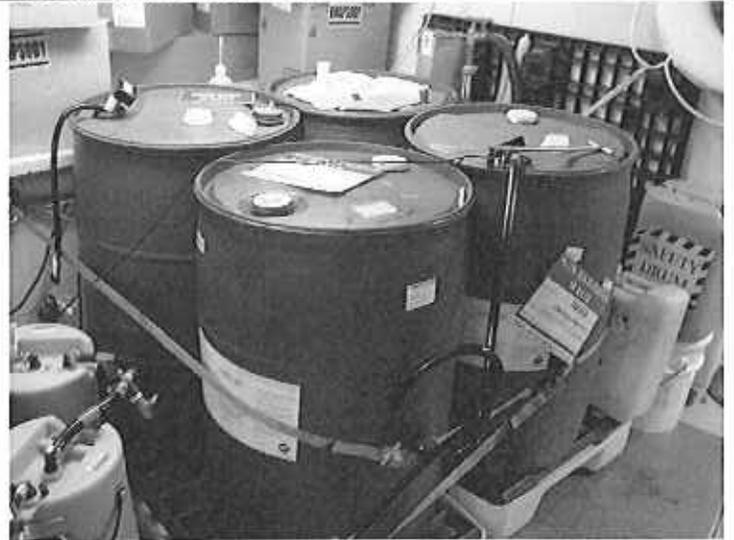
PHOTO #:04 AUGUST 8, 2014
TAKEN BY: LAZARO ELEUTERIO FILE No.: P7090129
DESCRIPTION: PHOTO WASTE CHEMICALS IN PHOTO LAB

X-rays are done digitally and therefore do not have a waste product. Photo waste goes through a silver recovery system, and is treated to less than 6 ppm and is then drummed (photo #04) and offloaded. Fluorescent bulbs go to a bulb crusher with a mercury vapor removal system. The filters are offloaded as hazardous waste and bulbs are offloaded. Hazardous waste materials include items such as used cartridges and filters, paints, thinners, chemicals, some batteries, sludge oil, aerosols (punctured), incinerator ash, pyrotechnics, photo waste and sharps. Hazardous waste is offloaded in Victoria. Hazardous waste logs were reviewed and appear to be consistent with MOU requirements.

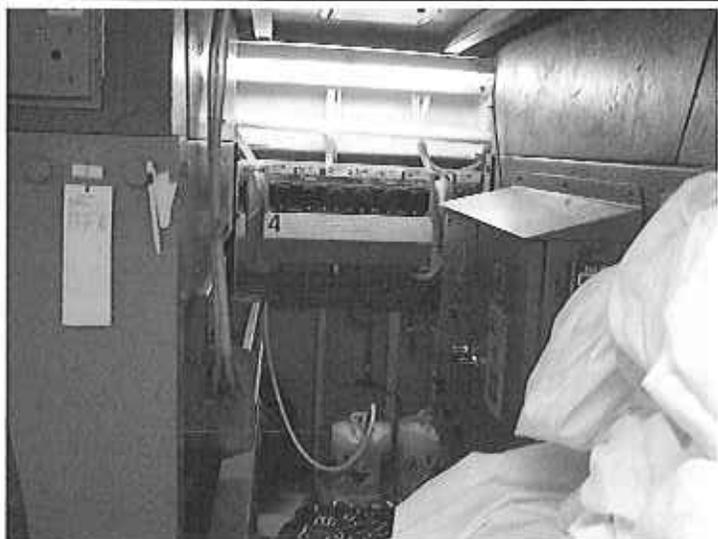
PHOTO #:05 DATE: AUGUST 8, 2014
TAKEN BY: LAZARO ELEUTERIO FILE No.: P7090131
DESCRIPTION: LAUNDRY CLEANING DETERGENTS

Laundry water is sent to the graywater tanks. Laundry uses Ecolab phosphate free, non-toxic cleaning products (photo #05). Any illness contaminated laundry is separated and sent to a dedicated washing machine. Dry cleaning uses a hydrocarbon system (Exxon Mobil, non PERC) (photo #06). The liquid residual goes to the oily water separator system and the dry materials are drummed and offloaded about twice per year.

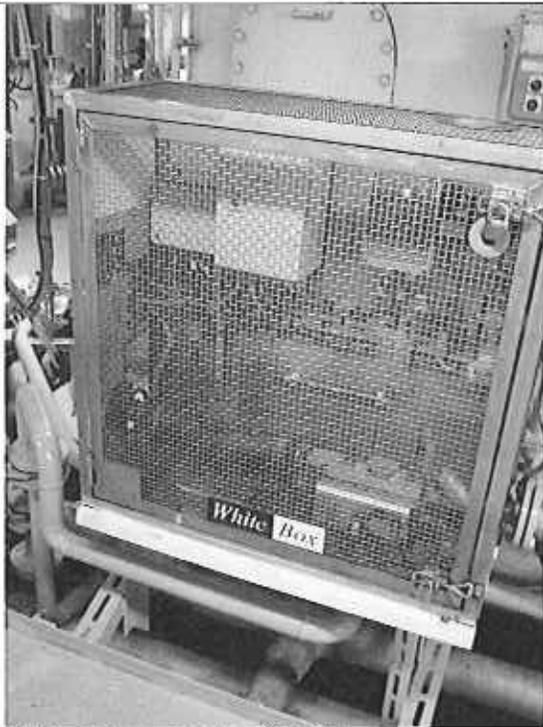
PHOTO #:09 DATE: AUGUST 8, 2014
TAKEN BY: LAZARO ELEUTERIO FILE No.: P7090140
DESCRIPTION: BILGE OILY WATER SEPARATOR (OWS) WHITE BOX

Oily bilge water is treated with a Marin Flocculant oily water separator (photo #10) with a company standard of less than 5 ppm oil content. The white box (photo #09) is used to only allow discharges at less than 5 ppm maximum. The White Box is calibrated once per year. The Chief Engineer is the only one with the keys to the white box. Discharges (photo #11) of treated oily bilge take place outside of MOU related waters.

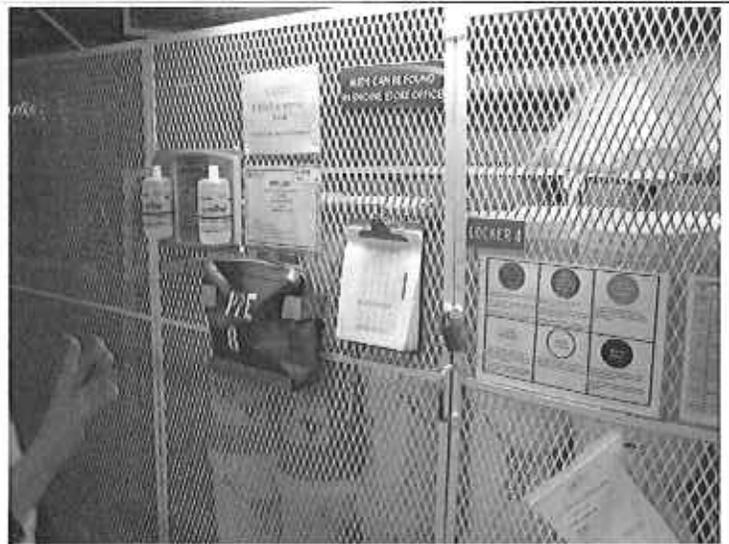
PHOTO #:12 AUGUST 8, 2014
TAKEN BY: LAZARO ELEUTERIO FILE No.: P7090143
DESCRIPTION: CHEMICAL STORAGE LOCKER

Chemicals are stored (photo #12) in various locations and separated by types to prevent reactions.

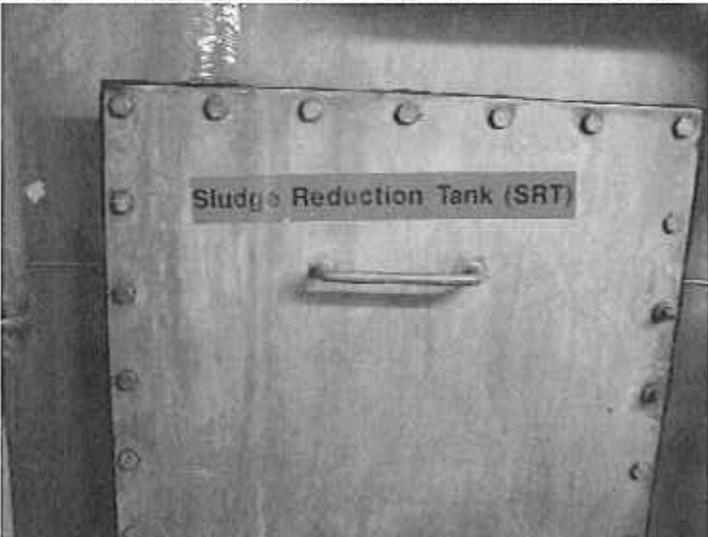
PHOTO #:15 DATE: AUGUST 8, 2014
TAKEN BY: LAZARO ELEUTERIO FILE No.: P7090149
DESCRIPTION: SLUDGE REDUCTION TANK (SRT)

Solids from the SRT are sent through the Hamaan unit which consists of aeration, baffles, and chlorination. Solids are then discharged outside of MOU related waters.

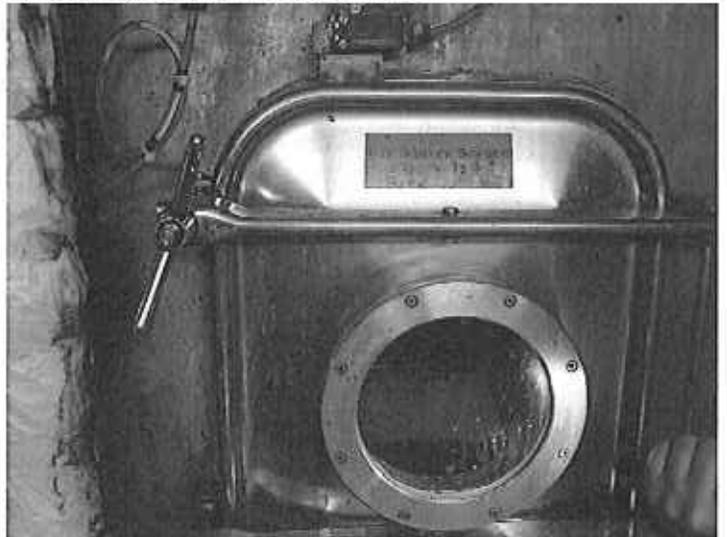
PHOTO #:16 AUGUST 8, 2014
TAKEN BY: LAZARO ELEUTERIO FILE No.: P7090150
DESCRIPTION: SHAKER SCREEN PLASTICS TANK

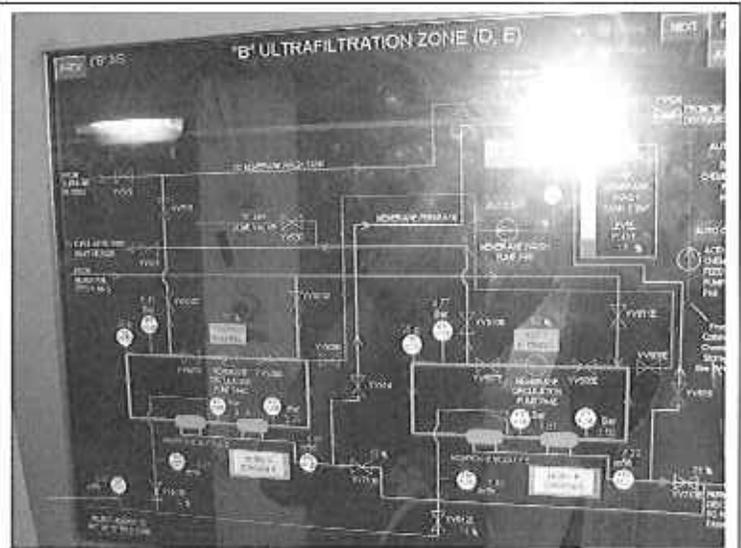
PHOTO #:18 DATE: AUGUST 8, 2014
TAKEN BY: LAZARO ELEUTERIO FILE No.: P7090153
DESCRIPTION: CONTROL SCREEN NEAR ADVANCED WASTE
WATER TREATMENT SYSTEM (AWTS)

Effluent is continuously monitored for turbidity and pH. An electronic system, AMOS, is used to plan and track maintenance for the system. During the inspection, the turbidity was 8 NTU at the effluent prior to going to the holding tank. There is also a dissolved oxygen sample point at the AET (photo #25). Sampling is done on the vessel for process control with an on-board sampling laboratory which analyzes TSS, COD, BOD, pH, total chlorine, and total coliform. The AWTS can be monitored (photo #18) from the ECR or from various parts of the system.

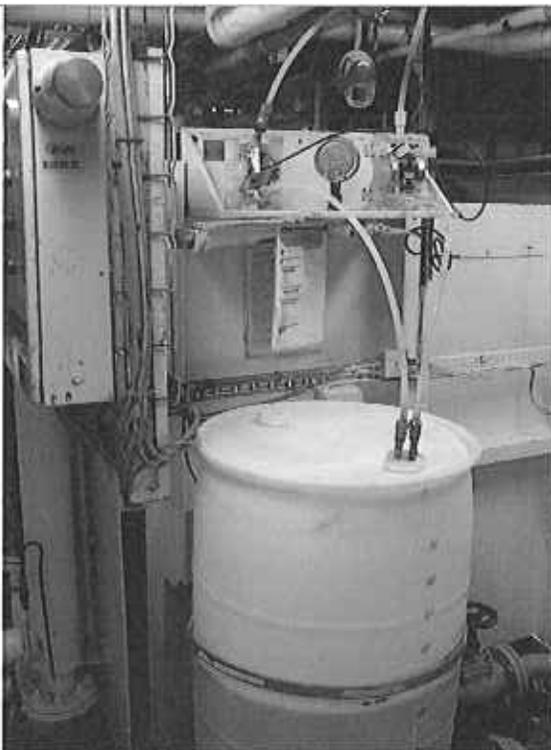
PHOTO #:19 DATE: AUGUST 8, 2014
TAKEN BY: LAZARO ELEUTERIO FILE No.: P7090154
DESCRIPTION: FLOC FEEDING SYSTEM (MC130) FOR AWTS

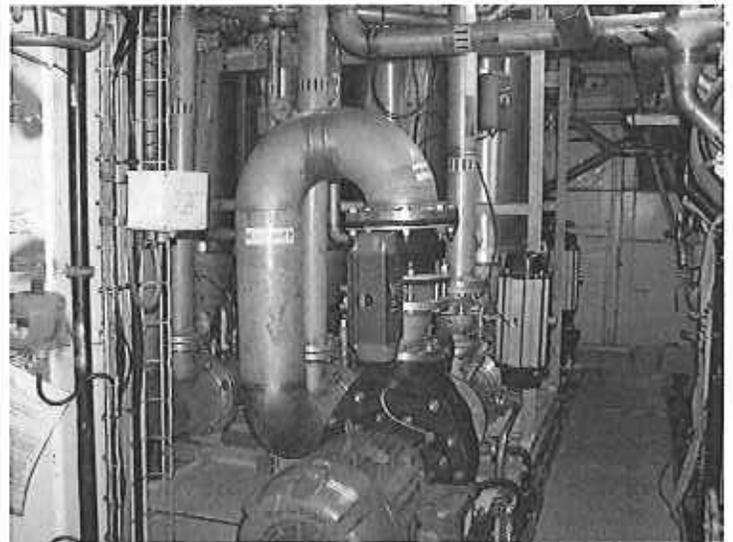
PHOTO #:20 AUGUST 8, 2014
TAKEN BY: LAZARO ELEUTERIO FILE No.: P7090156
DESCRIPTION: AWTS MEMBRANES

The system is challenging to operate, however produces great effluent. The staff have to monitor and assure that chemicals or grease does not interfere with the system, and may have to re-direct the flows to the old Hamaan unit if the influent might harm the AWTS. The membranes get clogged easily and may need replacement soon.

It is recommended that staff continue to work towards high functioning wastewater treatment systems. The staff on board the vessel were very knowledgeable of the systems and protocols.

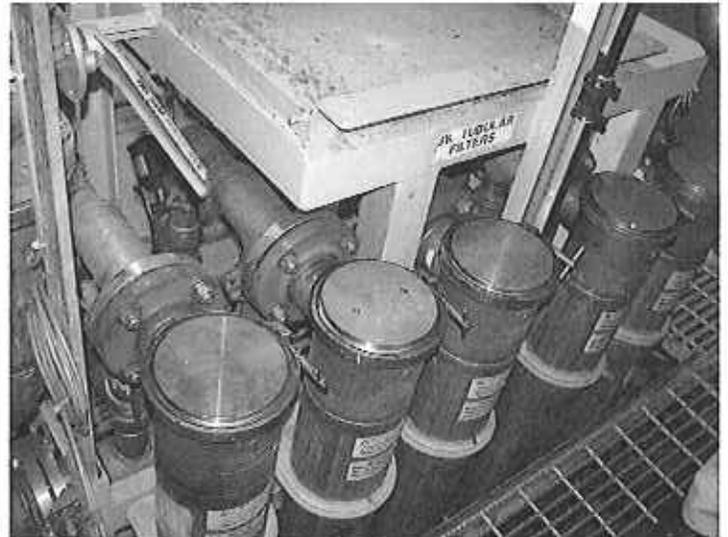
PHOTO #:22 DATE: AUGUST 8, 2014
TAKEN BY: LAZARO ELEUTERIO FILE No.: P7090161
DESCRIPTION: TUBULAR FILTERS FOR AWTS

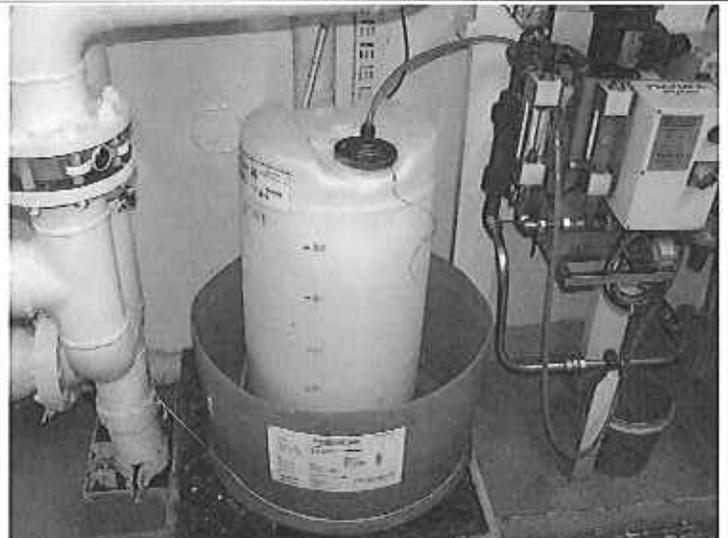
PHOTO #:24 AUGUST 8, 2014
TAKEN BY: LAZARO ELEUTERIO FILE No.: P7090165
DESCRIPTION: 2ND FLOC METERING SYSTEM (DREWFLOC 2468)

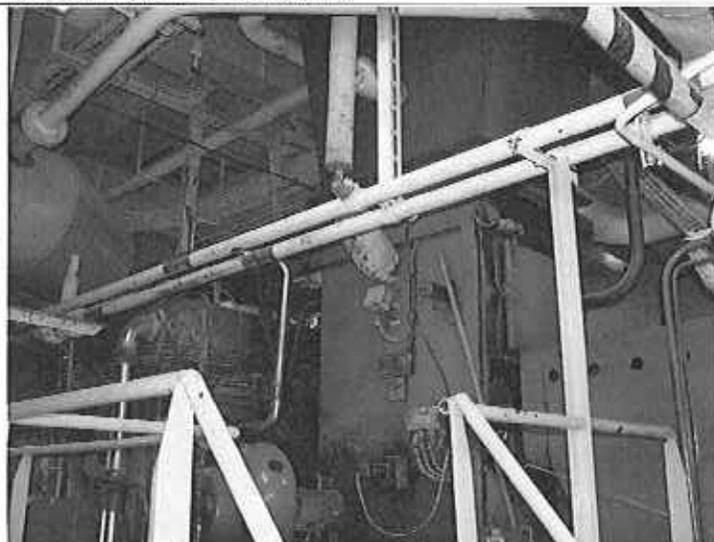
PHOTO #:28 AUGUST 8, 2014
TAKEN BY: LAZARO ELEUTERIO FILE No.: P7090170
DESCRIPTION: INCINERATOR (LOWEST LEVEL) - BURNER

Oily rags, some food contaminated materials, medical waste is incinerated outside of 13 miles. The incinerated materials are loaded at the top level in the garbage/recycling area (photo #30) and moves to the bottom level where burning occurs and the ash is collected (photo #28). Incinerator ash is offloaded to Burlington Environmental and tested every six months to ensure non-metals status. Recent results have passed for non-metals.

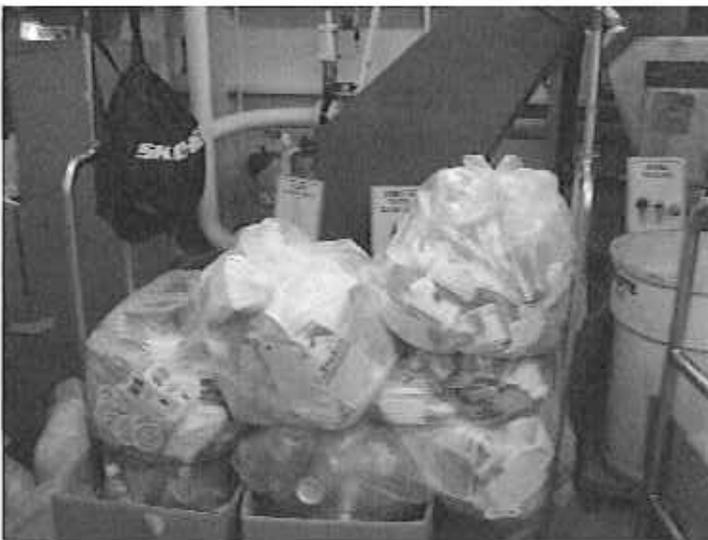
PHOTO #:29 DATE: AUGUST 8, 2014
TAKEN BY: LAZARO ELEUTERIO FILE No.: P7090176
DESCRIPTION: GARBAGE/RECYCLING AREA SORTING

Solid waste (garbage, recyclables, etc) is collected and sorted (photo #29) and either reused, recycled, incinerated or offloaded to shore as appropriate. Some dry waste is offloaded in Seattle along with the used cooking oil. The garbage record book was reviewed and showed consistency with requirements. Glass (separated by color) (photo #31), compacted aluminum (photos #34 and #35), tin, scrap metal, china/ceramics, wood pallets, some plastics, some paper and cardboard (photo #33), some electronics, batteries (photo #32) and used cooking oil, cork and other items are recycled in Victoria. Reduction, reuse and recycling progress is tracked and minimization improvements are constant.

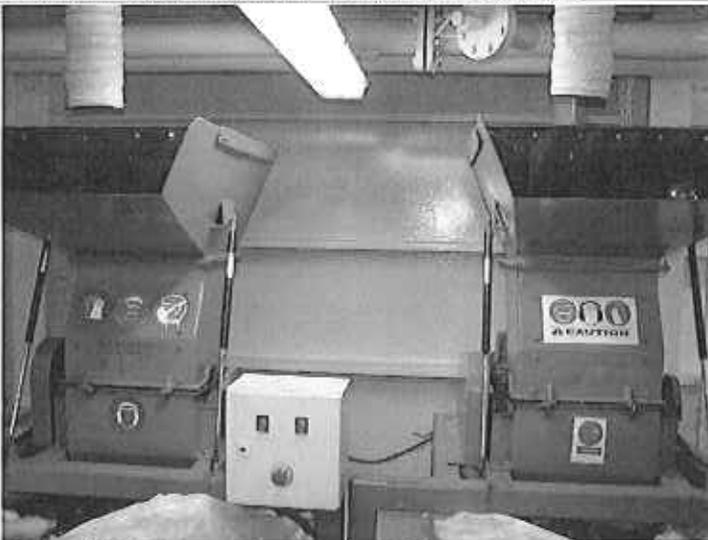
PHOTO #:31 DATE: AUGUST 8, 2014
TAKEN BY: LAZARO ELEUTERIO FILE No.: P7090179
DESCRIPTION: GARBAGE/RECYCLING AREA CRUSHERS

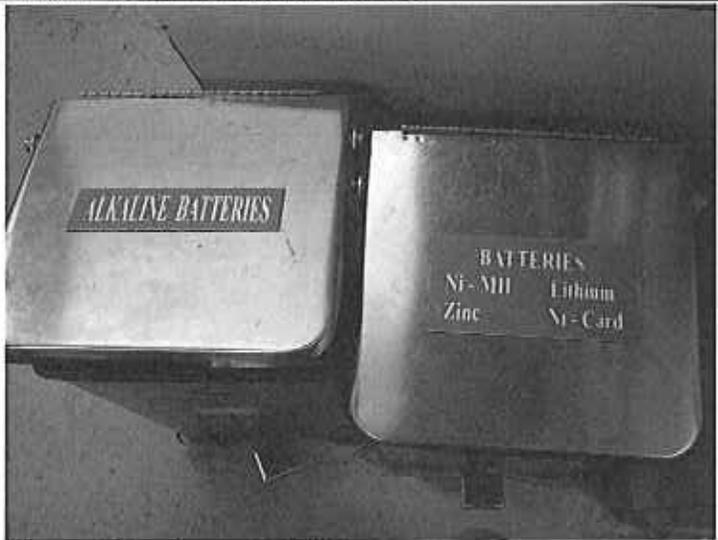
PHOTO #:32 AUGUST 8, 2014
TAKEN BY: LAZARO ELEUTERIO FILE No.: P7090182
DESCRIPTION: USED BATTERY SORTING

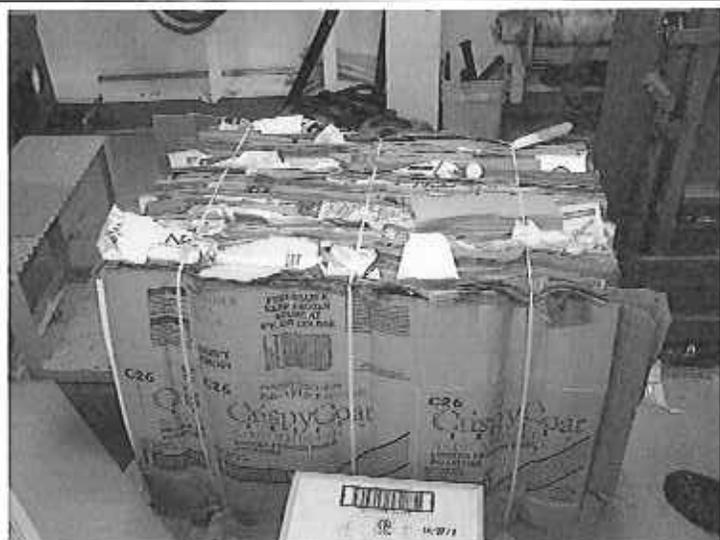
PHOTO #33 DATE: AUGUST 8, 2014
TAKEN BY: LAZARO ELEUTERIO FILE No.: P7090183
DESCRIPTION: CARDBOARD COMPACTED FOR RECYCLING

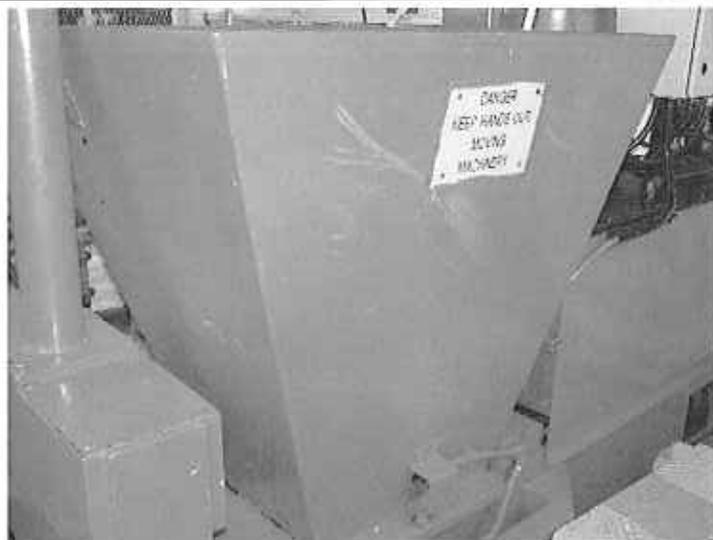
PHOTO #34 DATE: AUGUST 8, 2014
TAKEN BY: LAZARO ELEUTERIO FILE No.: P7090184
DESCRIPTION: ALUMINUM COMPACTOR

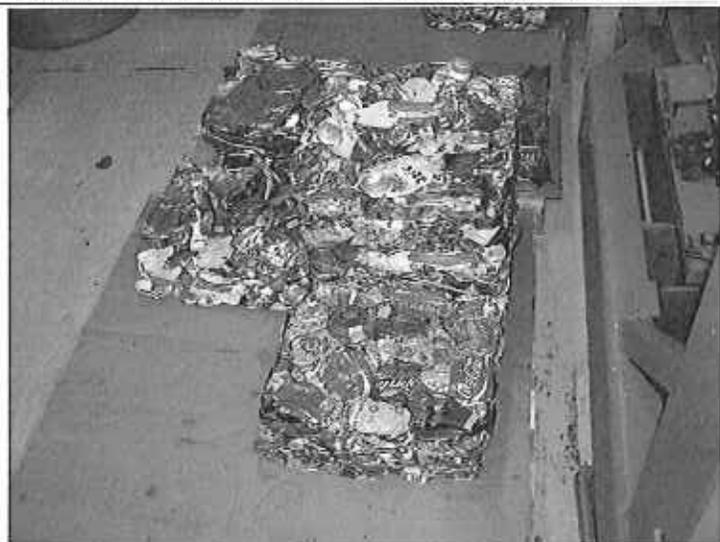
PHOTO #35 DATE: AUGUST 8, 2014
TAKEN BY: LAZARO ELEUTERIO FILE No.: P7090185
DESCRIPTION: COMPACTED ALUMINUM

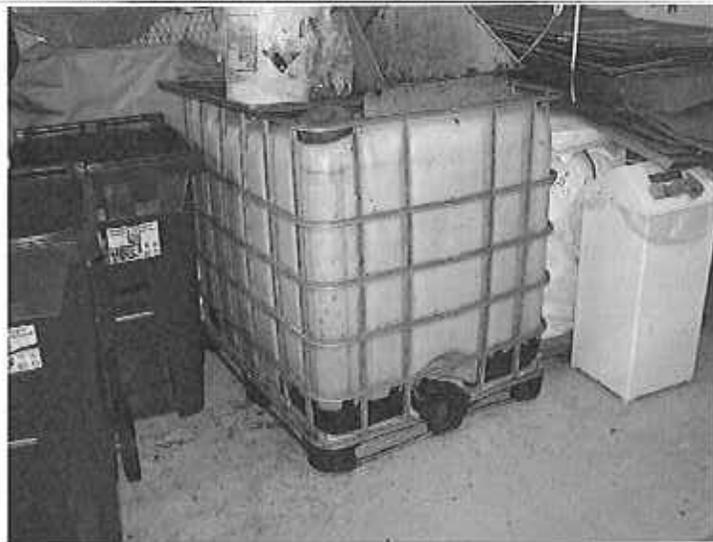
PHOTO #36 AUGUST 8, 2014
TAKEN BY: LAZARO ELEUTERIO FILE No.: P7090186
DESCRIPTION: USED COOKING OIL AND GREASE

Food waste is collected in various locations, is sorted and then sent through a pulper and then to a tank for further dewatering. Pulped food waste and galley water is discharged outside of MOU related waters. Food waste such as pineapple heads, banana, orange and cantaloupe peels, pulper residue and butcher and fish waste are composted (photos #37 and #38) and sent ashore in Victoria. Records reviewed were consistent with food waste discharge protocol. Galleys use Ecolab phosphate free and non-toxic detergents and degreasers. Used cooking oil (photo #36) is recycled in Seattle. Grease is collected in a grease trap (photo #42) and combined with the used cooking oil for recycling.

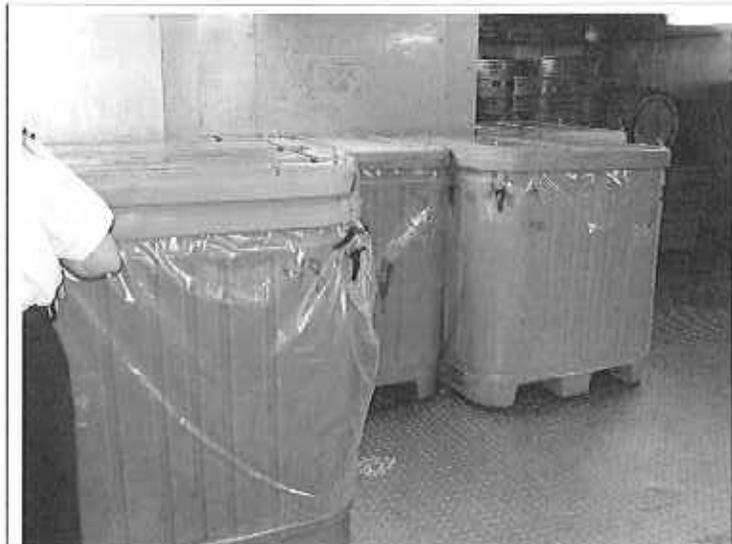
PHOTO #:37 DATE: AUGUST 8, 2014
TAKEN BY: LAZARO ELEUTERIO FILE No.: P7090187
DESCRIPTION: COMPOST BINS

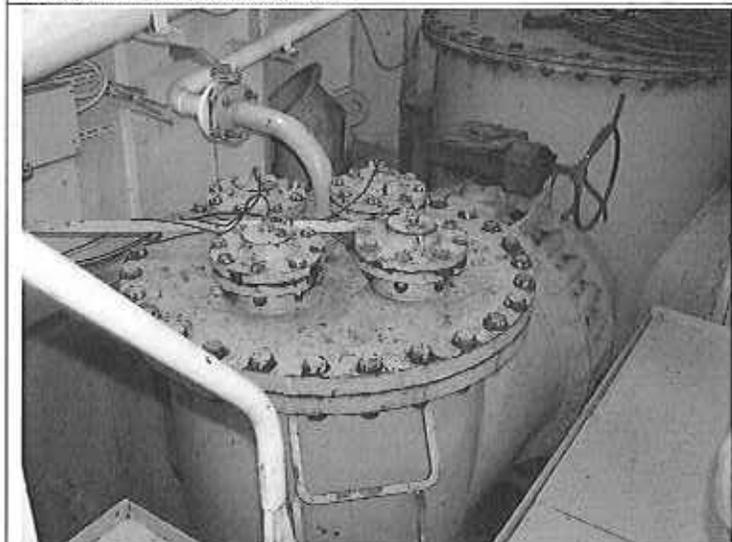
PHOTO #:39 DATE: AUGUST 8, 2014
TAKEN BY: LAZARO ELEUTERIO FILE No.: P7090189
DESCRIPTION: ANTIFOULING SEACHEST

Air conditioning condensate is re-used as technical water. The last ballast water exchange occurred prior to the Seattle/Alaska season deep off the coast. Antifouling is done via a Cathelco biofouling system for the Sea-chest (photos #39 and #41).

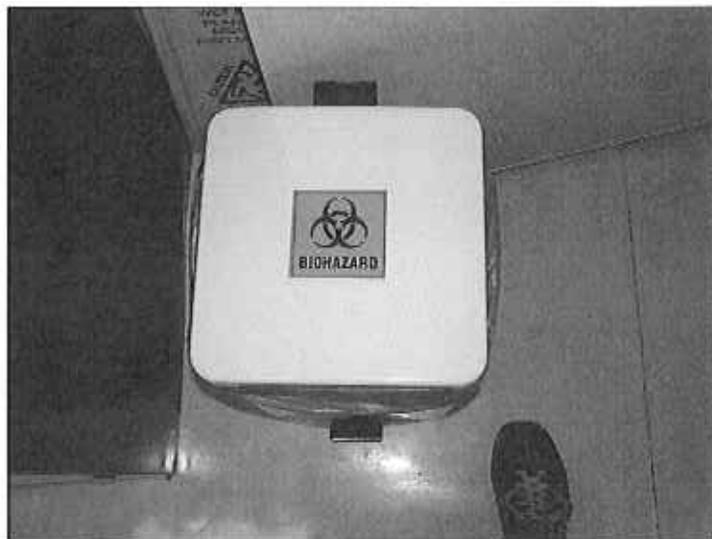
PHOTO #:42 DATE: AUGUST 8, 2014
TAKEN BY: LAZARO ELEUTERIO FILE No.: P7090196
DESCRIPTION: MEDICAL CENTER BIOHAZARD STORAGE

Unused or outdated pharmaceuticals are either incinerated or off-loaded back to the vendor when feasible. Narcotics are sent to the blackwater/AWTS due to a DEA agreement with RCCL and a medical license. Drains in the medical facility go to the blackwater tanks. Biohazardous waste is collected (photo #43) in the medical center and is incinerated or offloaded as required. Gas cylinders are stored in a secure locker and levels/leaks monitored in the ECR (photo #44).
