6.6.4 Reach Analysis

This section includes reach summaries (as reach information sheets) for Camano Island's Saratoga Passage marine shorelines, as depicted in Figure 6-6.

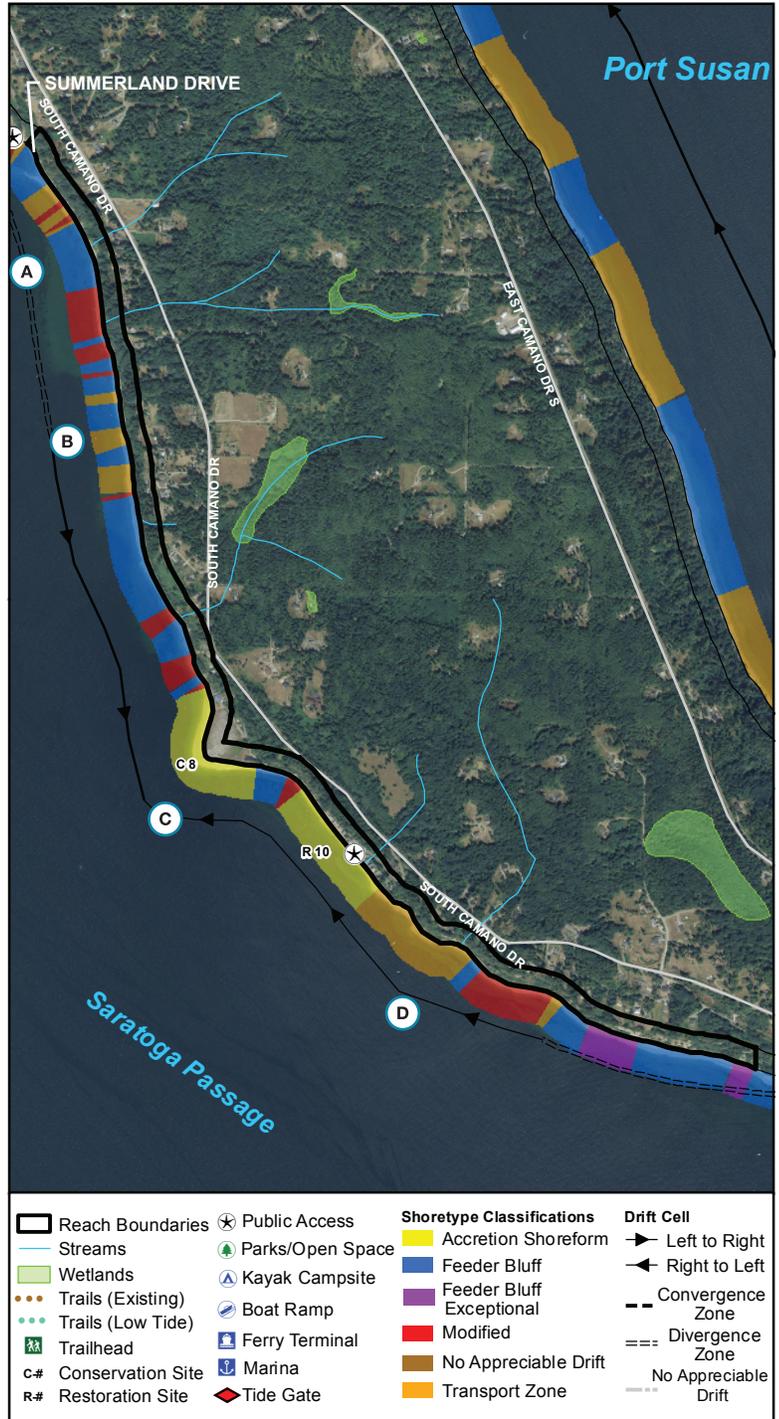
GEOMORPHIC KEY INFORMATION

Geomorphic Shoretype (Map 9)

Feeder Bluff (46%), Modified shoreline (18%), and Transport Zone (17%) focused to one longer stretch of Accretion Shoreform (19%) at drift convergence

Net Shore Drift (Map 8)

Two drift cells converge at a barrier beach; one originates at Camano Head with northward drift and one originates approximately 1 mile north of Pebble Beach with southward drift.

Shoreform Current (Map 10)

Primarily Bluff-backed Beach (90%), Barrier Beach (10%) at drift convergence

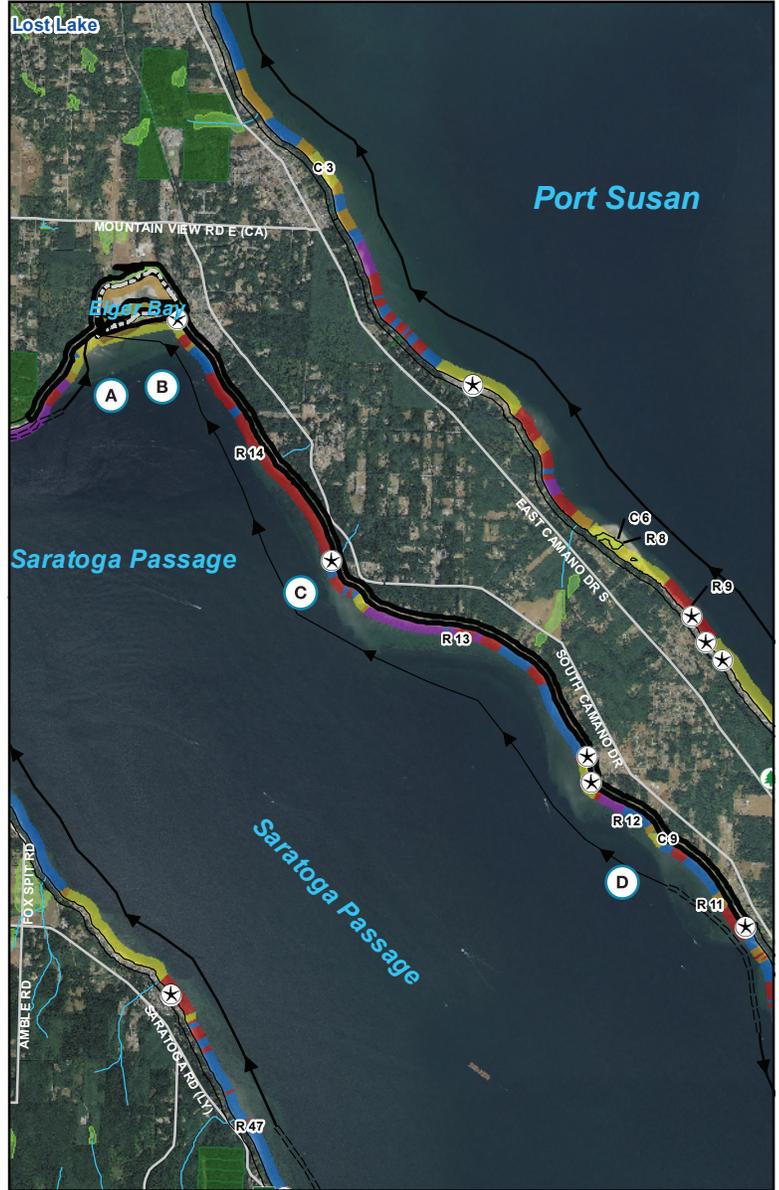
Shoreform Current (Map 10)

Primarily Bluff-backed Beach (73%), with Barrier Lagoon (18%), Barrier Beach (7%), and Artificial (2%) shoreforms focused around Elger Bay

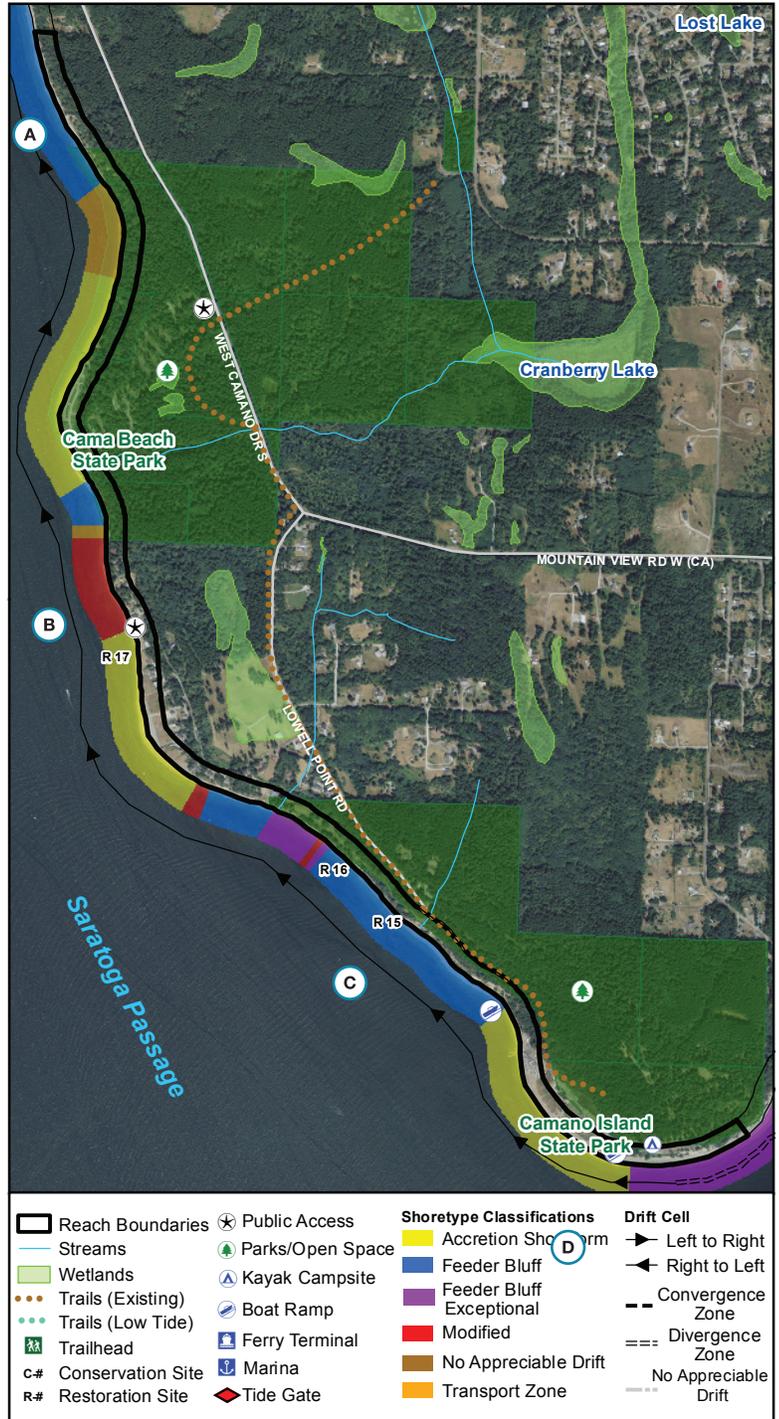
Shoreform Current (Map 10)

Primarily Bluff-backed Beach (87%); Barrier Beach (13%) at southern end of reach

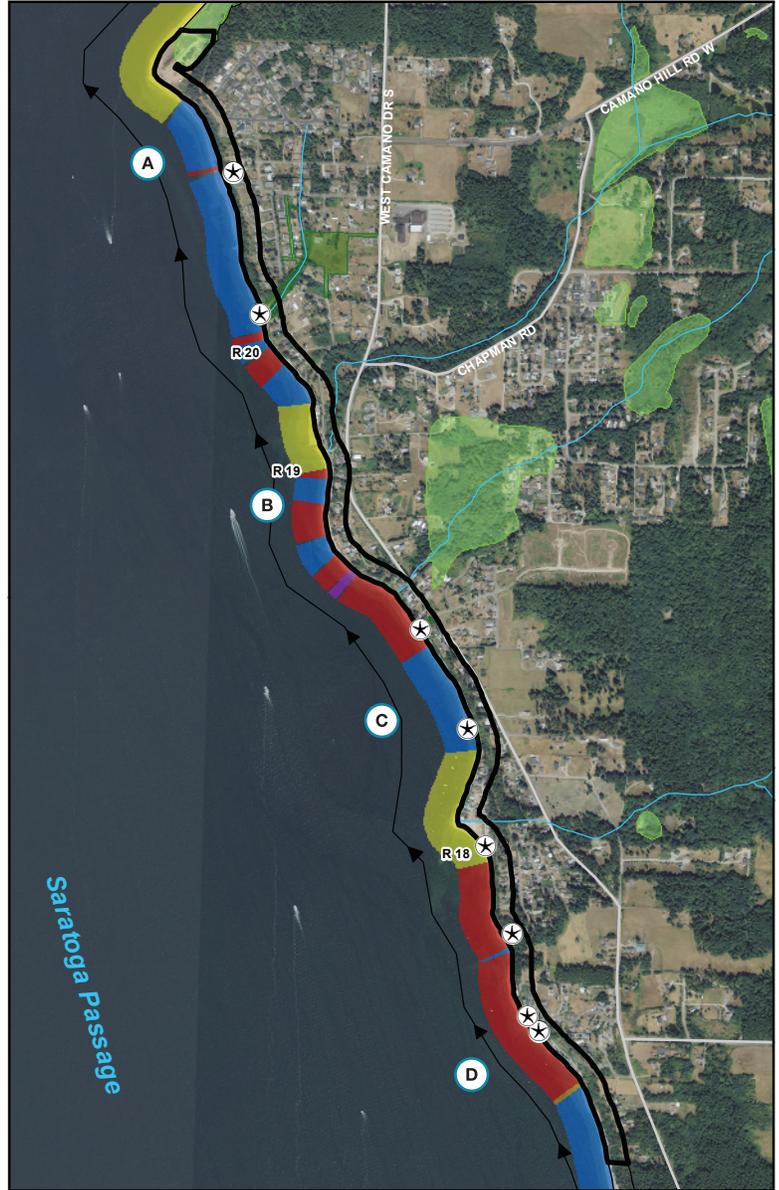
Shoreform Current (Map 10)

Primarily Bluff-backed Beach (94%); Barrier Beach (6%) at northern end of reach

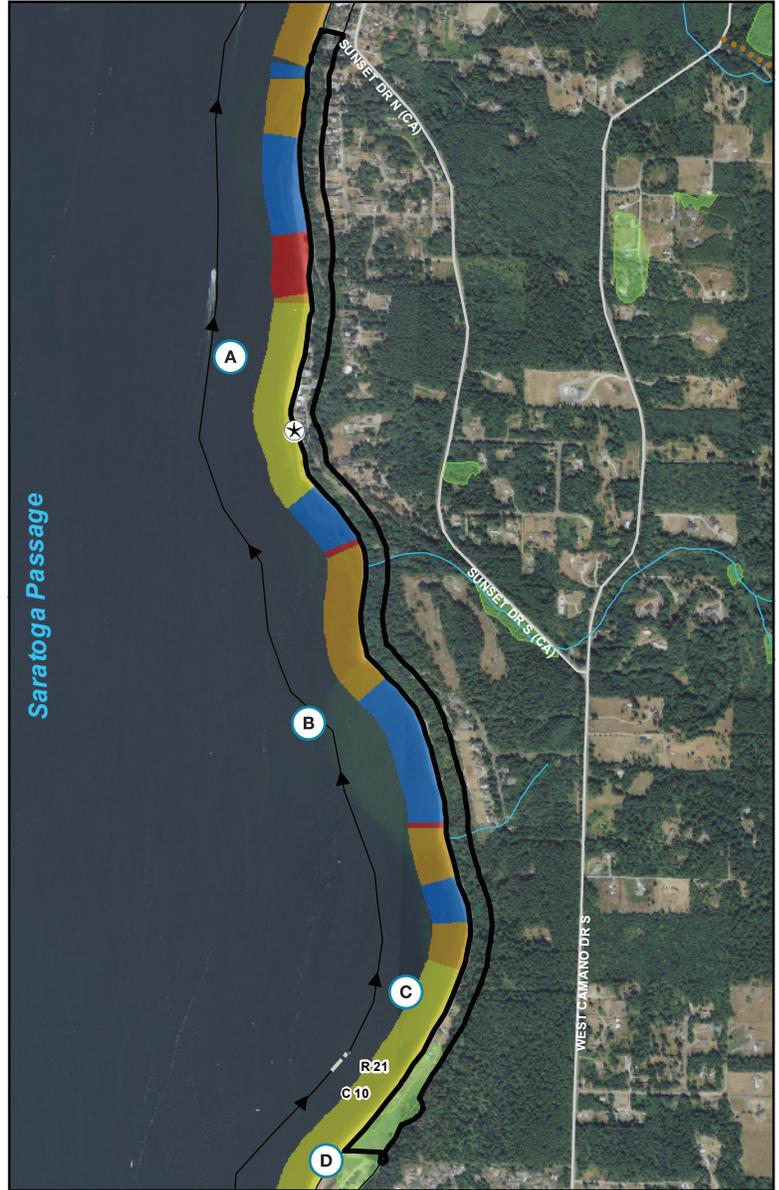
Shoreform Current (Map 10)

Primarily Bluff-backed Beach (70%); two areas of Barrier Beach (30%) in areas of accretion

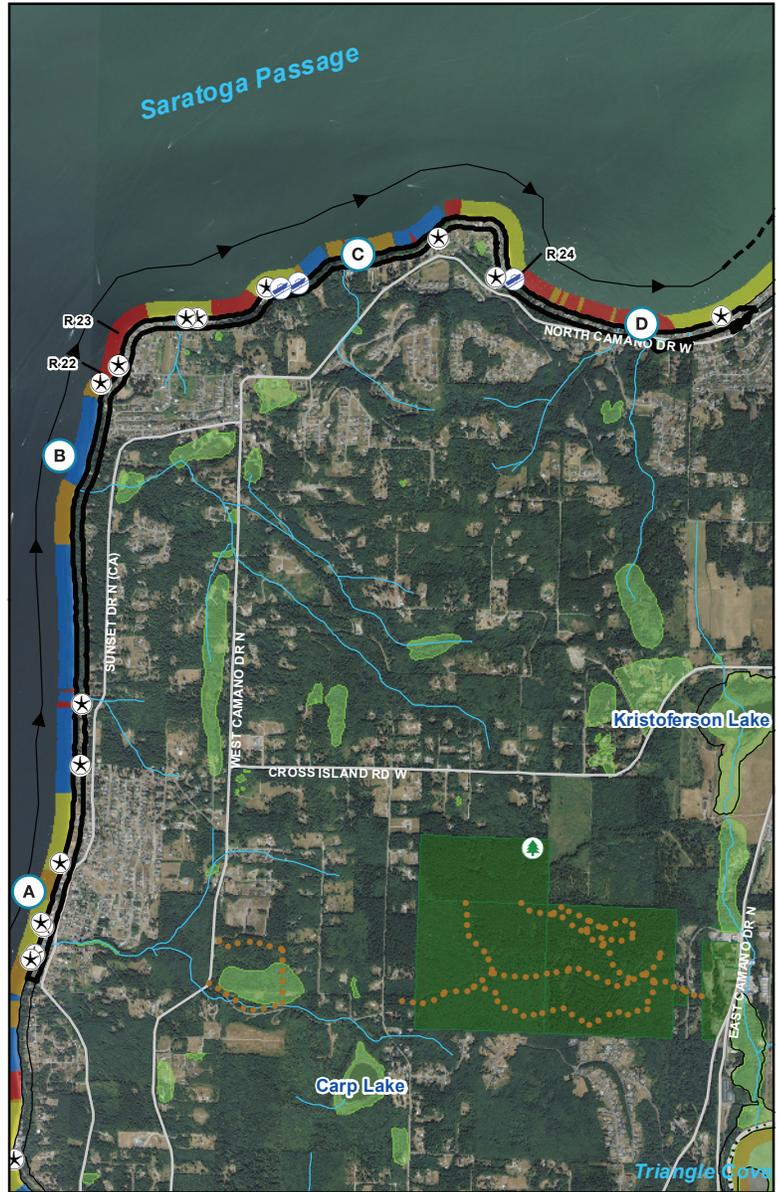
Shoreform Current (Map 10)

Primarily Bluff-backed Beach (77%); three areas of Barrier Beach (23%) in areas of accretion

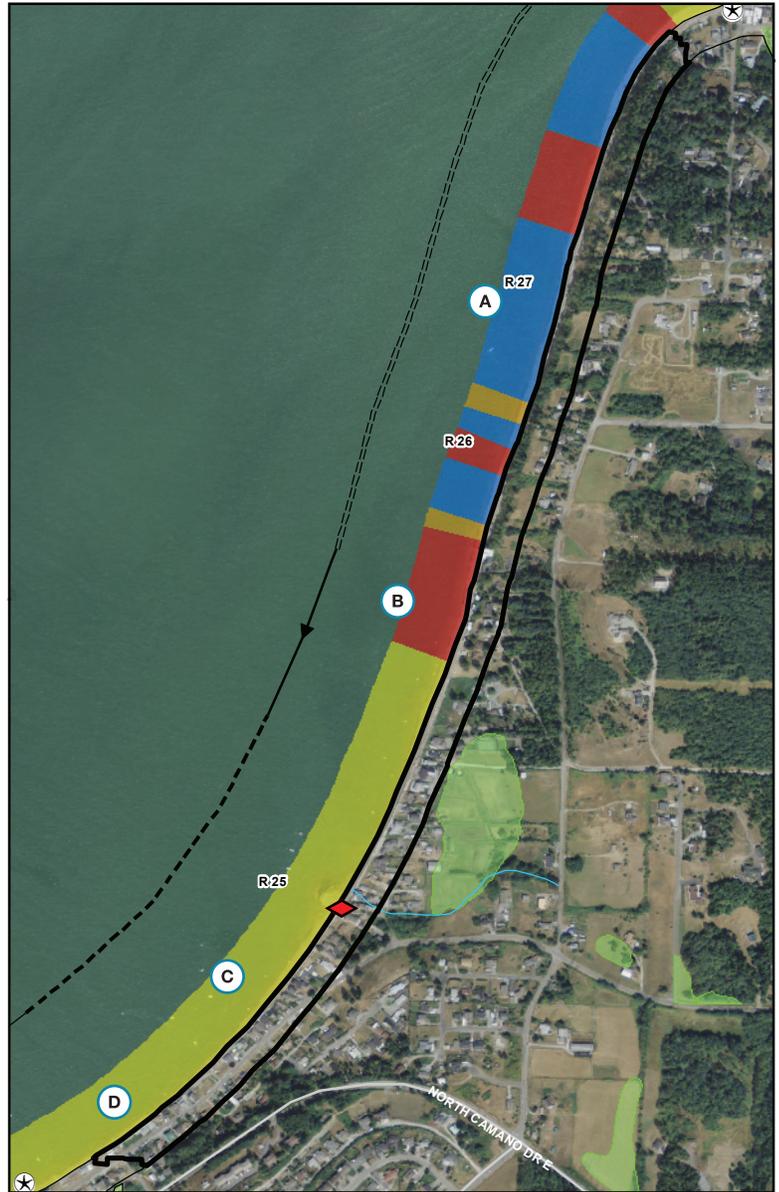
Shoreform Current (Map 10)

Bluff-backed Beach (51%) within left to right drift cell, Barrier Beach (49%) supported by area of convergence
