Incident Report: Davy Crockett Emergency Response

Update as of July 13, 2011

OPERATIONS UPDATE – July 13, 2011

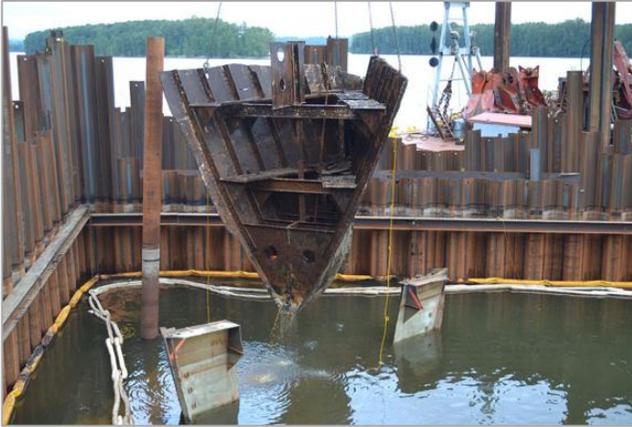
The lower half of the bow peak is lifted toward the cleaning barge Chetco. (7/13/11)

The lower half of the bow peak tank was removed by divers on Wed., July 13, 2011 (see photo gallery). Now that the entire forward peak tank has been removed, only the forward and aft deep tanks and double-bottom tanks under cargo hold #1 remain, as can be seen in the [July 13 bow deconstruction diagram](#).

The section of the bow peak tank removed on Wednesday weighed 53,550 pounds and brings the total amount of steel removed from the Davy Crockett to 3,957,677 pounds. Nearly 730,000 pounds of debris and oiled-debris has been removed from the vessel to date.
