Incident Report: Davy Crockett Emergency Response

Update as of July 5, 2011

OPERATIONS UPDATE – July 6, 2011

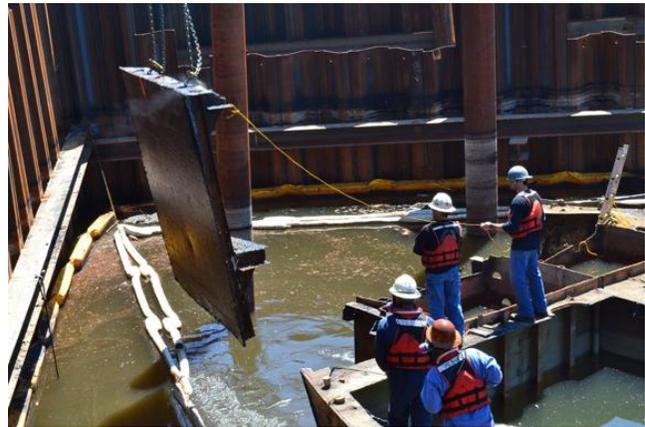
The port side-shell from the forward peak tank is lifted from the Davy Crockett. (7/6/11)

Dive teams removed nearly 30,000 pounds of steel from the Davy Crockett on Wednesday, July 6 (see photo gallery). The [July 6 bow deconstruction diagram](#) shows how much of the deck plate, frames and forward peak tank have been removed to date.

Divers will remove starboard side-shell from the forward peak tank on Thursday, July 7 and cleaning crews will continue to pressure wash steel as it is lifted from the Davy Crockett to the cleaning barge.
